**Environmental
Protection Agency**

July 26, 2011

RE: LORAIN COUNTY
VILLAGE OF LAGRANGE
KEYSTONE MIDDLE SCHOOL
NPDES PERMIT NO. OHC000003
OHIO EPA PERMIT NO. 3GC05474*AG
CONSTRUCTION STORM WATER

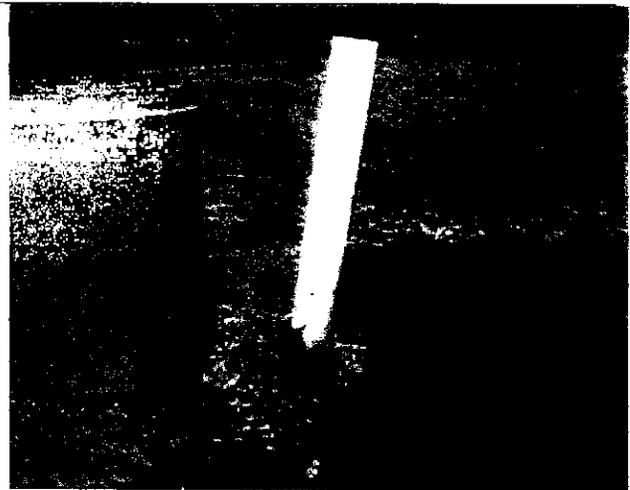
Figure 2. The new outlet structure will require a dewatering device similar to this one.

- **The preexisting sediment basin has not been modified to accommodate the runoff generated from the site.**
 - According to one of the workers from G.E. Baker, the sediment basin had been used for the High School Project just across the road. He said they decided to leave the riser pipe dewatering device in place until the new and larger outlet structure is installed to accommodate the runoff generated from both sites. They are supposedly in the process of sizing the sediment basin correctly to handle all runoff from *both* sites. Please be sure that the basin is sized correctly (with a Dewatering volume of 67 cubic yards per acre of drainage area, and a Sediment settling volume of 1000 cubic feet per acre of drainage area), and that a new dewatering device is installed correctly to treat the runoff collected in the sediment basin. Please implement the dewatering device as specified in the Storm Water Pollution Prevention Plan (SWP3) (See Figures 1 & 2).

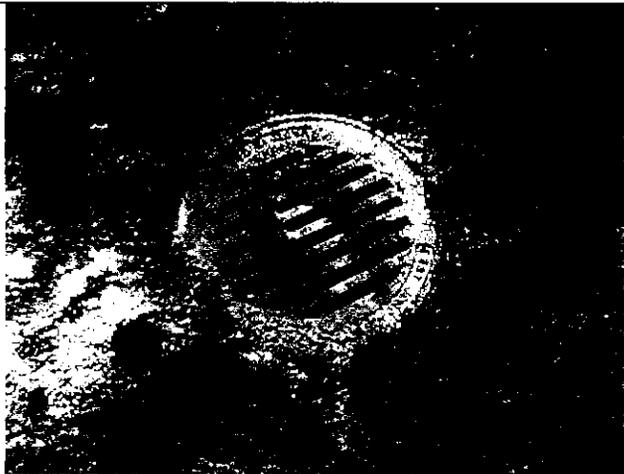
- **There are preexisting catch basins on site that have no inlet protection.**
 - There were several preexisting catch basins on site (near Opportunity Way) that were vulnerable to sediment laden water entering them. Discharging sediment laden water to surface waters of the State is a ***direct violation of the NPDES permit and punishable with fines up to \$25,000 per day of violation.*** Please be sure to install inlet protection ***immediately*** as specified in the SWP3 (See Figure 3).

Figure 3. The preexisting catch basins need inlet protection.

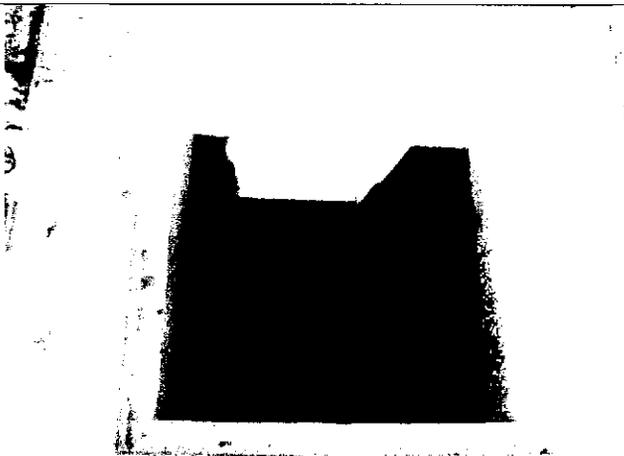
- **Several catch basins were missing grates on top.**
 - Please install grates on top of all catch basins to prevent unwanted materials from entering the storm sewers and clogging them (See Figure 5).

Figure 5. The catch basins need grates on top.
