**Environmental
Protection Agency**

RE: LORAIN COUNTY
BLACK RIVER BASIN
CITY OF LORAIN
WHITTIER MIDDLE SCHOOL

NOTICE OF DEFICIENCY

On August 17, 2010, Ohio EPA conducted a follow-up inspection of the Whittier Middle School project, located at 2321 Fairless Drive, Sheffield Township, City of Lorain, Lorain County (site). Ohio EPA records indicate that the site is covered by the General National Pollutant Discharge Elimination System (NPDES) Permit for Storm Water Associated with Construction Activity (General Storm Water Permit), permit No. 3GC04783*AG. I was accompanied by Eric Gray of Telamon Construction, Inc. The inspection documented the following:

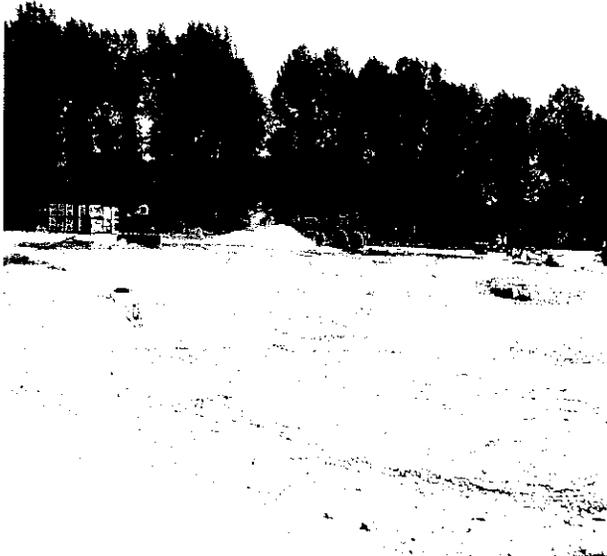
- The sediment basin has been completed (Figure 1), however, the temporary outlet structure has not been installed. A piece of filter fabric was observed to be placed over the outlet structure for sediment control (Figure 2). Remove the filter fabric and immediately install the temporary riser pipe in accordance with the site's storm water pollution prevention plan (SWP3).

- Some areas of the site were observed to have been idle for a long period of time. Stabilize all areas that will remain idle for 21 days or longer or that are at final grade. Such areas include the banks of the sediment basin (Figure 1) and the topsoil storage pile (Figure 5).

Figure 1. The sediment basin has been completed. The banks of the sediment basin need to be stabilized.

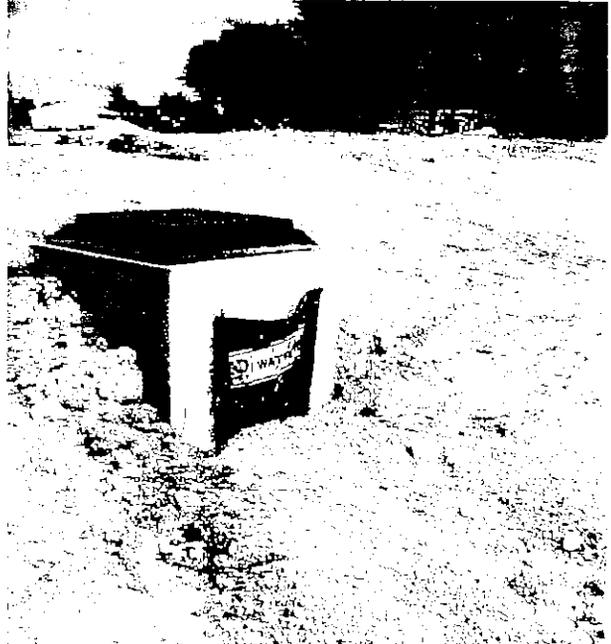
Figure 2. The temporary outlet structure for the sediment basin has not been installed.

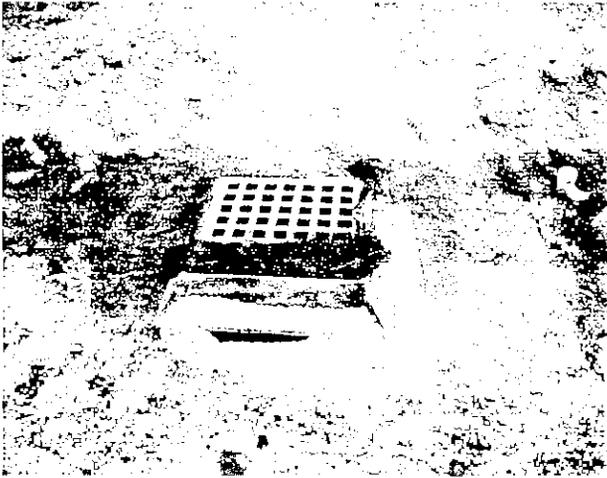
- Improper or no inlet protection was observed to be installed (Figure 3). Install inlet protection in accordance with the site's SWP3. It was observed in the SWP3 details that filter fabric is to be wrapped around the grates of the catch basins once concrete/asphalt has been placed. This is incorrect. A commercially approved media (dandy bag, silt sack, etc.) will need to be installed on these inlets once final grade has been reached.

Figure 3. Improper inlet protection has been installed around the site's storm sewer inlets.

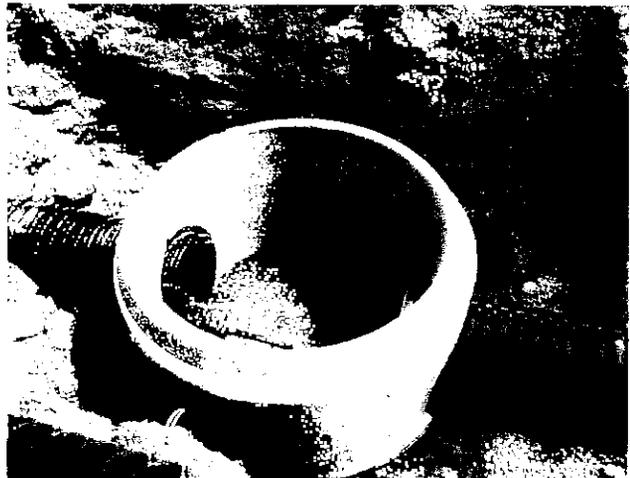
- A concrete manhole was observed to have been installed in the ground; however the storm sewer connections have not been completed (Figure 4). Storm water runoff is able to seep into the storm sewers at the connections. Finish installation of the manhole and storm sewer connections, ensuring that all seals are water-tight.

Figure 4. This storm sewer connection has not been completed. Storm water runoff is able to seep into the storm sewer at the connections.

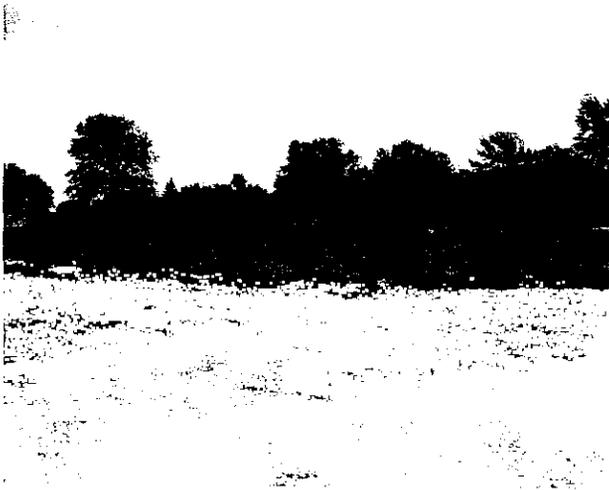
Figure 5. Since only a small area of the topsoil stockpile is in constant use, the idle areas of the stockpile need to be stabilized.

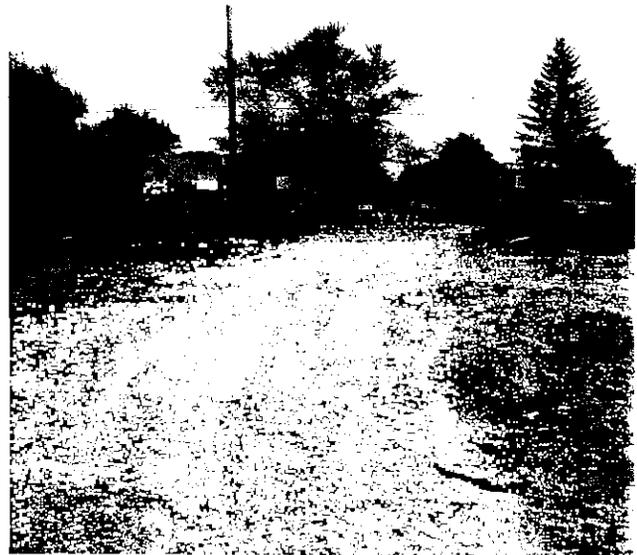
- The construction entrance was observed to be in poor condition. Maintain or reinstall the construction entrance as necessary.
- At the time of the inspection, Telamon Construction had not filed a co-permittee notice of intent (NOI). A co-permittee application form with instructions was given to Mr. Gray. Future forms and instructions can be obtained from:

Figure 6. The construction entrance was observed to be in poor condition.
