State of Ohio Environmental Protection Agency

RE: LORAIN COUNTY
BLACK RIVER WATERSHED
CITY OF OBERLIN
EAST COLLEGE STREET

NOTICE OF VIOLATION

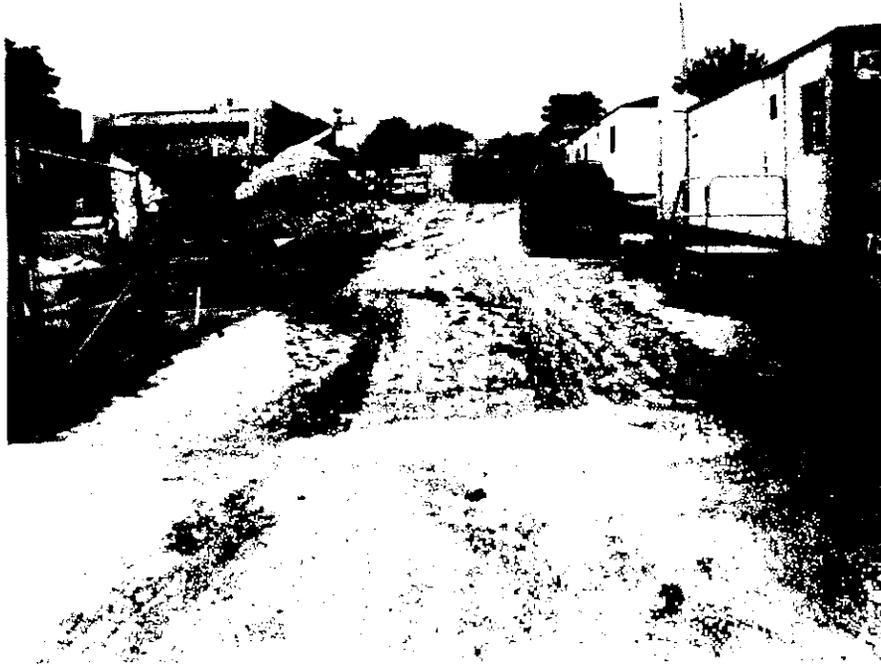
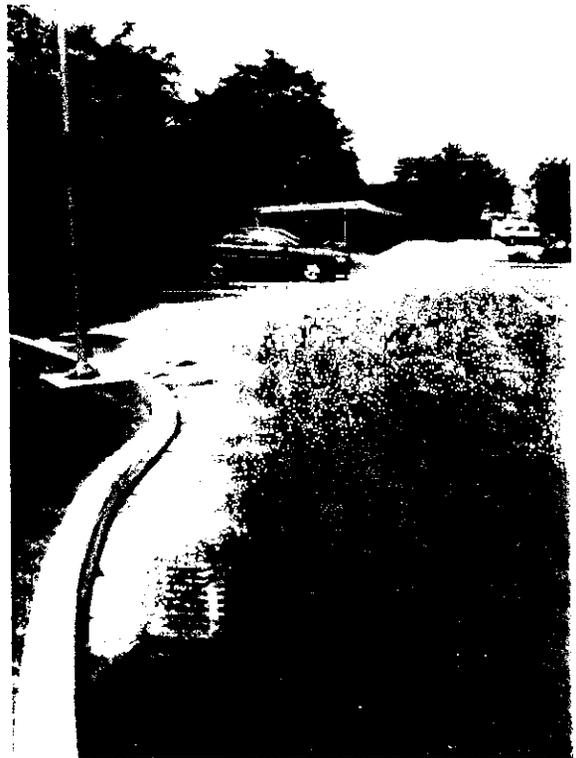
- **Failure to control off-site tracking of sediment out onto S. Pleasant St.** This is a violation of Part III.G.2.g.ii of the NPDES permit and ORC 6111.04 and 6111.07. Video taken by the complainant on April 28 and 29, 2009, shows sediment-laden discharges into Plum Creek during or shortly after a rain event. Upon review of the video, the source of the sediment is soils tracked out onto S. Pleasant St. at the SCA project construction entrance. Good housekeeping measures must be implemented to clean up soils that are tracked off-site. A mechanical broom sweeper is on site, however be aware that vacuum sweepers are more efficient. Be sure to clean up materials that get tracked off-site as soon as possible and certainly prior to a storm event to prevent turbid discharges in the future.

Fig 1-3. A construction entrance has been added at the south end of 43 E. College St. However, the lack of a water bar and off-site tracking has lead to sediment discharges into adjoining storm sewer systems.

- **Failure to install runoff controls across the south construction entrance.** This is a violation of Part III.G.2.c of the NPDES permit and ORC 6111.04 and 6111.07. The south construction entrance consists of an existing paved drive. Construction vehicles accessing the soil stockpile deposit sediment on this drive, where it can be washed off site by runoff or tracked off-site by construction vehicles. The detail drawing contained in the SWP3 for rock construction entrances indicates that a water bar may be necessary to intercept sediment-laden flows and direct them to a sediment control. A water bar was not installed. The amended SWP3 specifies that a water bar will be placed across the drive and the existing pavement is to be replaced with geotextile and stone. Please install these runoff controls in accordance to the revised SWP3.

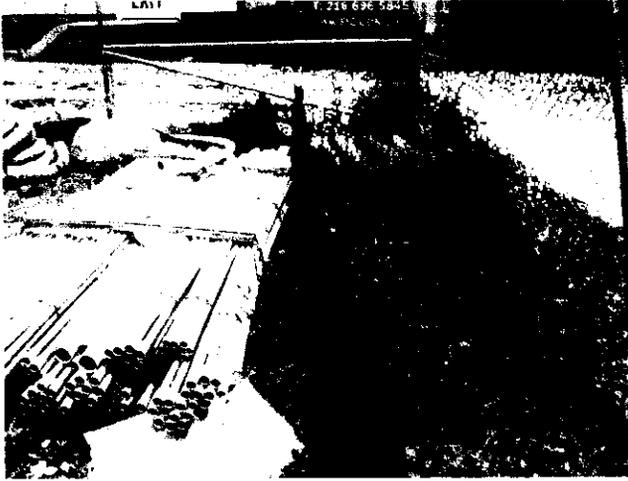
- **Failure to properly install and maintain silt fence on the project.** This is a violation of Part III.G.2.h of the NPDES permit and ORC 6111.04 and 6111.07. This violation pertains to the silt fence located around the soil stockpile and along the south construction entrance. Silt fence cannot have gaps, must be trenched in, pulled tight, backfilled and extended to intercept the entire width of flow in order to cause runoff to pond. Please install and repair the silt fence as necessary for it to function as intended.

Fig 4 (LEFT). There is a gap between two sections of silt fence near the construction entrance located on 43 E. College St.

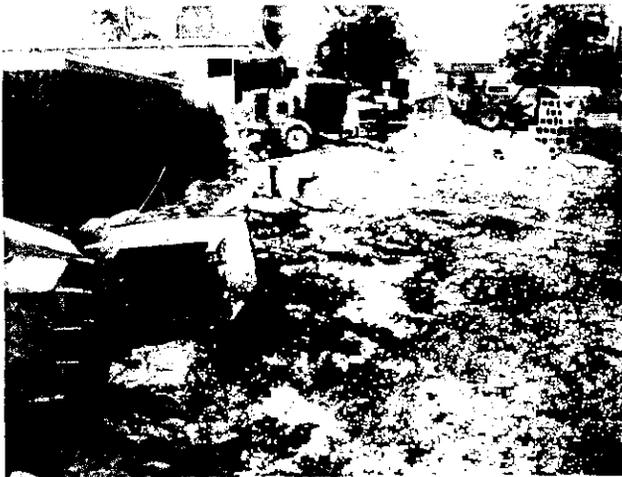
- **Failure to provide berms, covers or other containment structures around mortar mix operations.** This is a violation of Part III.G.2.g.i of the NPDES permit and ORC 6111.04 and 6111.07. Mortar mix operations were set up immediately adjacent to the sediment trap. Stockpiles of materials used to create mortar and washwaters from mortar mixing operations were observed in or by the sediment trap, allowing their discharge from the site. The NPDES permit does not authorize the discharge of wastewater such as mortar mix washwater.

Fig 6 (LEFT). The mortar mix area is located immediately adjacent to the sediment trap. Washwater from mortar mix operations is not contained to prevent discharge.

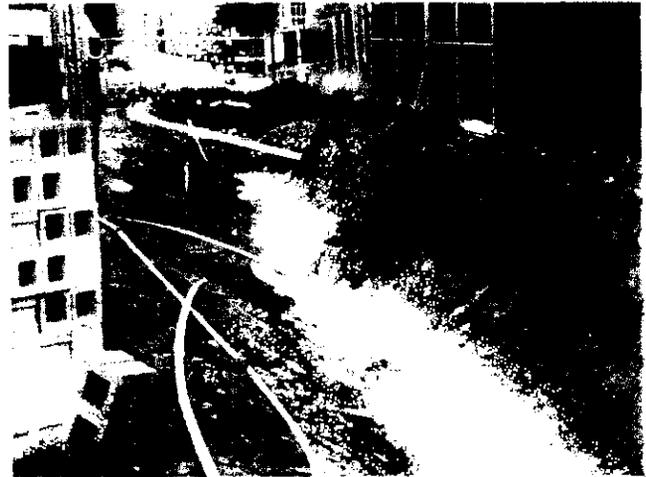
- **Failure to amend the Storm Water Pollution Prevention Plan (SWP3) whenever there is a change in design, construction, operation or maintenance which has the potential to create a discharge of pollutants in storm water runoff.** This is a violation of Part III.D of the NPDES permit and ORC 6111.04 and 6111.07. My inspection revealed that the sediment trap was not placed in the location indicated on the SWP3 and that a second rock construction entrance has been installed at the back

Fig 7 (RIGHT). The sediment trap is not located where shown on the SWP3 nor constructed per the detail drawings shown in the plan.

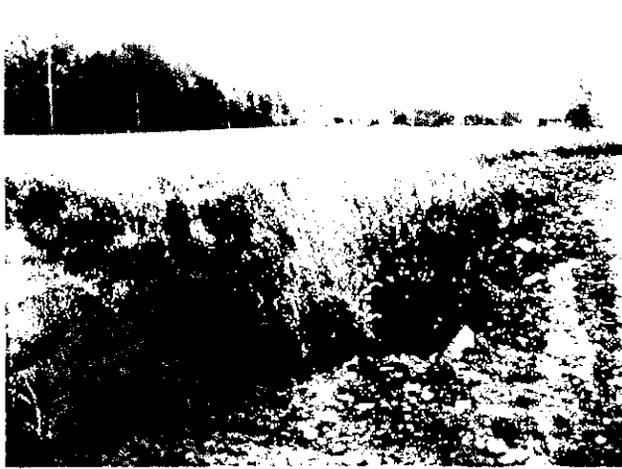
Fig 10 & 11. The fill material taken to 45250 Hamilton Rd has been placed in wetlands.
