**Environmental
Protection Agency**

July 11, 2011

RE: PORTAGE COUNTY
ROOTSTOWN TOWNSHIP
GENERAL ALUMINUM
CONSTRUCTION STORM WATER

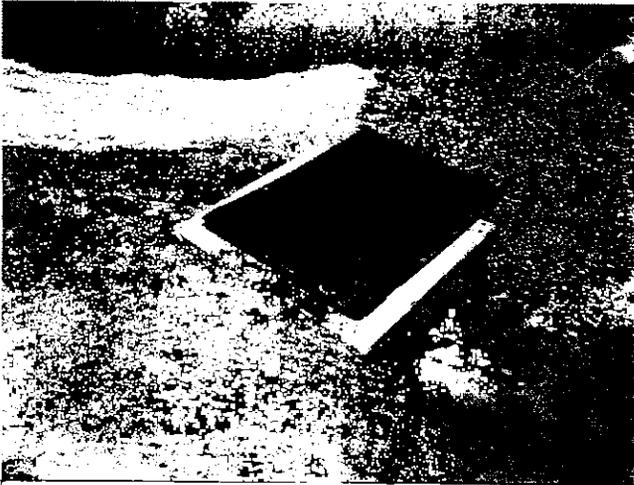
4. The inlet protection on the outlet structure of the sediment basin is not an appropriate sediment control (Figure 7). Please install an approved form of inlet protection, as specified in the *Rainwater and Land Development Manual* (Ohio Department of Natural Resources, 2006), available on-line at <http://www.dnr.state.oh.us/tabid/9186/default.aspx>.

Figure 7 – The inlet protection on the outlet structure of the sediment basin is not an approved control.
