State of Ohio Environmental Protection Agency

July 8, 2010

RE: SUMMIT COUNTY
SUMMIT LAKE BASIN
CITY OF AKRON
DR THOMAS MC EBRIGHT
COMMUNITY LEARNING CENTER

On June 17, 2010, Ohio EPA conducted an inspection of the Dr. Thomas Mc Ebright Community Learning Center project located at 349 Cole Avenue, City of Akron, Summit County (site). Ohio EPA records indicate that the site is covered by the General National Pollutant Discharge Elimination System (NPDES) Permit for Storm Water Associated with Construction Activity (General Storm Water Permit), permit No. 3GC04519*AG. The inspection documented the following:

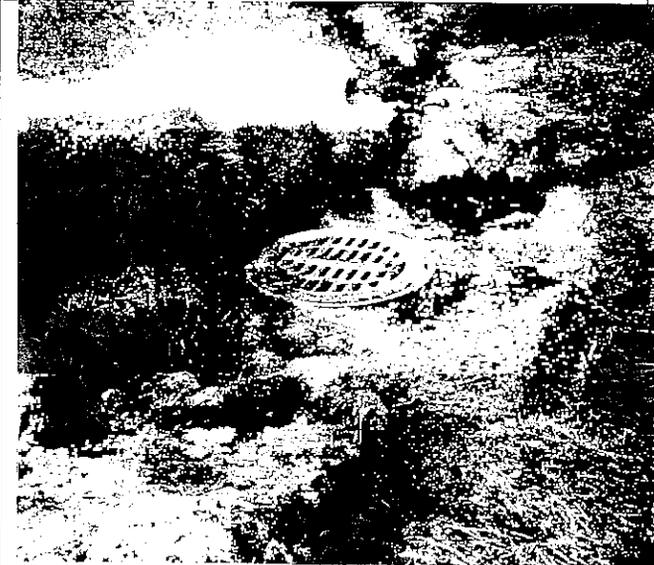
- No or improper inlet protection has been installed throughout the site. Mr. Simonetta stated that it is not possible to install the inlet protection as called for in the site's SWP3 due to the fact that many of the storm sewer inlets are located in the construction access roads. It was also noted that some of the storm sewer inlets were buried beneath at least a foot of stone. A revision will need to be made to the site's SWP3 to provide adequate inlet protection.

Figure 3. No inlet protection was observed on most of the site's storm sewer inlets.

Filter fabric was wrapped around the grates and then set into the catch basin before the stone drive was installed. Based on a conversation between Paul Schmoll and Sean Green, this method is acceptable and revised drawings are not required.

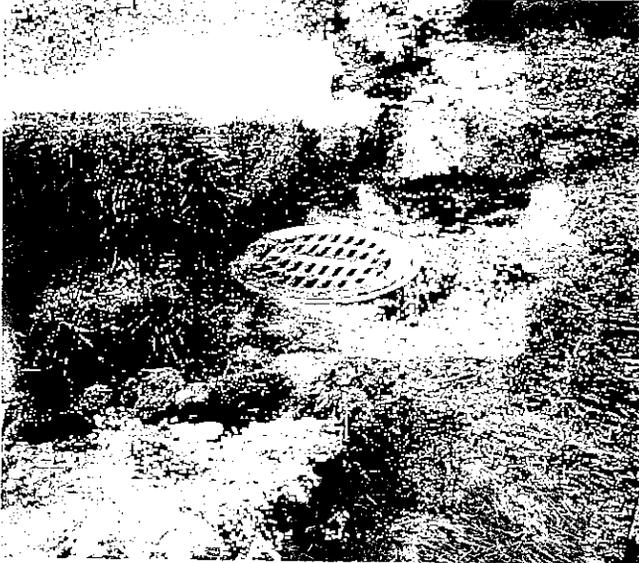
- No or improper inlet protection has been installed throughout the site. Mr. Simonetta stated that it is not possible to install the inlet protection as called for in the site's SWP3 due to the fact that many of the storm sewer inlets are located in the construction access roads. It was also noted that some of the storm sewer inlets were buried beneath at least a foot of stone. A revision will need to be made to the site's SWP3 to provide adequate inlet protection.

Figure 3. No inlet protection was observed on most of the site's storm sewer inlets.
