**Environmental
Protection Agency**

August 9, 2010

RE: SUMMIT COUNTY
LITTLE CUYAHOGA RIVER BASIN
CITY OF AKRON
WINDEMERE COMMUNITY LEARNING CENTER

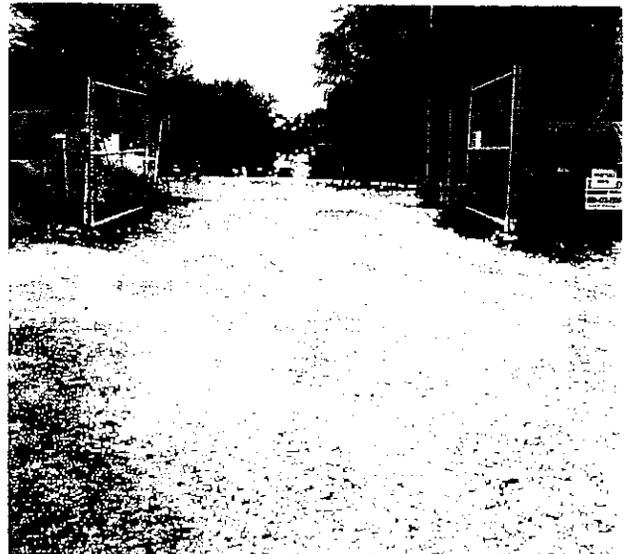
Figure 2. Offsite tracking was observed at the main construction entrance.

- Sediment deposition was observed within the proposed biofilter areas (Figure 1). Remove all sediment before constructing the biofilters.
- Offsite tracking was observed (Figure 2). Reinstall and maintain the construction entrance in accordance with the site's SWP3. Mud spilled, dropped, washed or tracked onto public roads shall be removed immediately by scraping or sweeping. Offsite tracking was also observed at a rear entrance (Figure 3). Ensure all construction traffic is using the main construction entrance.

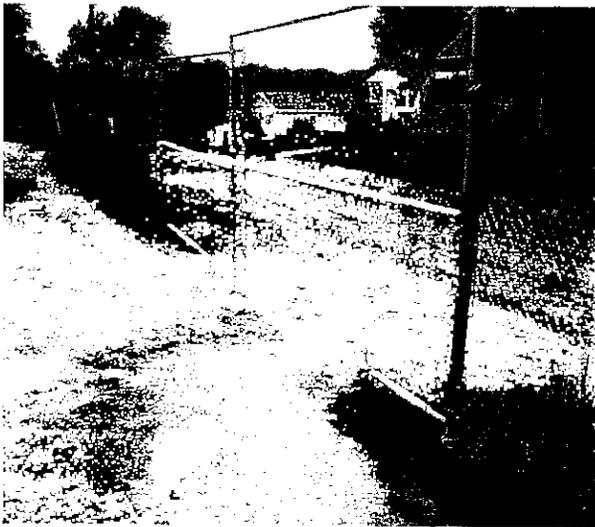
Figure 3. Offsite tracking was observed at a rear construction entrance.

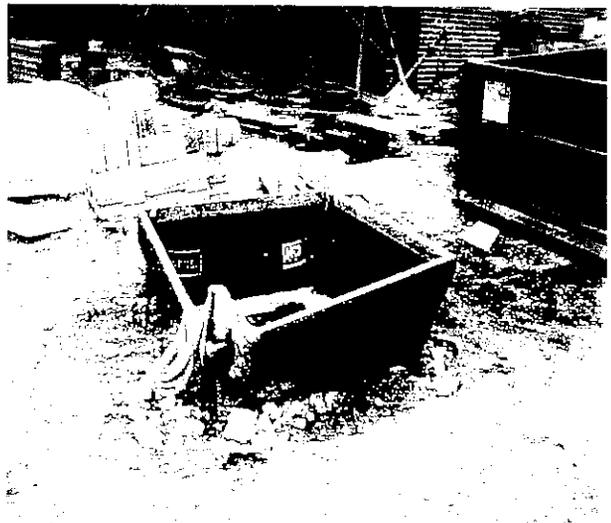
Figure 4. Inlet protection has been damaged.

- Inlet protection has been damaged (Figure 4). Repair or reinstall inlet protection as necessary.
- The concrete washout pit was observed to be poorly constructed (Figure 5). Reinstall the concrete washout pit in accordance with the site's SWP3.

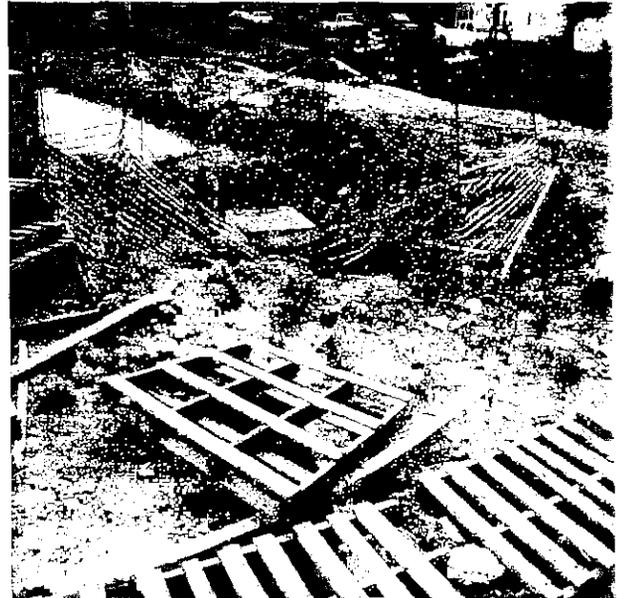
Figure 6. Runoff from mortar and grout activities is flowing into the biofilter area.

- Mortar and grout runoff was observed entering the biofilter area near the batching facilities (Figure 6). Use BMPs to prevent mortar and grout runoff from discharging into the biofilter areas.
