State of Ohio Environmental Protection Agency

July 7, 2010

RE: SUMMIT COUNTY
LITTLE CUYAHOGA RIVER BASIN
CITY OF AKRON
WINDEMERE COMMUNITY LEARNING CENTER

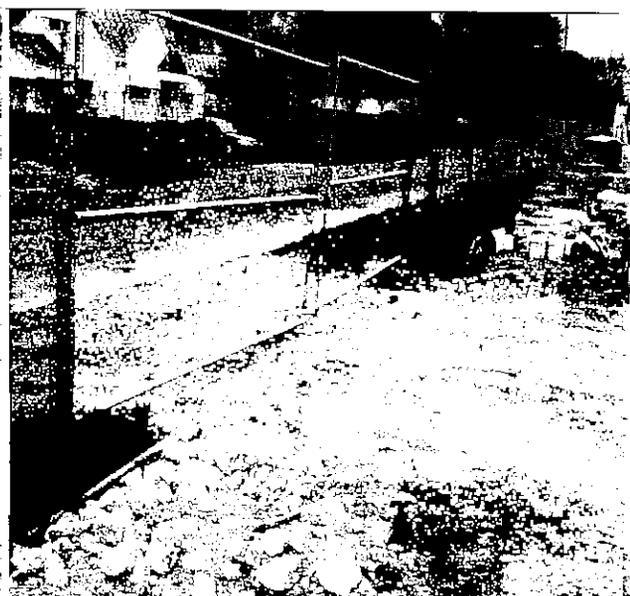
- Sediment laden storm water runoff appears to be flowing offsite along a rear entrance to the site (Figure 2). Best management practices (BMPs) need to be used to prevent storm water runoff from flowing offsite. I talked with Clay Poling of RPJ Construction Managers and he stated that he would build a berm across the entrance to keep the storm water runoff on-site.

Figure 2. Sediment-laden storm water runoff is flowing offsite via an unused rear entrance.

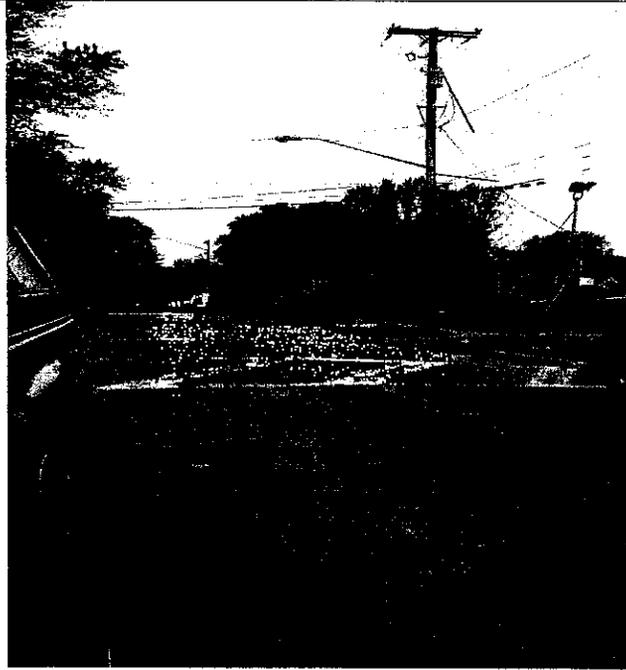
- Heavy offsite tracking was observed (Figure 5). Reinstall and maintain the construction entrance in accordance with the site's SWP3. Mud spilled, dropped, washed or tracked onto public roads shall be removed immediately by scraping or sweeping.

Figure 5. Heavy offsite tracking was observed.

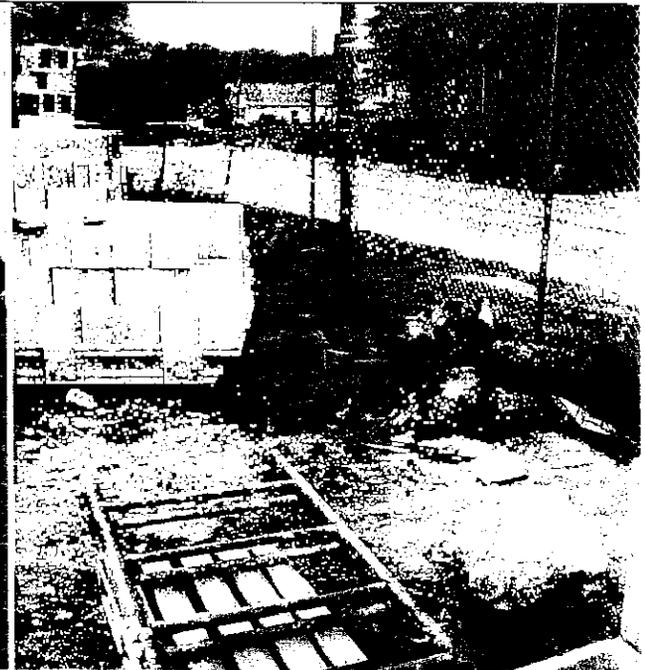
- Silt fence had been torn or damaged (Figure 6). Reinstall silt fence in accordance with the site's SWP3.

Figure 6. Silt fence needs repaired or reinstalled.
