RE: SUMMIT COUNTY
SPRINGFIELD LAKE OUTLET BASIN
CITY OF AKRON
HYRE COMMUNITY LEARNING CENTER

On June 17, 2010, Ohio EPA conducted an inspection of the Hyre Community Learning Center project located at 2443 Wedgewood Drive, City of Akron, Summit County (site). Ohio EPA records indicate that the site is covered by the General National Pollutant Discharge Elimination System (NPDES) Permit for Storm Water Associated with Construction Activity (General Storm Water Permit), permit No. 3GC04518*AG. The inspection documented the following:

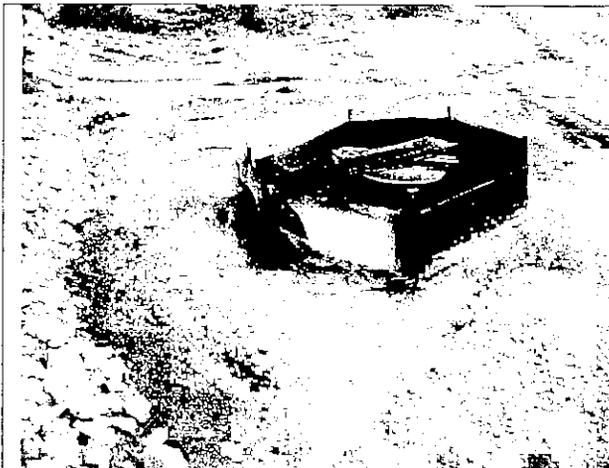
- Improper inlet protection has been installed around the site's storm sewer inlets (Figures 1 and 2). Much of the inlet protection has been damaged. Heavy sediment deposition was observed around the storm sewer inlets. Remove existing inlet protection and reinstall in accordance with the site's storm water pollution prevention plan (SWP3).

Figure 1. Improper inlet protection has been installed and damaged.

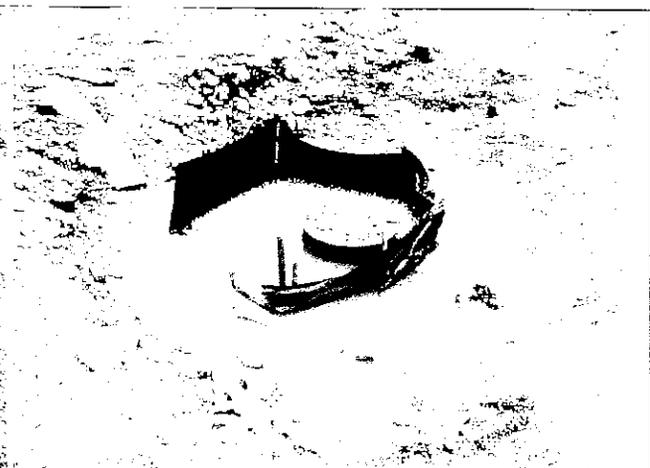
Figure 2. Improper inlet protection has been installed and damaged.

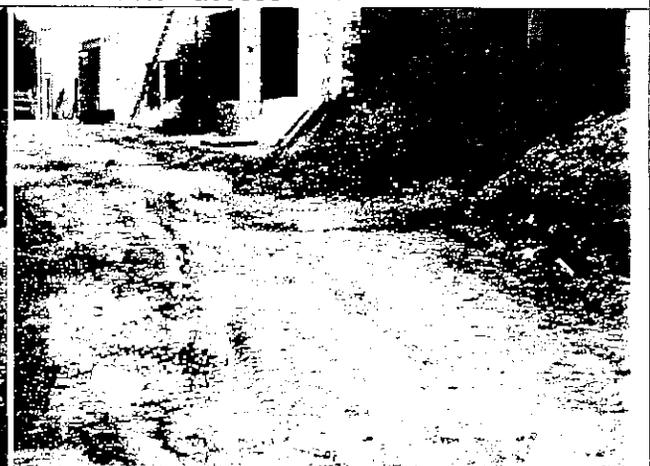
- A concrete washout pit was observed to be in need of maintenance (Figure 5). Reinstall the concrete washout pit in accordance with the site's SWP3 and maintain as necessary. Concrete washout was observed in random areas throughout the site (Figure 6). Ensure all concrete traffic is using the washout pits provided.

Figure 6. Concrete washout was observed in various areas throughout the site.

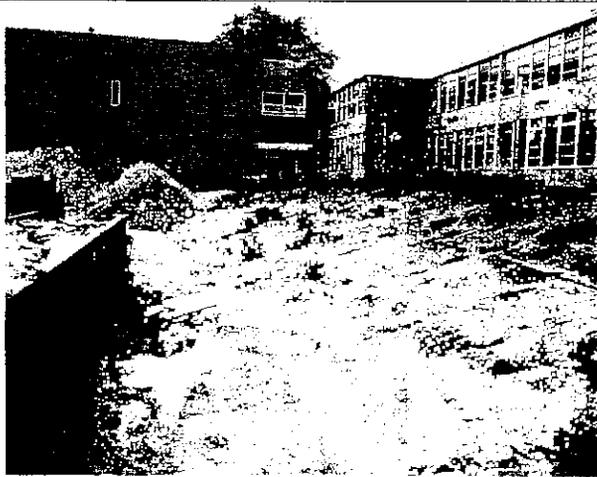
- Some areas of the site appeared to be idle for long periods of time (Figure 7). Stabilize all areas that will remain idle for a period of 21 days or longer or that are at final grade.

Figure 7. Any areas of the site that will remain idle for 21 days or longer will need to be temporarily stabilized.
