**Environmental  
Protection Agency**

August 4, 2011

RE: SUMMIT COUNTY  
VILLAGE OF BOSTON HEIGHTS  
PAYCHEX OFFICE BUILDING  
CONSTRUCTION STORM WATER

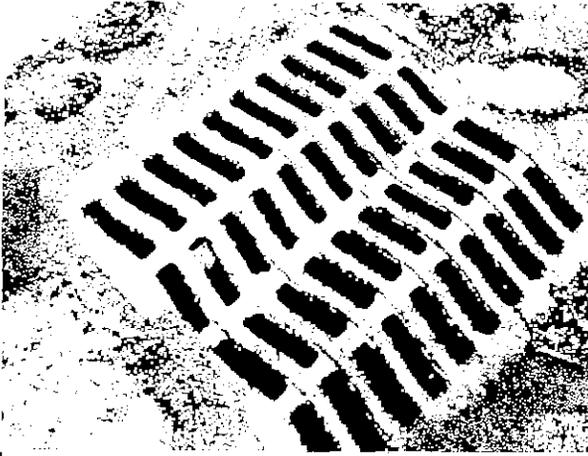
1. The inlet protection still has not been replaced (Figure 1). Please remove the geotextile fabric under the grate and replace it with a framed structure designed in accordance with the *Rainwater and Land Development Manual* (Ohio Department of Natural Resources, 2006), available on-line at <http://www.dnr.state.oh.us/tabid/9186/default.aspx>. You must also install an approved form of inlet protection, such as a Dandy Bag or Silt Sack, on the storm drain in the northeast corner of the parking lot.

Figure 1 – The inlet protection on the storm drains should be modified.

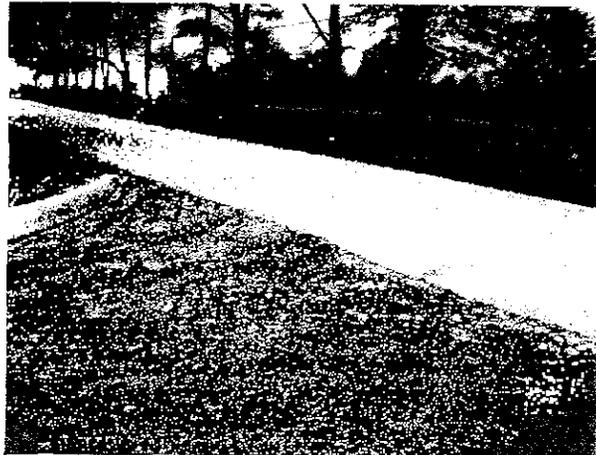
4. The rock construction entrance still needs to be repaired (Figure 4). You should either clean the gravel that is currently present or add more stone to the entrance in order to reduce the amount of sediment that is tracked onto Hines Hill Road. In addition, you should clean the paved parking area on the east side of the site to prevent sediment from washing into the storm drains.

Figure 4 – The rock construction entrance should be repaired.
