Environmental  
Protection Agency

July 11, 2011

RE: SUMMIT COUNTY  
CITY OF MACEDONIA  
WESTERN RESERVE  
GRACE BRETHERN CHURCH  
CONSTRUCTION STORM WATER

On June 23, 2011, I, along with Dan Bogoevski of the Ohio EPA, performed an inspection at the above-referenced site to determine compliance with the Ohio EPA General Storm Water National Pollutant Discharge Elimination System (NPDES) Permit for Construction Activities #3GC05012\*AG. Our records indicate that Western Reserve Grace Brethren Church was granted coverage under the NPDES permit on July 16, 2010.

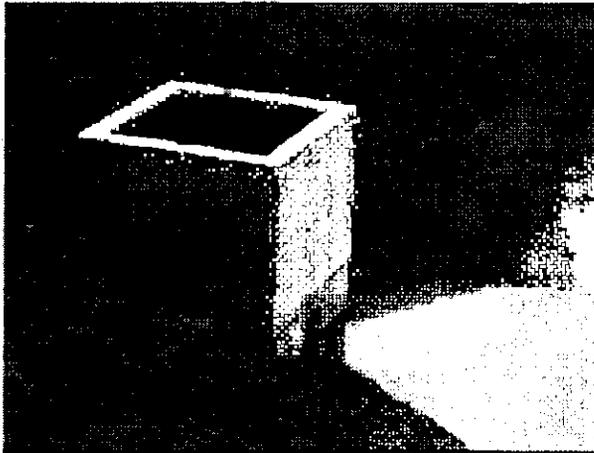
1. The sediment basin/trap that is present on site does not have an appropriate outlet structure (Figures 1 and 2). Although the Storm Water Pollution Prevention Plan (SWP3) calls for a sediment trap, a sediment basin is really necessary to treat the runoff from a site of this size. You should contact the engineer for this project to request the design specifications of a properly designed outlet structure (either a riser pipe or a skimmer device). The design requirements for these structures can be found in the *Rainwater and Land Development Manual* (Ohio Department of Natural Resources, 2006), available on-line at <http://www.dnr.state.oh.us/tabid/9186/default.aspx>.

Figure 1 – The current outlet structure is not appropriate for treating sediment-laden water.
