Environmental  
Protection Agency

June 20, 2011

RE: TRUMBULL COUNTY  
MESOPOTAMIA  
ADVANCE ECO-AGRICULTURE LLC  
NPDES PERMIT NO. OHC000003  
OHIO EPA PERMIT NO. 3GC05200\*AG  
CONSTRUCTION STORM WATER

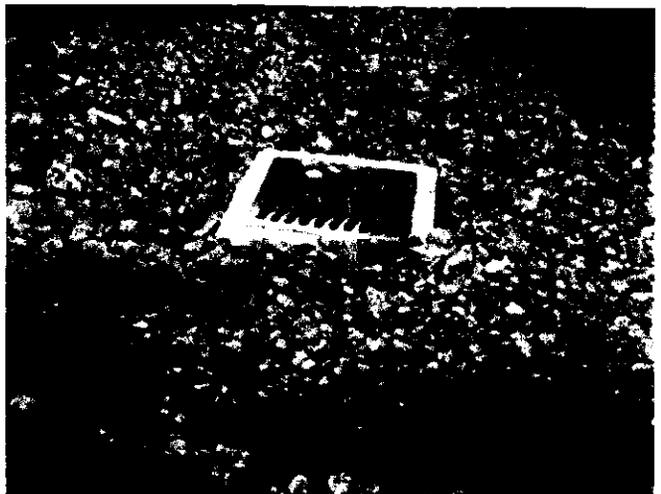
4. No inlet protection is present on the storm drain next to the manufacturing building (Figure 4), and sediment-laden water is visible in the catch basin (Figure 5). As stated in the NPDES permit, control practices must be utilized to minimize the amount of sediment that enters storm drains.

Figure 4 – No inlet protection is present.

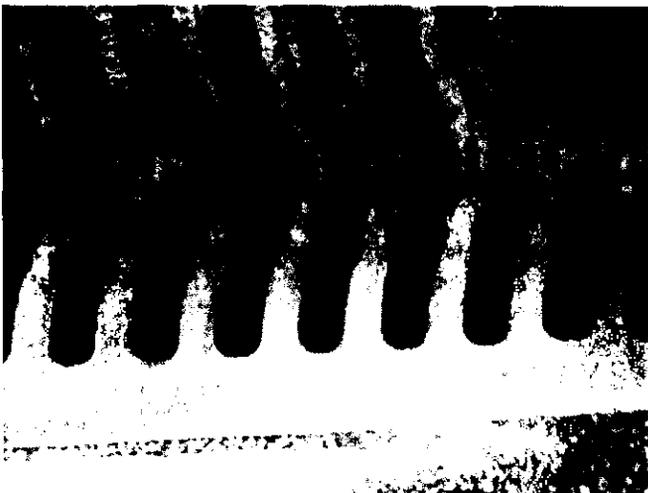
Figure 5 – Sediment-laden water can be seen in the catch basin, which discharges to waterways.
