**Environmental
Protection Agency**

May 3, 2011

RE: Wayne County
Baughman Twp.
BAU-TR-299-1.39 (Huprick Road)
Storm Water Construction

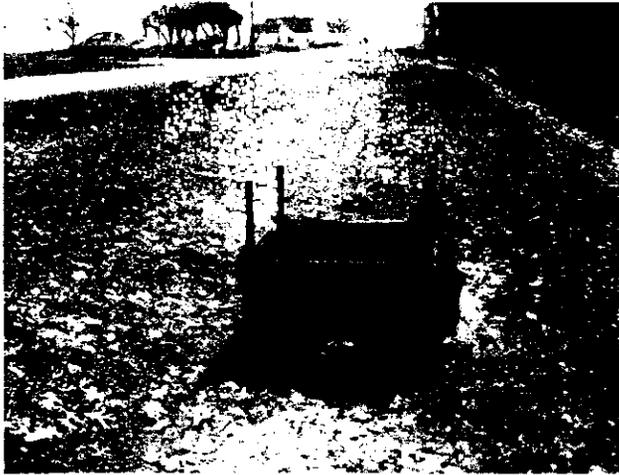
- Inlet protection around catch basins requires repair or replacement. Holes were observed in the geotextile around certain inlets and the geotextile was not trenched and backfilled around other inlets. Either condition prevents runoff from ponding around the inlet so that sediment can settle. Please make repairs or replace the geotextile, as appropriate.
- Perimeter silt fence is in need of repair at the back of the cul-de-sac and in the vicinity of STA 80+00. The silt fence in these locations is down and must be re-erected or better supported to withstand flow. Please make the appropriate repairs.

Fig 1 & 2. Storm drain inlet protection requires repair. In the photo on the left, a hole has developed in the geotextile allowing sediment-laden runoff to directly enter the catch basin. In the photo on the right, the geotextile has been lifted, limiting the effectiveness of this control measure.

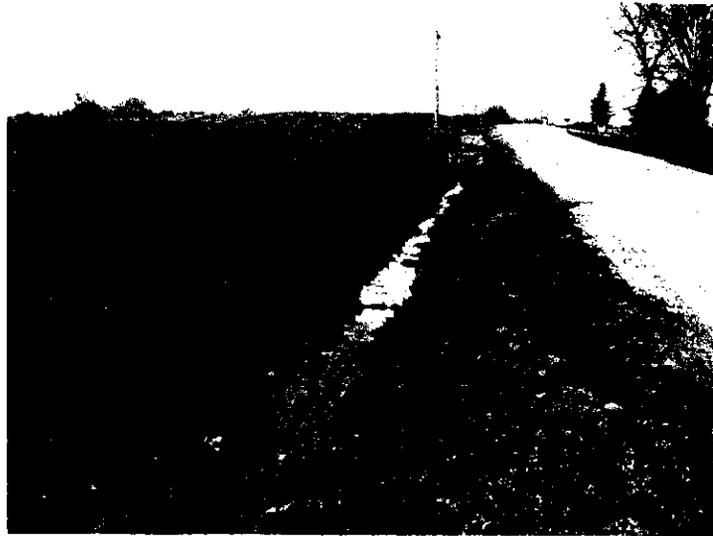
Fig 7. Swale along Huprick Road. These swales could easily be enhanced to meet post-construction requirements. As a redevelopment project, requirements could be met by enhancing a sufficient length of swales to treat 20% of the Water Quality Volume (WQV).
