**Environmental
Protection Agency**

RE: Wayne County
Upper Muskingum River Watershed
Baughman Twp.
BAU-TR-299-1.39 (Huprick Rd)

On September 2, 2010, I performed a compliance inspection of storm water best management practices (BMPs) at the above referenced construction site. While on site, I met with Rod Richardson, project superintendent for Terra Valley Excavating. Our records indicate that storm water discharges from this project have been authorized under the Ohio EPA General Storm Water National Pollutant Discharge Elimination System (NPDES) Permit for Construction Activities #3GC04796*AG.

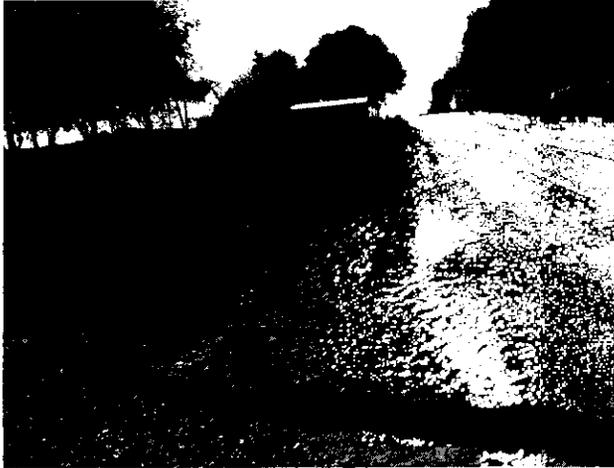
- **Check dams have not been constructed per the specification contained in the Storm Water Pollution Prevention Plan (SWP3).** Check dams have not been placed in the roadside ditch as specified in the SWP3, in particular, from STA 73+50 to STA

Fig 1 (LEFT). Check dams have not been installed in the roadside ditch as required by the SWP3.

80+00. Please install check dams where shown in the SWP3. Further, the check dams that have been installed elsewhere are not constructed per the detail drawing contained in the SWP3. The detail drawing calls for rock in addition to silt fence. No rock has been installed and silt fence has not been extended across the entire width of the channel, trenched in and backfilled. Please construct check dams per the detail drawing contained in the SWP3.

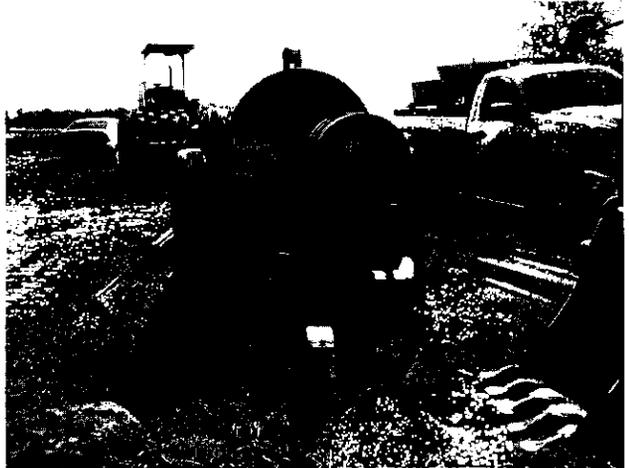
- A drip tray under the spigots or secondary containment has not been provided for the drums and tanks that store fuel, motor oil and other chemicals used on the construction site. The NPDES permit requires the implementation of non-sediment pollutant controls.

Fig 4 (RIGHT). No secondary containment or other form of spill prevention has been provided around the fuel tank or these 55-gallon drums of motor oil.

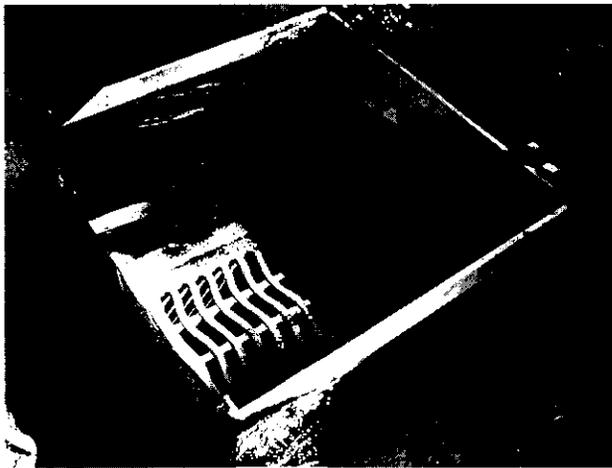
Fig 7 (LEFT). Storm drain inlet protection requires repair.

- **Storm drain inlet protection has not been installed** on all drains as required by the SWP3. Please install inlet protection around all storm sewer grates to prevent sediment from entering the sewer system. Be sure to maintain inlet protection, and all other BMPs, in a functional condition. Sediment controls must be capable of ponding runoff and be built per specification in order to be considered functional.
