Environmental
Protection Agency

Re: Hancock County
Dow Chemical Co.
Industrial
Storm Water

August 9, 2011

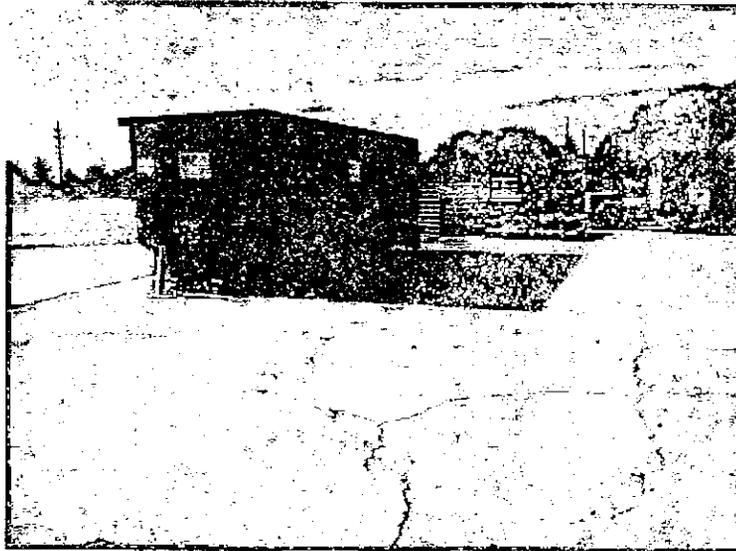
7/13/2011 Hancock County, DOW. General refuse roll-offs on the southeast side of building. Taken by Lynette Hablitzel. DOW_07132011_01.jpg

The roll-offs containing garbage were not covered. Please make sure all outside bins and roll-offs containing material are covered or ensure the containers are leak proof. It should be noted under the draft MSGP, Section 2.2.1, permittees are required to minimize exposure of materials by locating them inside or protecting with a storm resistant shelter. Industrial materials do not need to be enclosed or covered if storm water runoff from affected areas will not be discharged to receiving waters.

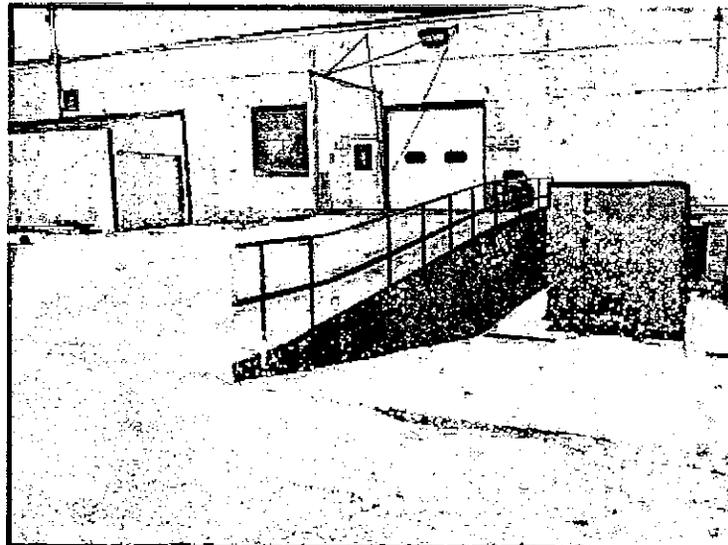
7/13/2011 Hancock County, DOW. Loading/unloading bay and compactor on east side of building. Taken by Lynette Hablitzel. DOW_07132011_02.jpg

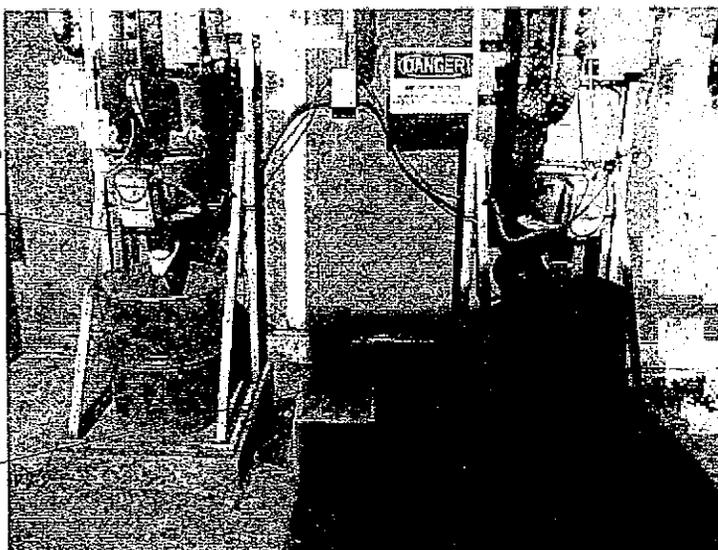
7/13/2011 Hancock County, DOW. . On east side of building. Uncovered receiving drums were beneath the pressure relief device for the air collection and filter system. Catch basin with metal screen located between drums. Taken by Lynette Hablitzel. DOW_07132011_04.jpg

Dust collection
and filter
system
pressure relief

Screen over
catch basin

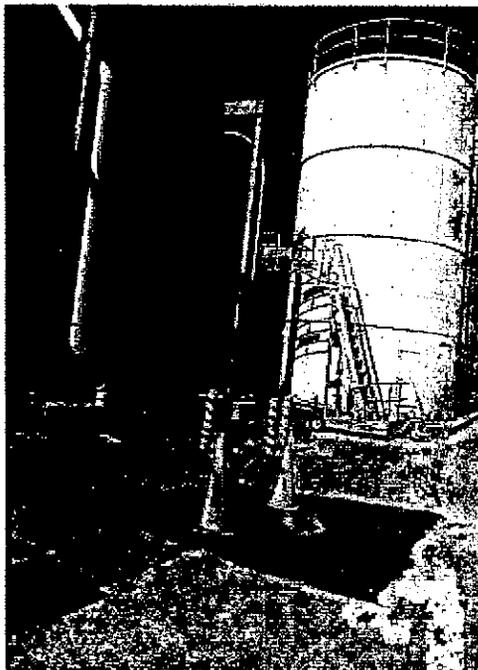
7/13/2011 Hancock County, DOW. On east side of building. Covered rail car unloading area. Plastic pellet storage silos on the right. Taken by Lynette Hablitzel. DOW_07132011_05.jpg

6. Good Housekeeping - The permit requires BMPs that result in the maintenance of a clean, orderly facility. Some plastic pellets were observed scattered throughout the railcar unloading area. Increased visual monitoring and sweeping is recommended for this area.

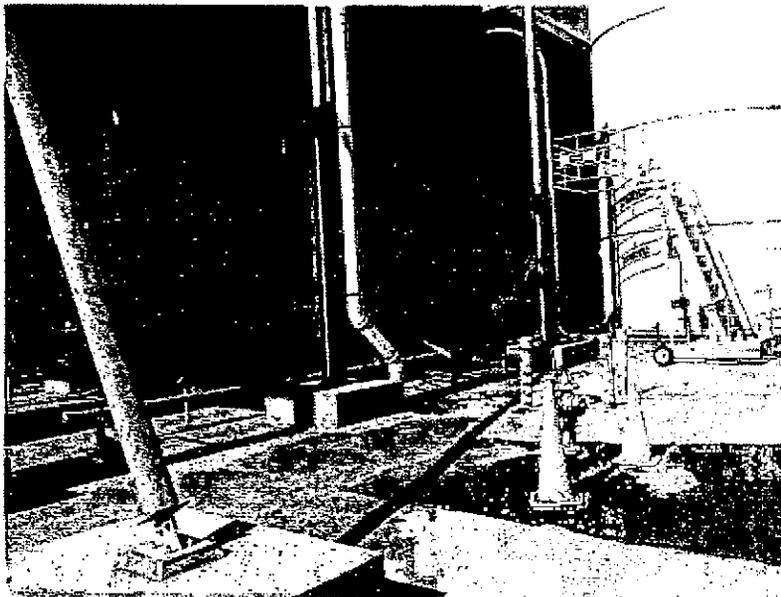
7/13/2011 Hancock County, DOW. On east side of building. Covered rail car unloading area. Plastic pellet storage silos on the right. Taken by Lynette Hablitzel. DOW_07132011_06.jpg
