Re: Lucas County
Arbors at Oregon
Construction
Storm Water

July 8, 2009

Arbors at Oregon

June 08, 2009

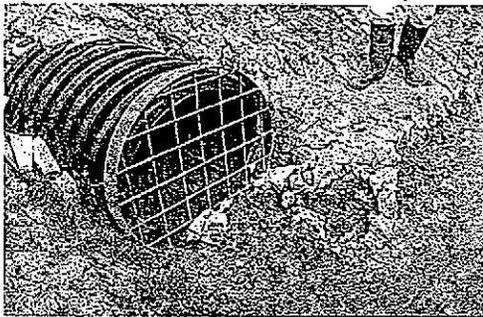
ArborsatOregon_060809_02
Outlet from Retention Pond.
