Ohio Environmental Protection Agency

**Re: 1003-25-0656
Columbus
Franklin County**

The purpose of this letter is to serve as a written follow-up and subsequent Notice of Violation (NOV) to an inspection conducted on March 22, 2010, by Michael Dalton, Ohio Environmental Protection Agency (Ohio EPA). This inspection revealed an oil discharge from Heartland Refinery at 4001 East 5th Avenue, Columbus, Ohio. The discharge entered Mason Run, a tributary of the Big Walnut Creek drainage system in violation of Sections 6111.04 and 3750.06 of the Ohio Revised Code (ORC).

Emergency Response Section - District Office Investigation Report (DOIR)

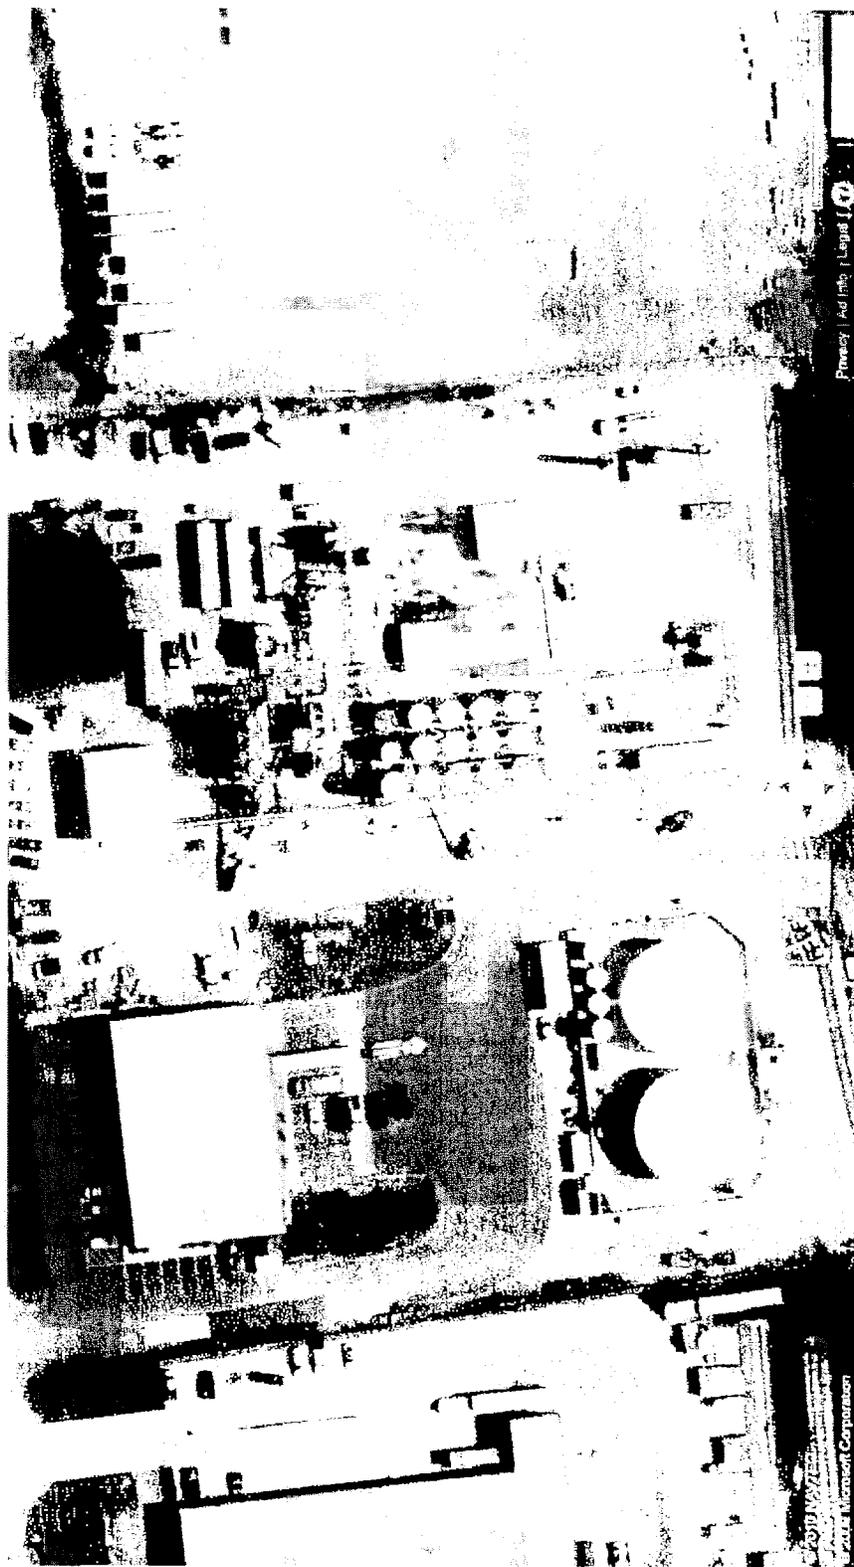
Figure 1: Aerial view of the Heartland Petroleum facility during late stage of construction. The storm water outfall is indicated by the red arrow. North is to the left. Photo from Bing Maps.

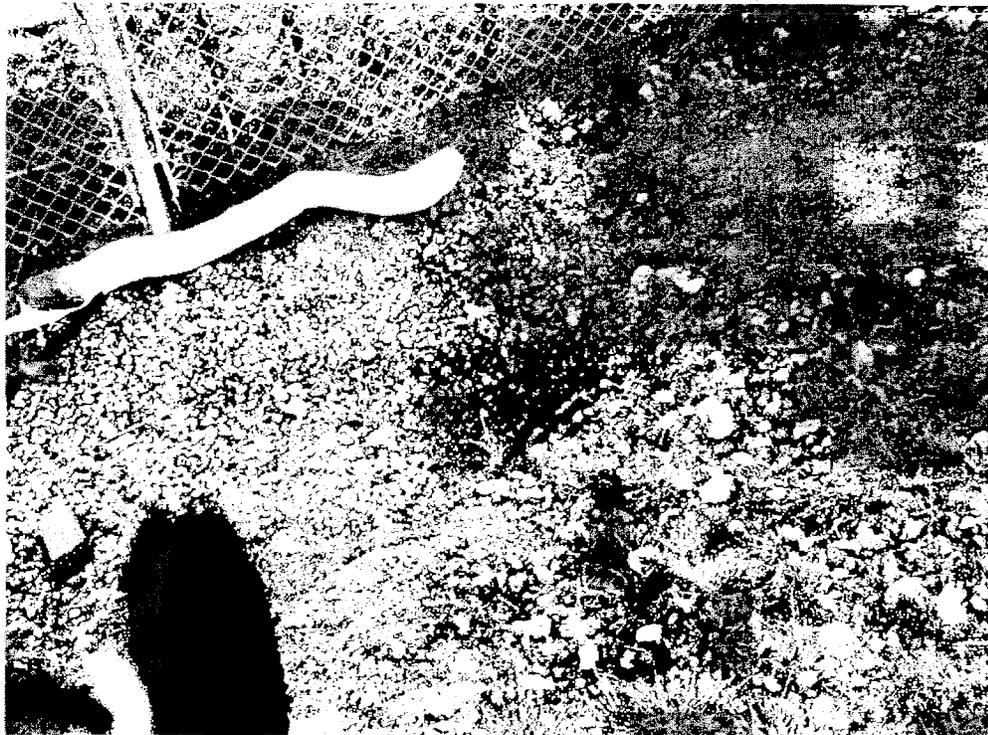
Figure 6: 03/25/2010 15:52 The storm sewer overflow outlet on the bank of the railroad ditch at the southeast corner of the property. This was the discharge point for the oil.

The OSC arrived at the Heartland facility at 15:30 and met with Mr. Kopf and Mr. Warren Wright, the plant engineer. The OSC gave Mr. Kopf the Notice of Violation. The OSC and Mr. Wright then walked through the process area while Mr. Wright explained what they found during the investigation. The tile where the oil was found on the 22nd was actually not intended to discharge to the ditch. It was supposed to flow in the opposite direction to the small pond. However the accumulation of sediment had blocked the tile and the water rose until it discharged via an overflow outlet to the ditch.

The sediment around both the inlet into the pond and the outlet to a second tile that was the intended outlet has been cleared away and the system is now draining properly. Mr. Wright showed the OSC the piping in the pond and explained the outlet was supposed to have a gravel filter surrounding it and the water would seep through this filter and into a riser via seepage holes near the bottom. It would then flow through the pipe to the ditch. The inlet pipe had a 45 degree angle section on its end, directed upward above the water surface. The inlet tile was nearly submerged and there was about three or four inches until the water in the tile could discharge into the pond. The OSC pointed out that this would prevent the oil in the pipe from discharging into the pond and trap it in the pipe. The purpose of this 45 degree fitting was not clear.

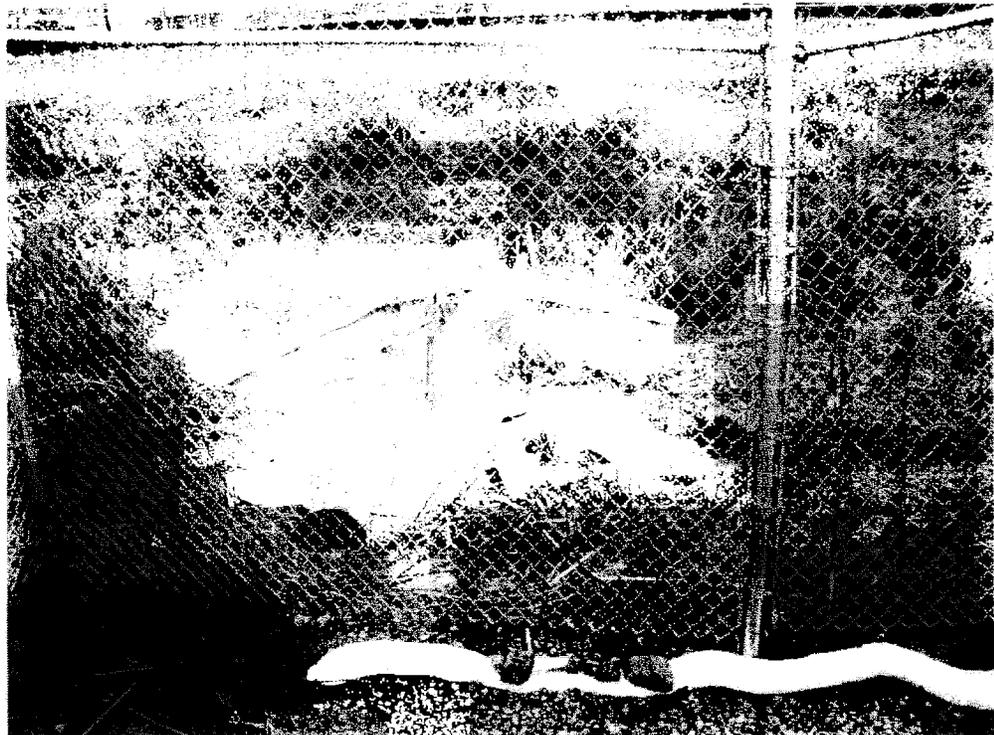
Figure 7: 03/25/2010 15:52 The storm sewer outfall is submerged in the water beyond the boundary fence in the area indicated by the arrow.

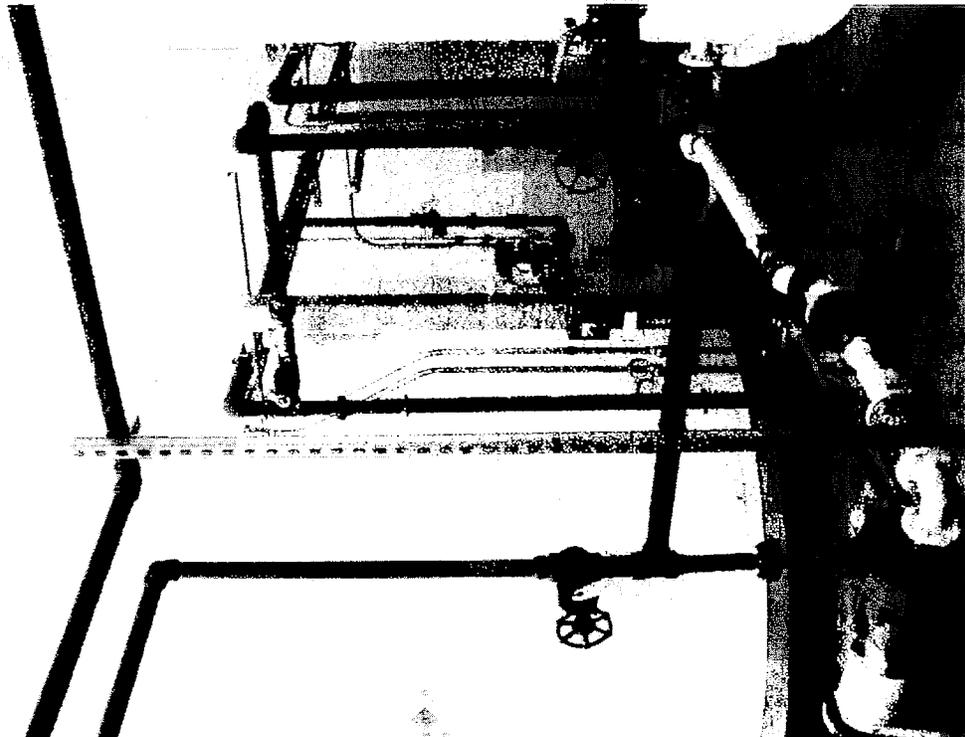
Figure 8: 03/25/2010 15:57 Piping in the area where the leak occurred. The arrow points at the replacement check valve.

Mr. Wright said the source of the oil was a leaking check valve on a pipe. The oil had accumulated in the dike and someone drained it without reporting the leak. Mr. Wright showed the OSC the replacement valve.

The leaking valve was replaced, two underflow weirs were installed in the drainage ditch, and sorbent materials were placed at the weirs to absorb the oil for removal.

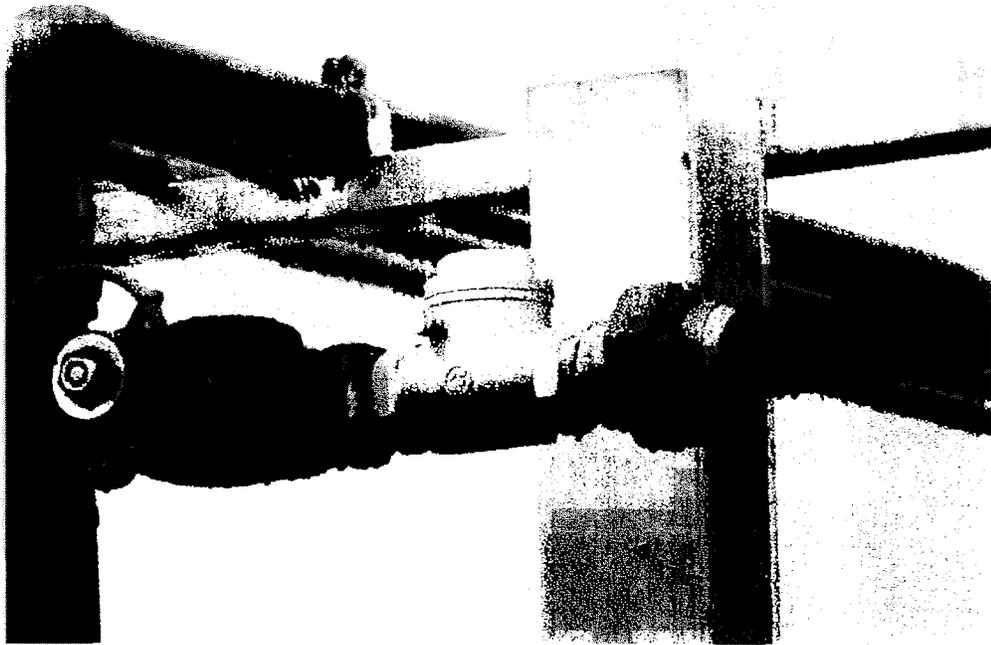
Figure 9: 03/25/2010 15:57 The replacement check valve.

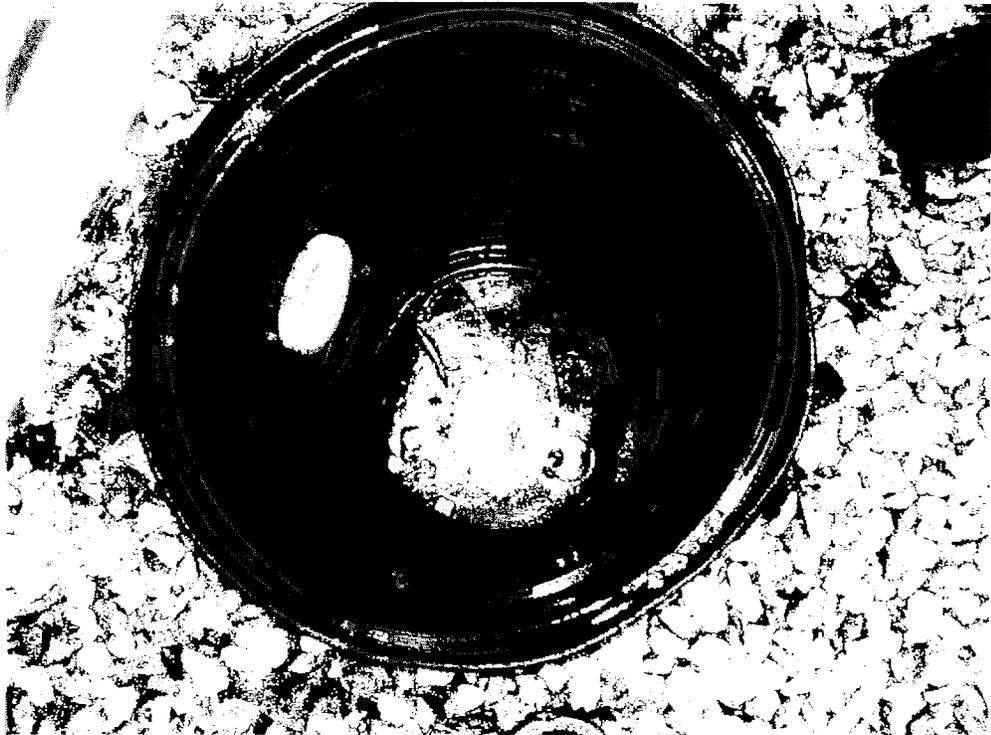
Figure 10: 03/25/2010 15:57 The interior of the small sump with oil on the water surface. The white pipe is capped outside the sump.

Mr. Wright was not aware of the small sump with the oil that the OSC had found on the previous visit and the OSC led him to it. Mr. Wright said the sump really served no purpose. What the OSC thought was a pipe leading from the dike was actually nothing more than a closed off stub. How the oil got into the sump was not known. Mr. Wright showed the OSC a series of excavations in the area that exposed the drain tiles from the dikes to the containment tank and none of them had encountered oil in the surrounding gravel. Mr. Wright speculated someone had poured a small amount of oil into the sump thinking it was connected to the drains.
