LUCAS SHADOW WOODS SUBDIVISION 2GC01199 2010/12/10 HABLITZEL, LYNETTE TOLEDO

Re: Lucas County
Shadow Woods Subdivision
Constuction
Storm Water

December 10, 2010

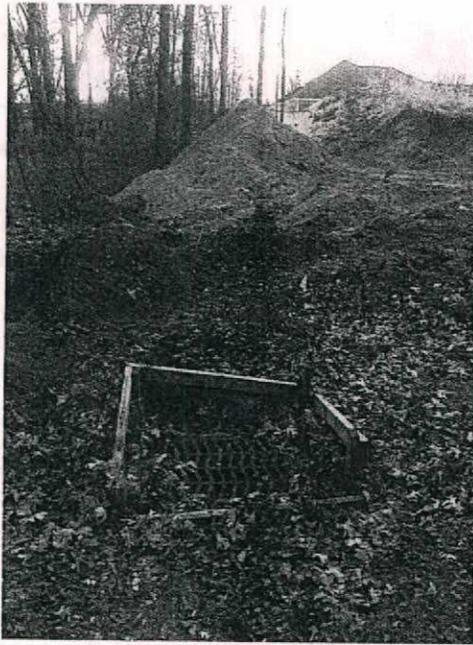
At the time of my visit, roads and utilities had been installed. It appeared that homes had been constructed and lawns established on several of the lots. North of 1720 Deer Trail Drive (appeared to be 1726 Deer Trail Drive), a house was being framed. Most of the concrete drive was poured; dirt had been tracked into the street; a significant amount of dirt was over the curb; and there was no curb inlet protection. There was a sandy stockpile north of 1738 Deer Trail Drive. The stockpile was disturbed but appeared to have had temporary seed applied in the past. The ground was disturbed and an excavator was sitting idle on the two lots between 1738 and 1814 Deer Trail. While inlet protection had been installed around the yard drain in the rear of the lot, its frame was broken and it was in disrepair.

12/3/2010 Lucas County, Shadow Woods Subdivision. Yard inlet protection broken between 1738 and 1814 Deer Trail. Taken by Lynette Hablitzel.
ShadowWoods_12032010_01.jpg

Dirt and sediment must be removed from the curbs and the street. Inlet protection must be installed and maintained on storm sewers down gradient from construction activities. Within seven (7) days of the date on this letter, please submit to this office **written notification** of the actions taken or proposed to prevent any future violations. Your response should include the dates, either actual or proposed, for the completion of the actions. If there are any questions, please contact me at (419) 373-3009.

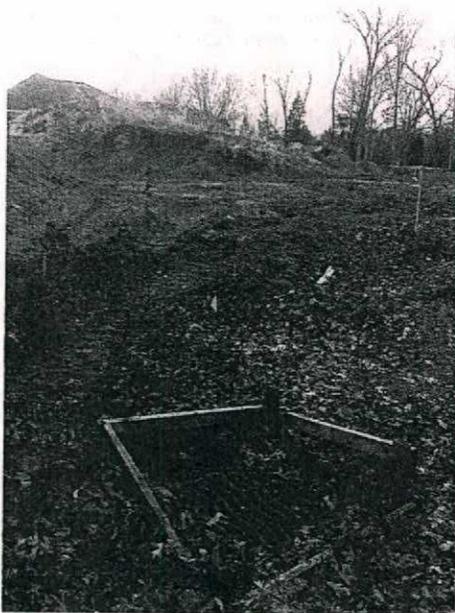
12/3/2010 Lucas County, Shadow Woods Subdivision. Yard inlet protection broken between 1738 and 1814 Deer Trail. Taken by Lynette Hablitzel.
ShadowWoods_12032010_02.jpg

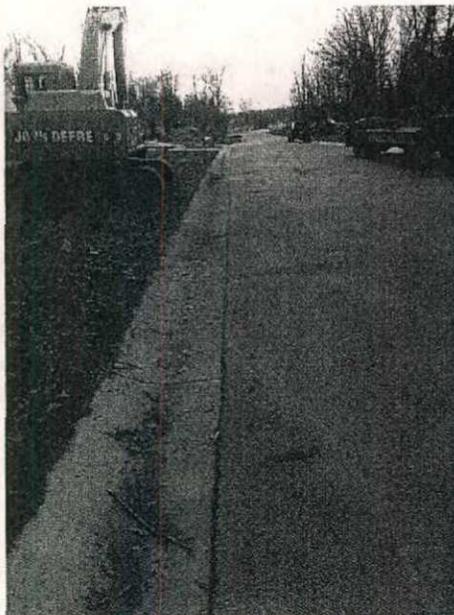
Your permit requires that a stable (non erodible) construction entrance be installed where vehicles access sites and that measures be implemented to minimize vehicle tracking and dust generation. *This is a violation of Part III.G.2.g.ii of the permit.*

12/3/2010 Lucas County. Shadow Woods Subdivision. Looking south at tracking in street and sediment in curb along Deer Trail. Taken by Lynette Hablitzel. ShadowWoods_12032010_03.jpg

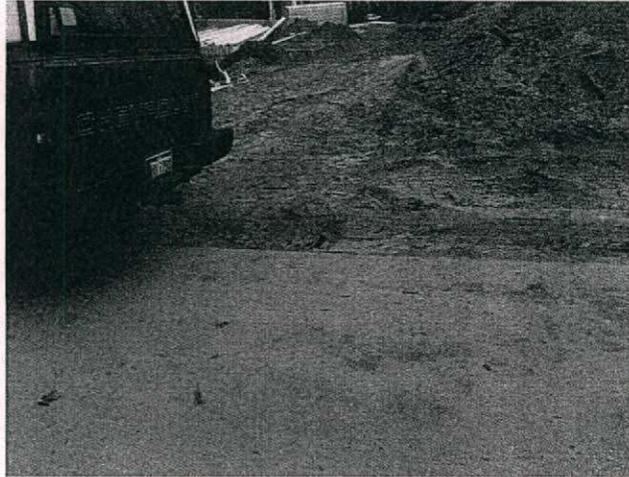
12/3/2010 Lucas County. Shadow Woods Subdivision. Curb inlet buried in dirt in front of 1726 Deer Trail. No inlet protection apparent. Taken by Lynette Hablitzel. ShadowWoods_12032010_05.jpg
