Air Pollution Control Division

Canton City Health Department

December 3, 2007

Re: Notice of Violation: OAC Rule 3745-20-02 (A)
OAC Rule 3745-20-03 (A) (1)
OAC Rule 3745-20-03 (A) (3)
OAC Rule 3745-20-04 (A) (2) (b)
OAC Rule 3745-20-04 (A) (6) (a)
OAC Rule 3745-20-04 (C)
OAC Rule 3745-20-05 (A)
OAC Rule 3745-20-05 (C)
Violations involving demolition at 12777 Mogadore Ave., NW, Lake
Township, Stark County, Ohio

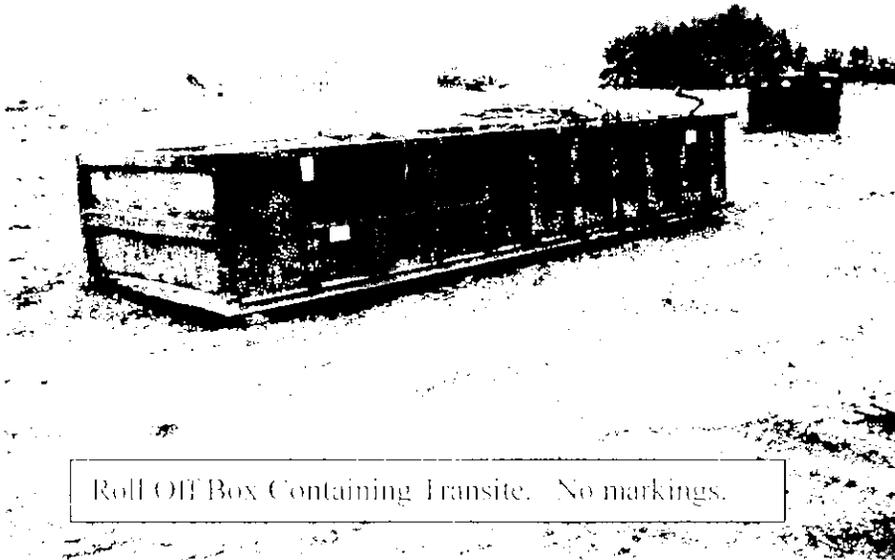
Finding #8: Glick Real Estate, LTD, on May 19, 2006 had asbestos-containing waste material sitting in unmarked roll off boxes.

Roll Off Box Containing Transite. No markings.

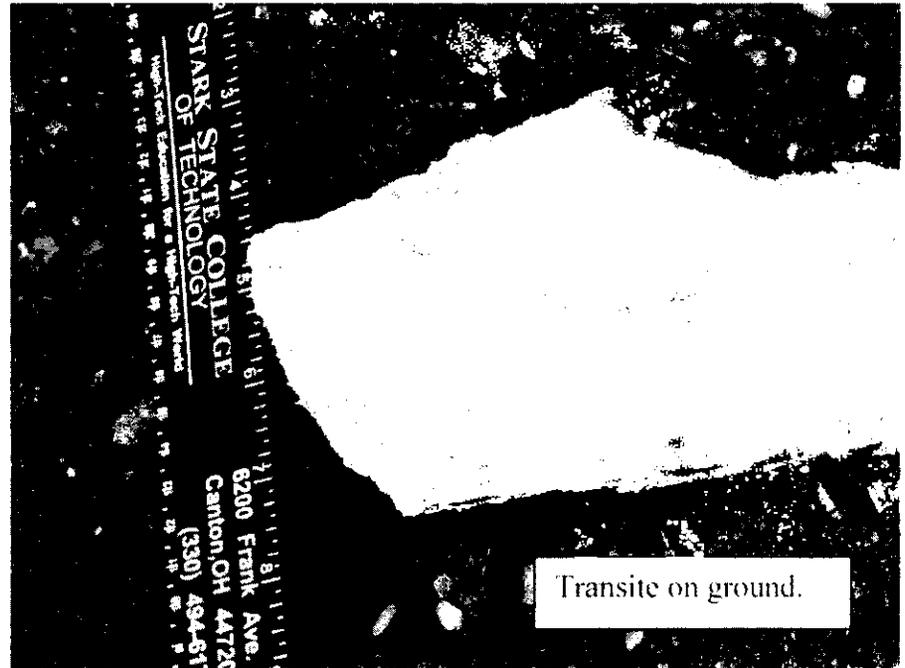
Transite on ground.

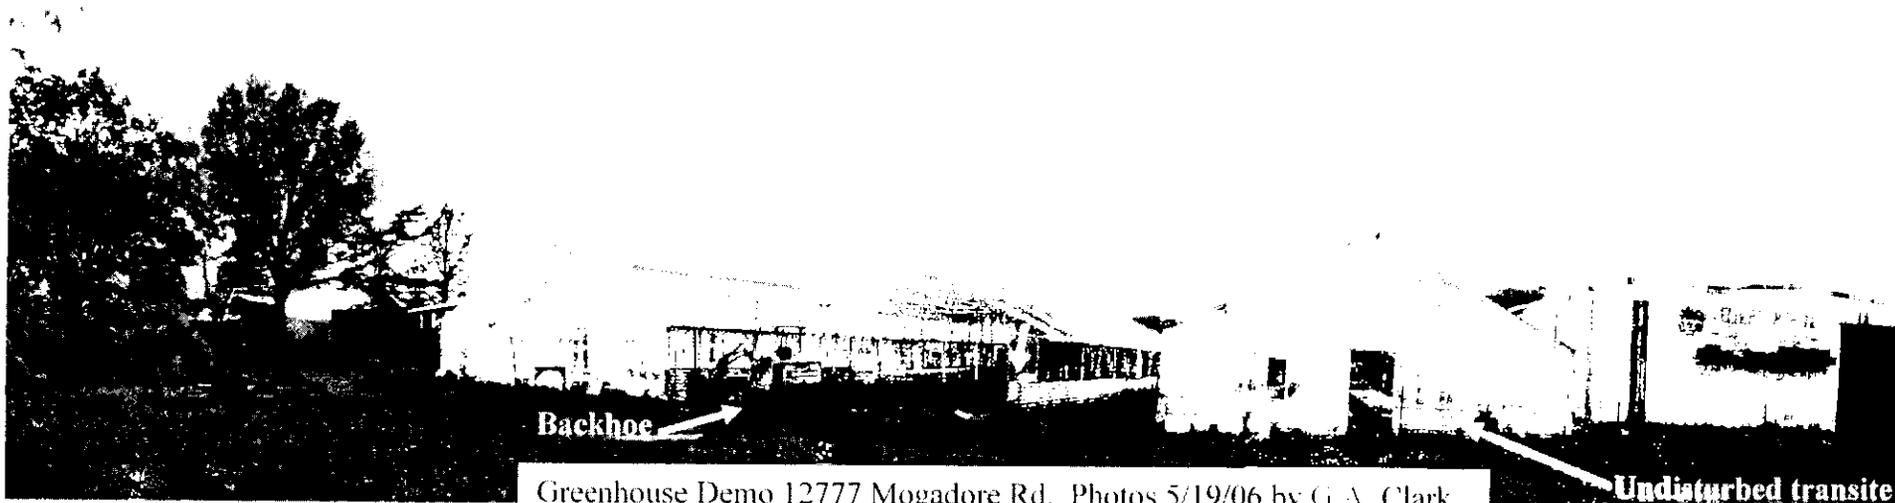
Backhoe

Undisturbed transite

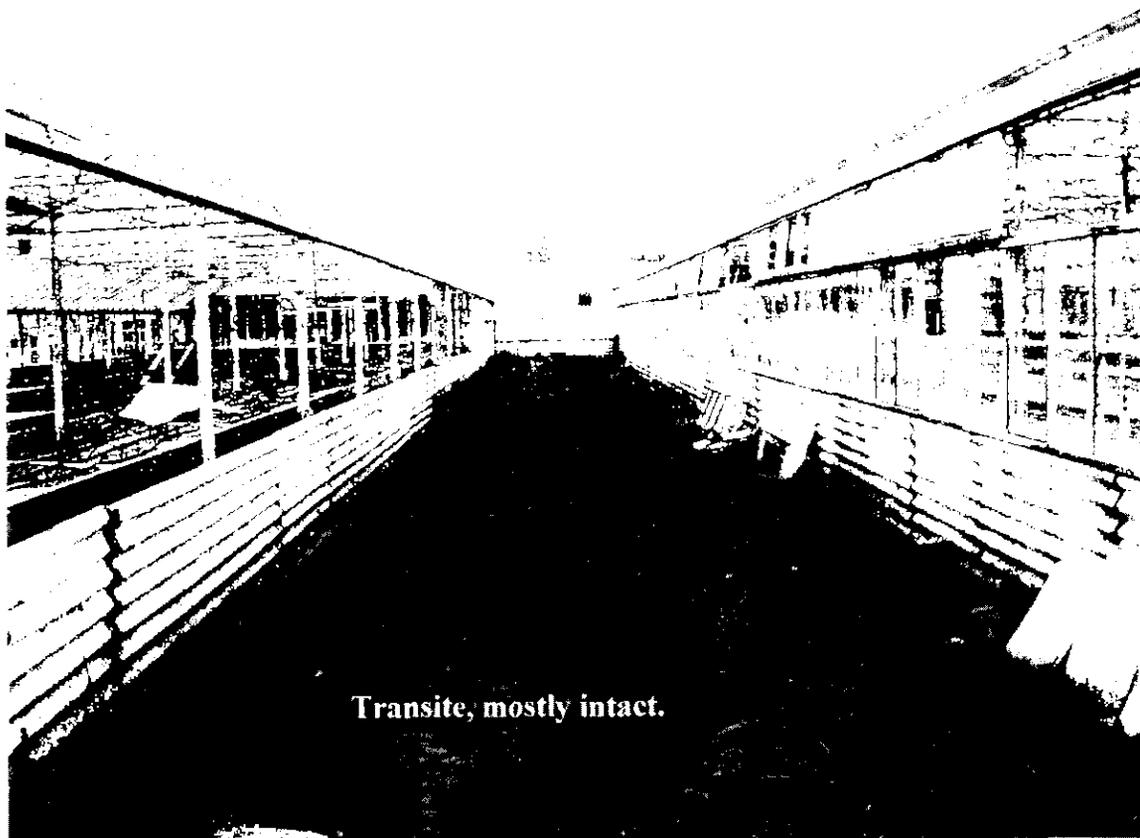
Transite, mostly intact.

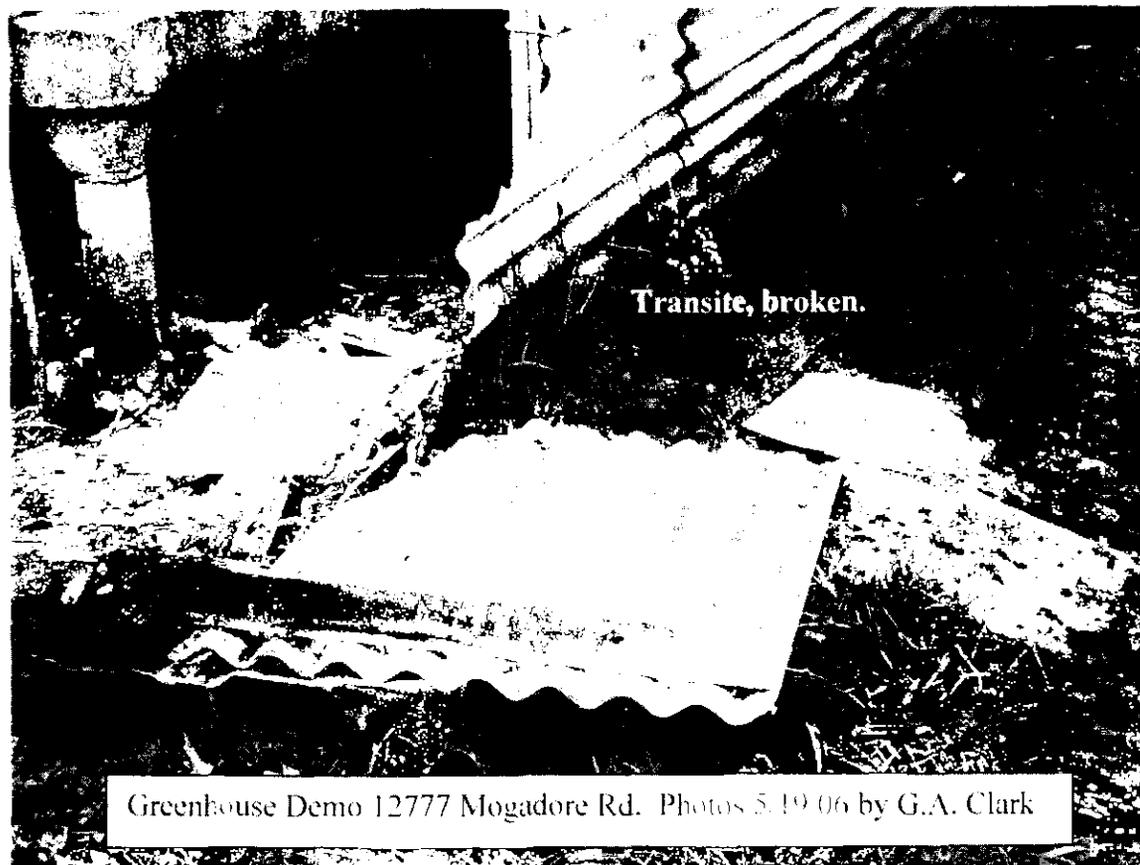
Transite, broken.

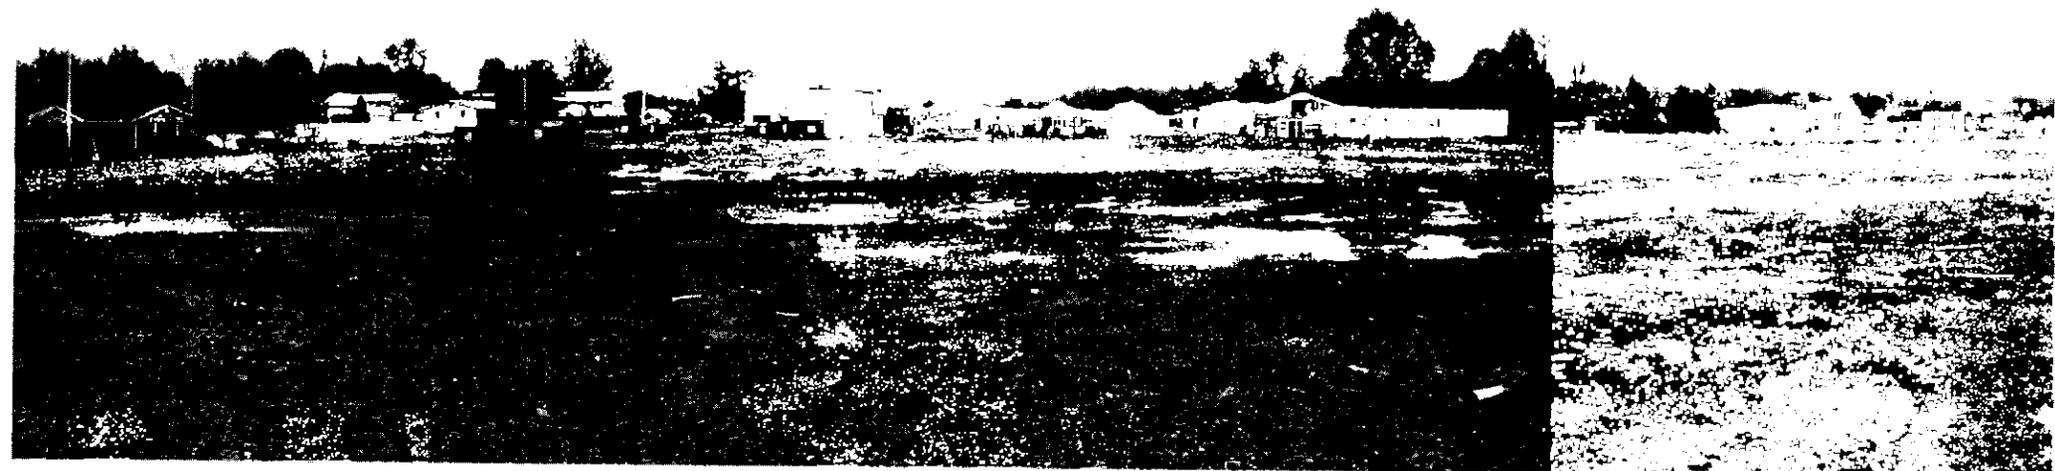
Greenhouse Demo 12777 Mogadore Rd. Photos 5/19/06 by G.A. Clark
View of rear of property. Transite pieces found on ground and in roll off boxes here.

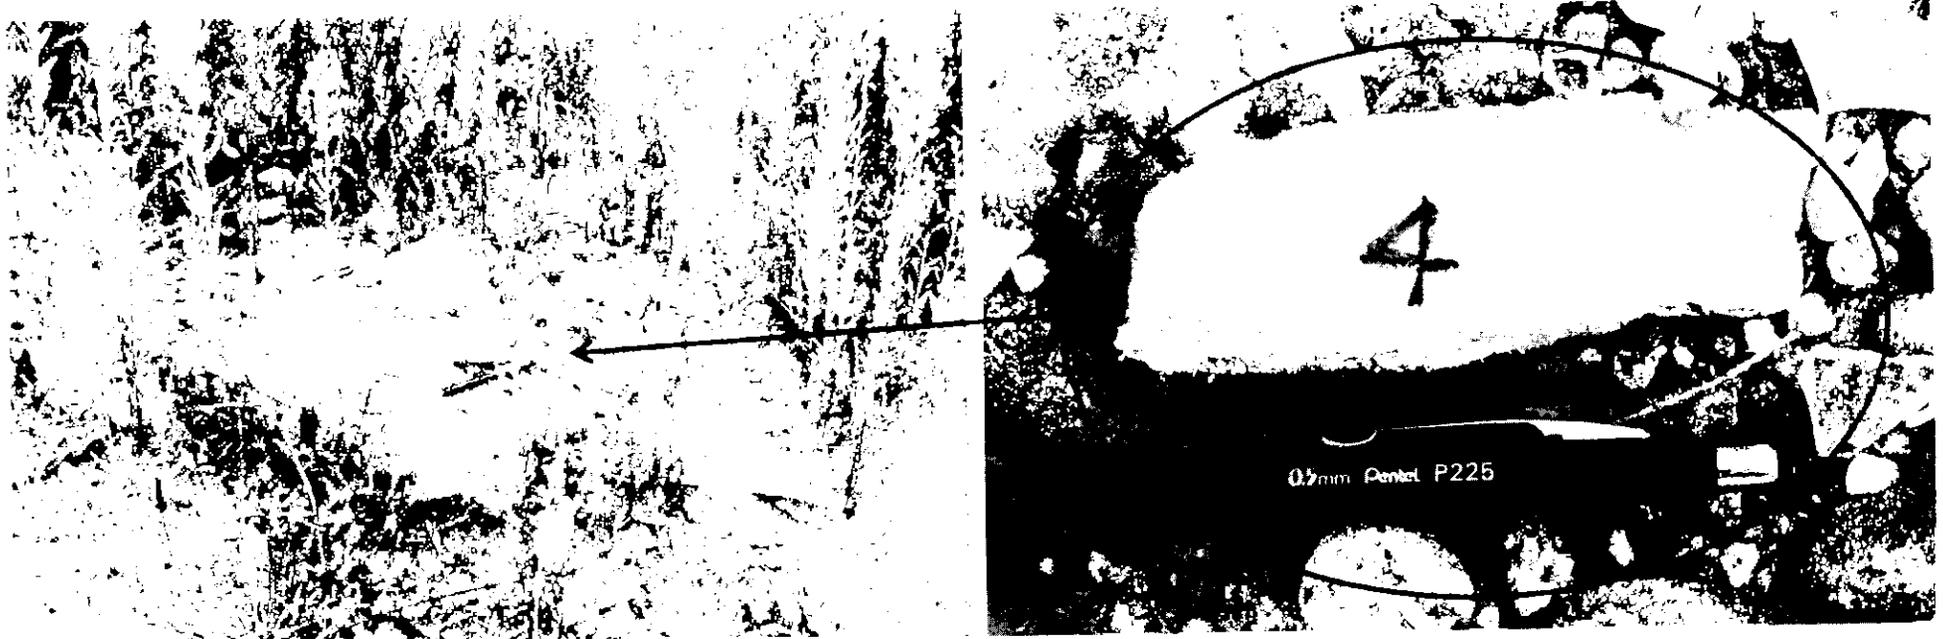
Examples of broken transite in field at rear of property.

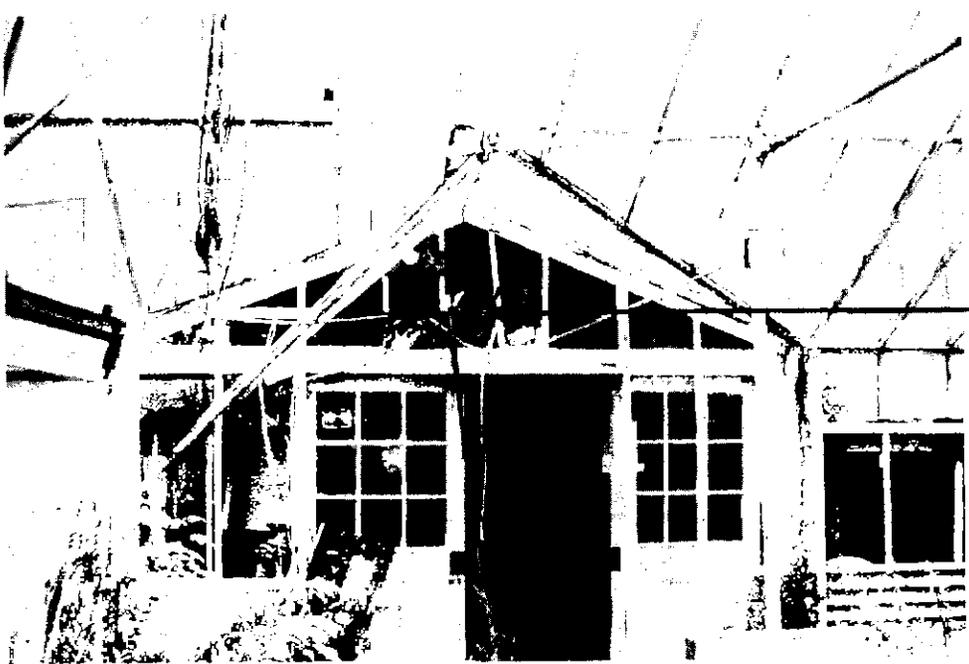
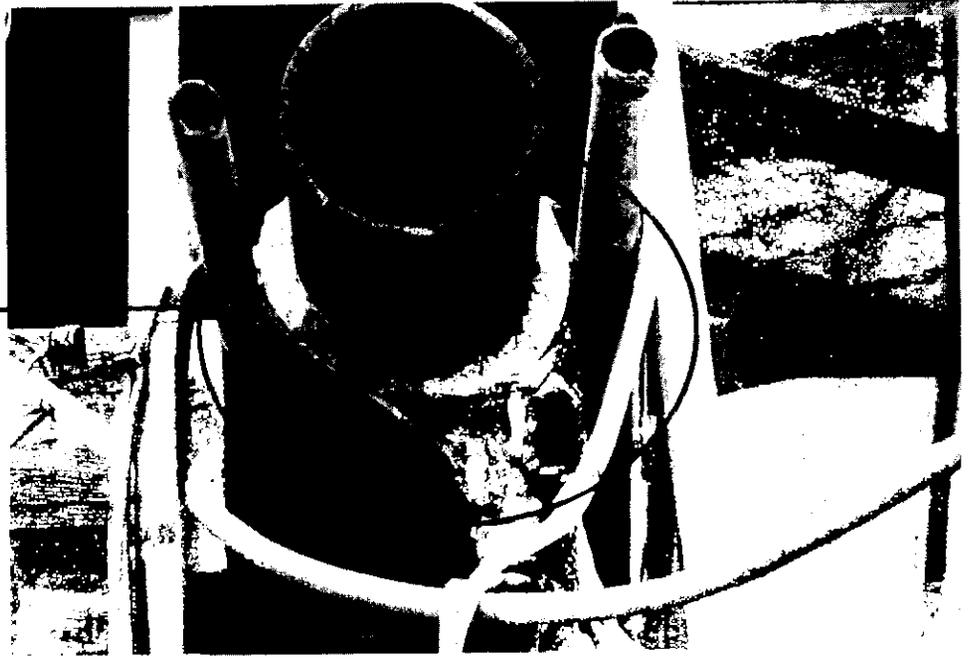
Asbestos insulation around pipe.

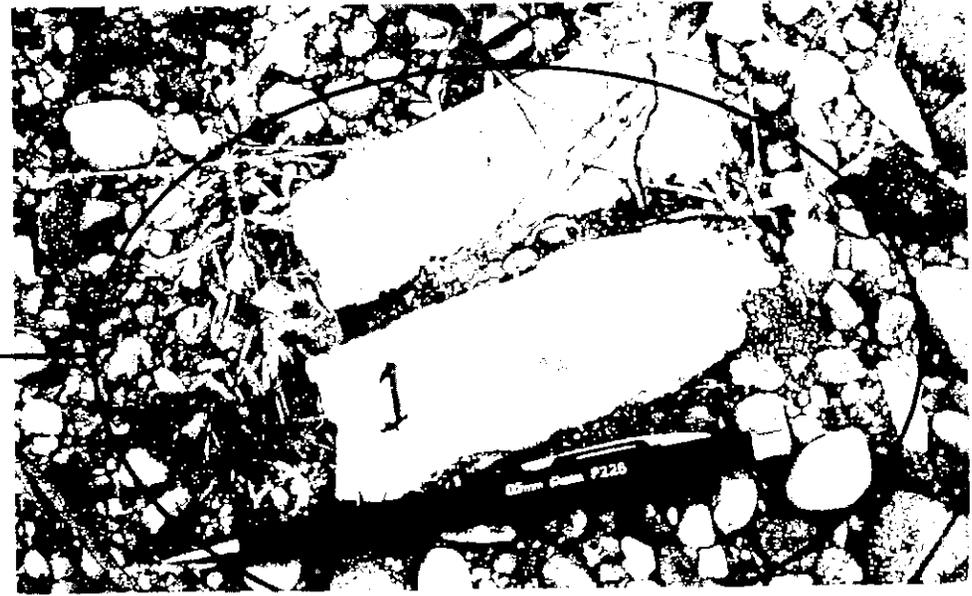
Additional example of broken transite in field at rear of property.
