Environmental
Protection Agency

March 7, 2011

RE: WILLIAM WATSON, RIDGE VIEW ESTATES
NPDES PERMIT NO. 3PW00034
ASHTABULA TOWNSHIP, ASHTABULA CO.
COMPLIANCE EVALUATION INSPECTION

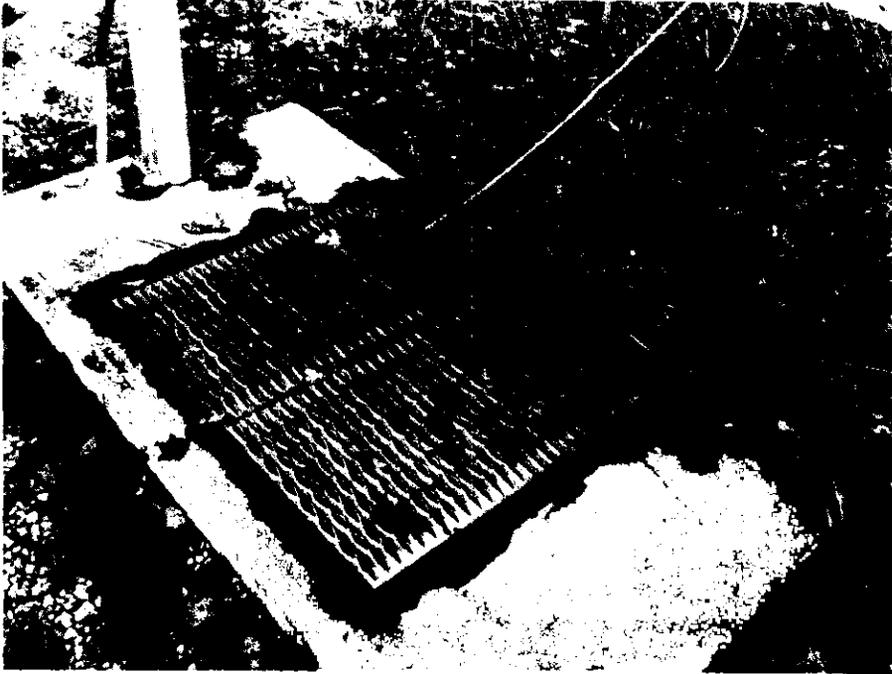
7. The sand filter dosing pumps were cycled and found not in operating condition, with the dosing tank flooded and discharging overland to the creek (see attached picture). The alarms were found in operating condition, but were turned off. The connection from the dosing tank to the sand filter could not be evaluated due to the inoperable pumps.

Sand Filter Dosing Tank Flooding with Discharge to Creek

Other Violations: Failure to Maintain Engineered Components: From examination of the clarifier and sand filter dosing tank and not operating due to inoperable or missing parts, causing the plant to discharge partially treated sewage to the receiving stream. It is unlikely that all these components became inoperable simultaneously. The clarifier effluent weirs, skimmer, and sand filter dosing pumps must be repaired or replaced as soon as possible. The partial plant bypass should be reported in the eDMR reports.

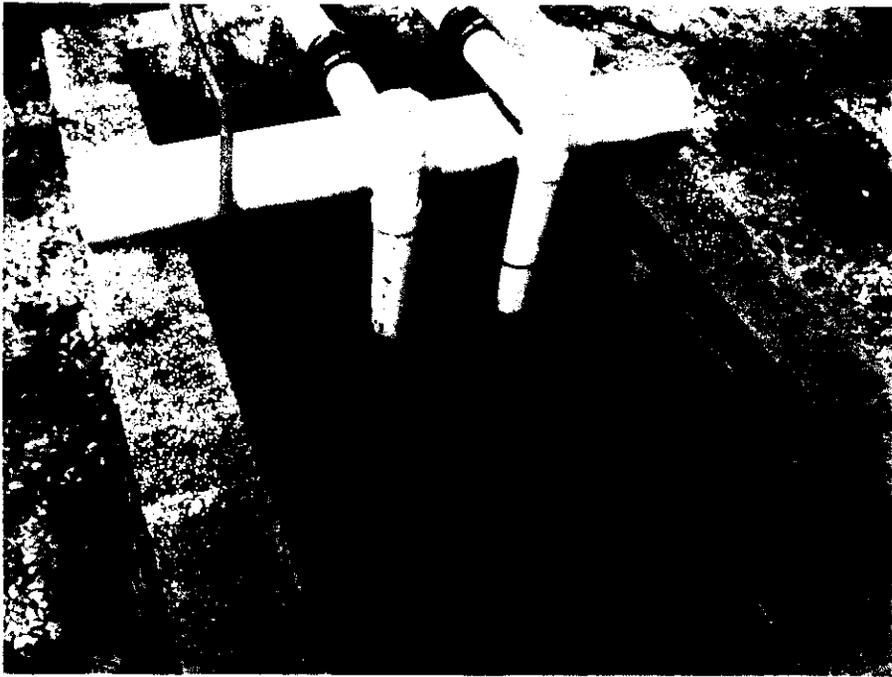
Clarifier Outlet / Sand Filter Dosing Tank

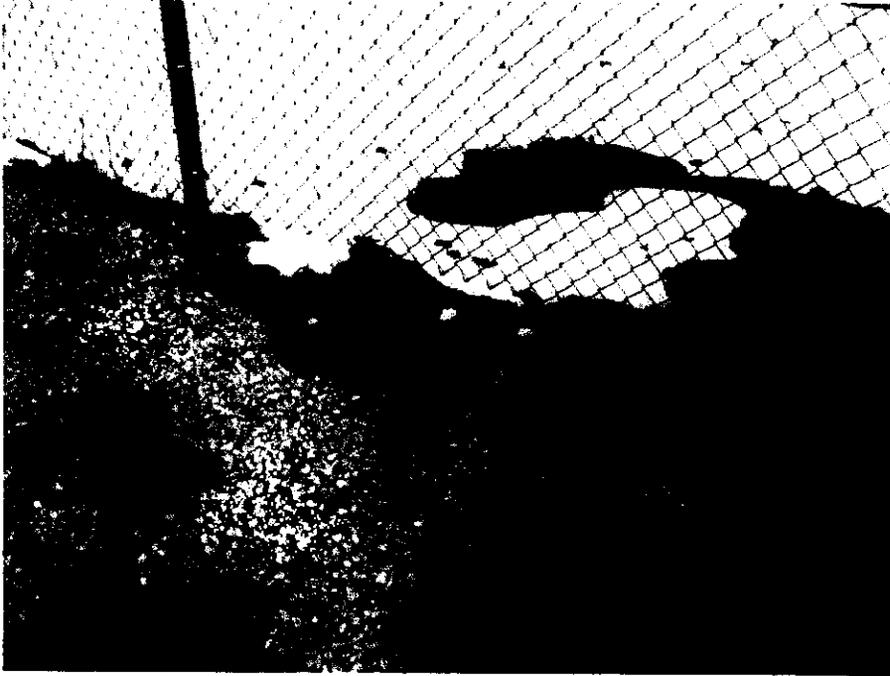
Removed Pumps
