**Re: Construction Storm Water Inspection at Village at Hannah Farms
Franklin County
Permit Number: 4GC01921*AG**

Village at Hannah Farms
Big Walnut Watershed
Photo by: Stephen Riley and Lisa Schaller
July 26, 2010

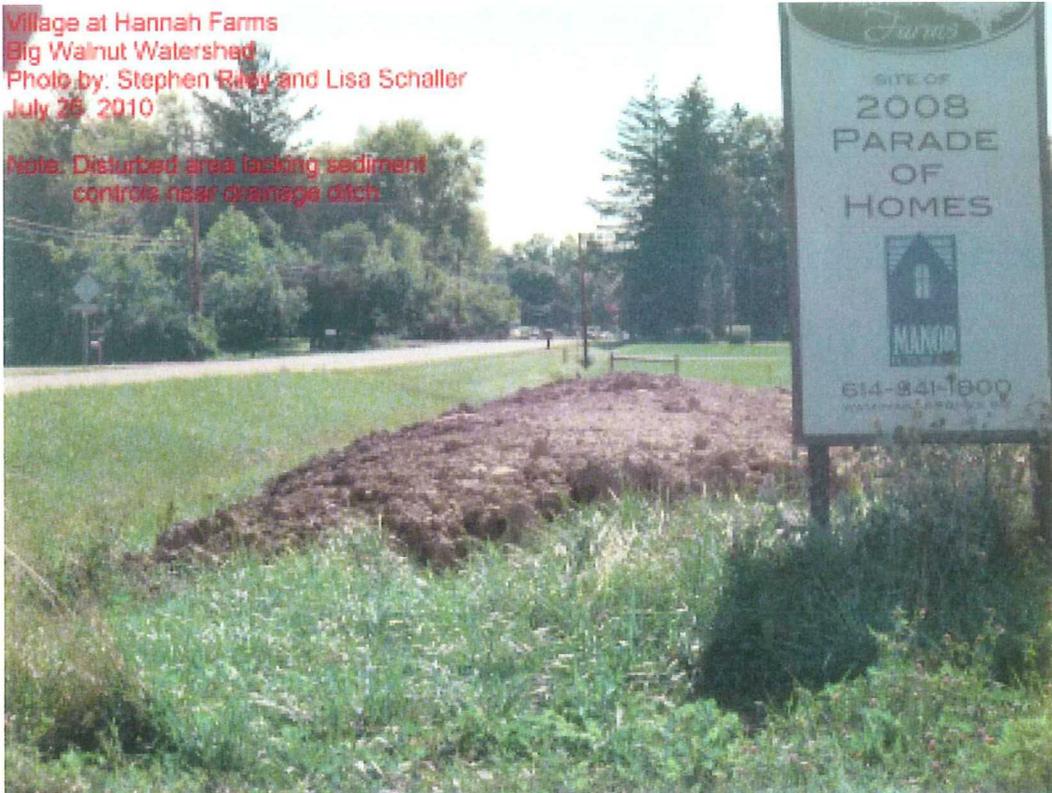
- During the site investigation, our staff found a lack of sediment and erosion controls along Clark State Road (Figure 1).
- Sediment controls for this project must be implemented in accordance with the General Storm Water Permit. Silt fencing must be implemented along the contour and control areas where sheet flow is present. The silt fence must be trenched in otherwise proper reinstallation will be required.

Note: Disturbed area lacking sediment
controls near drainage ditch

Figure 1: Lack of sediment controls along drainage ditch
