RE: Sunshine MHP Notice of Violation / Reconnaissance Inspection, NPDES Permit No. 1PV00019*CD/OH0049832, Miami County

NPDES Compliance Inspection Report

Inspection Findings

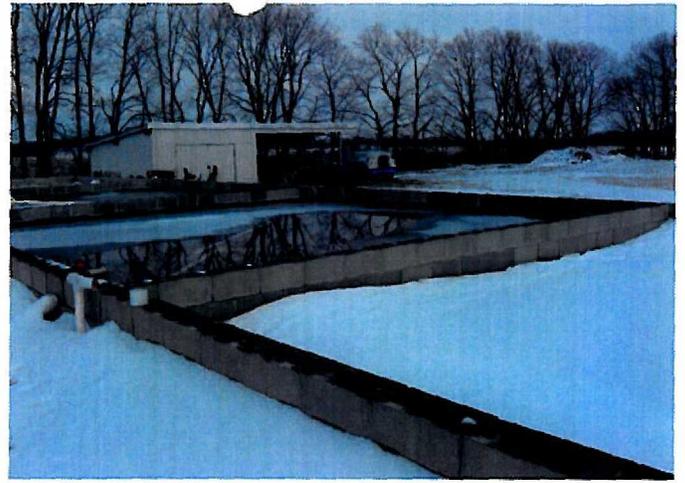
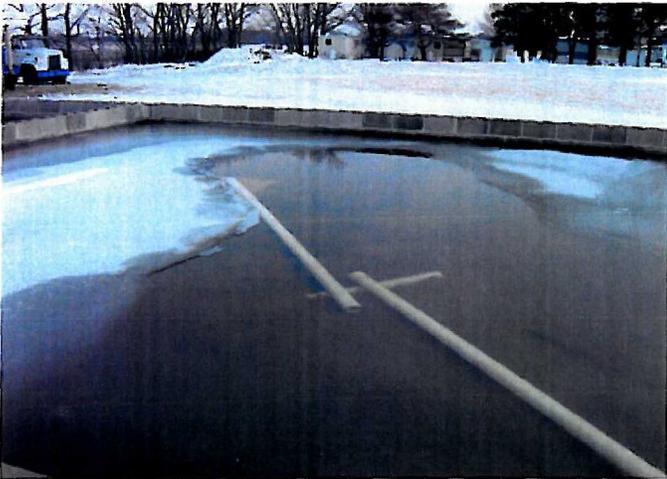
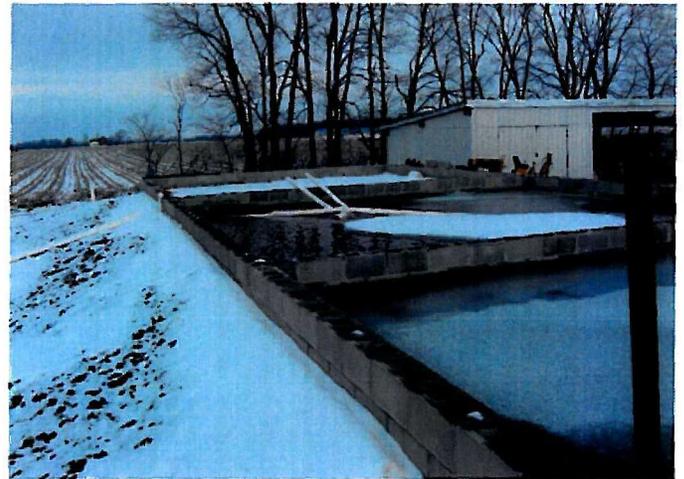
The old tertiary sand filters at the west plant have been demolished. The new filters have been placed on-line. The distribution arms and splash pads were added to the filters. However the distribution arms were not connected. There were blow holes in the sand where the influent flows were being introduced. The filters on-line had approximately four inches of water in them. Their surfaces were partially frozen over.

Sunshine MHP 01/26/2009, Tertiary Sand Filters.

On Monday January 26, 2009 an inspection of the Sunshine Mobile Home Park waste water treatment system (West plant only) was performed. The treatment system upgrades were at a similar state of completion as noted during a September 23, 2008 inspection. In order to complete the installation the distribution arms need to be run over to the splash pads. The flow totalizer needs to be installed. A security fence, designed to limit access to the plant will need to be installed. The old slow surface sand filters have been removed from the West plant. Final site grading / seeding will need to be completed when weather conditions allow.

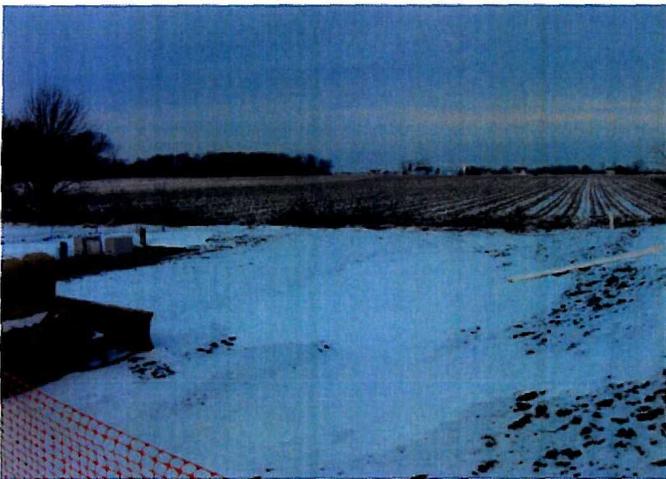
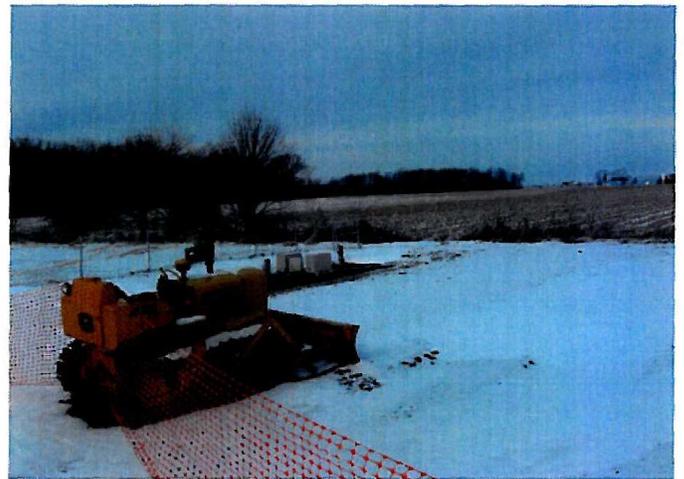
Sunshine MHP 01/26/2009, demolition site of old tertiary sand filters.

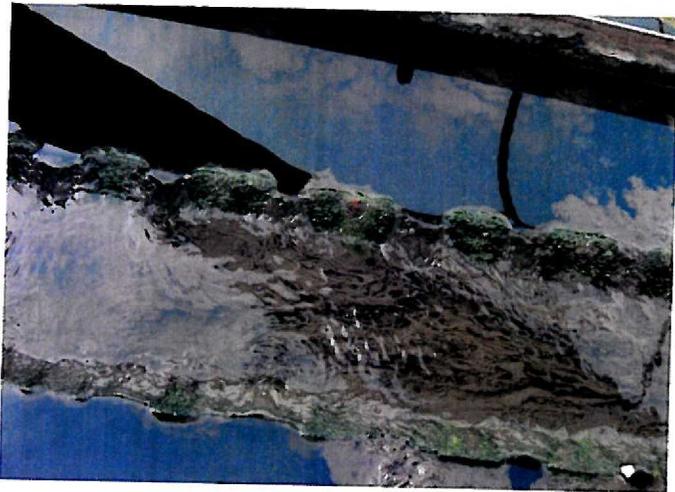
The final clarifier had a lot of pin floc solids rising in it. Some ice was formed on the surface. The effluent trough had a lot of growth in it. Clumps of solids were noted behind the weir and in the trough.

Sunshine MHP 01/26/2009, final clarifier effluent weir.

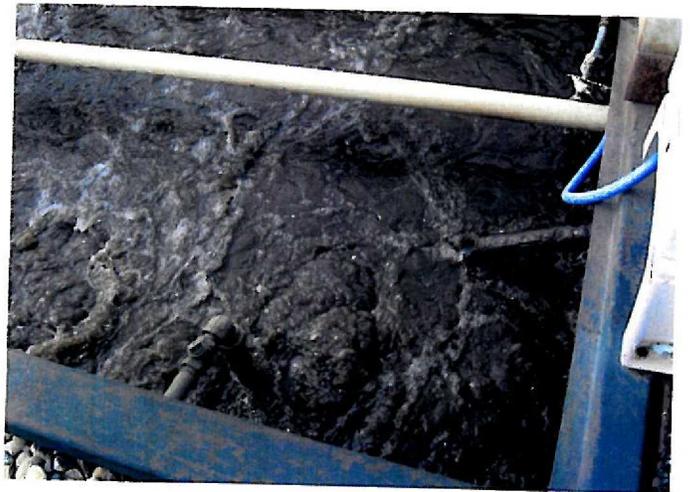
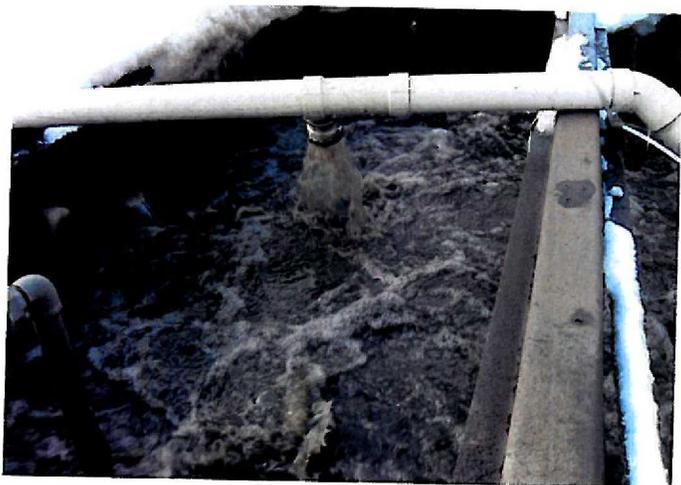
The west plant had good mixing. The mixed liquor appeared thin (light brown color, light colored foam).

Sunshine MHP 01/26/2009, aeration tank.

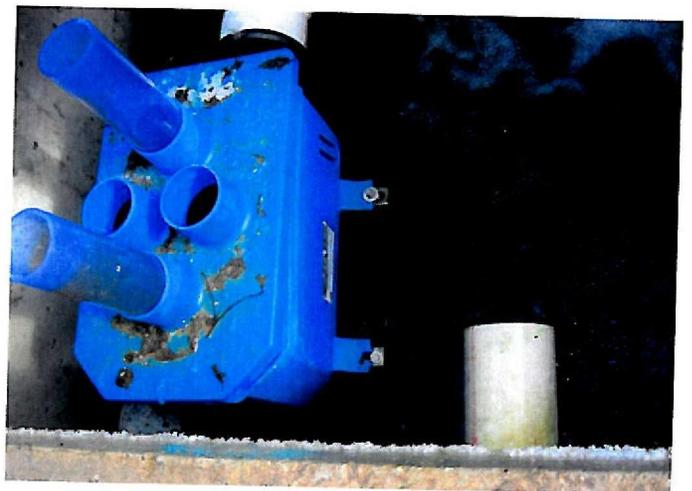
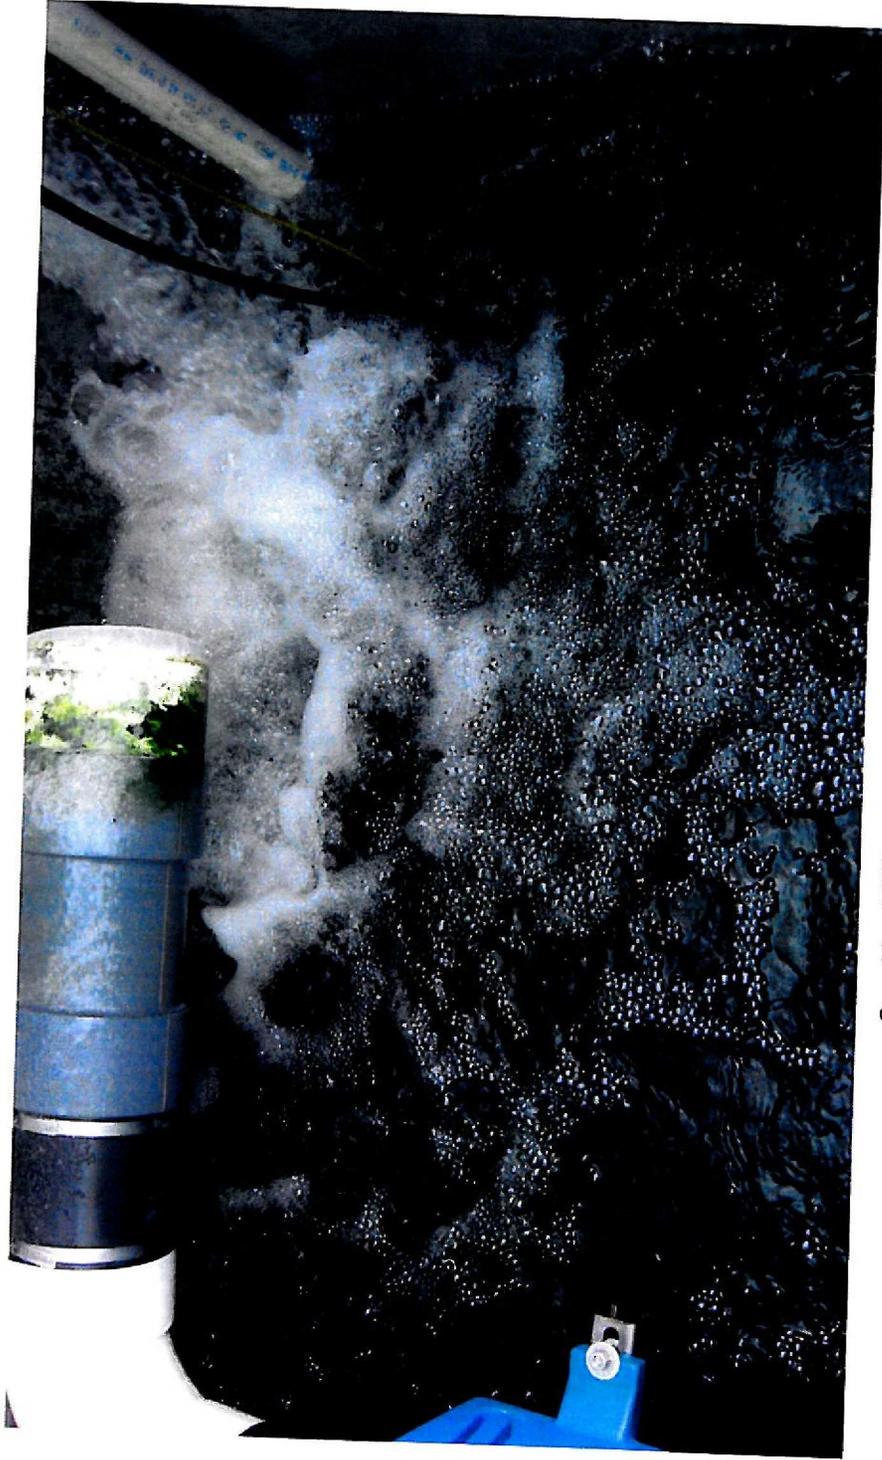
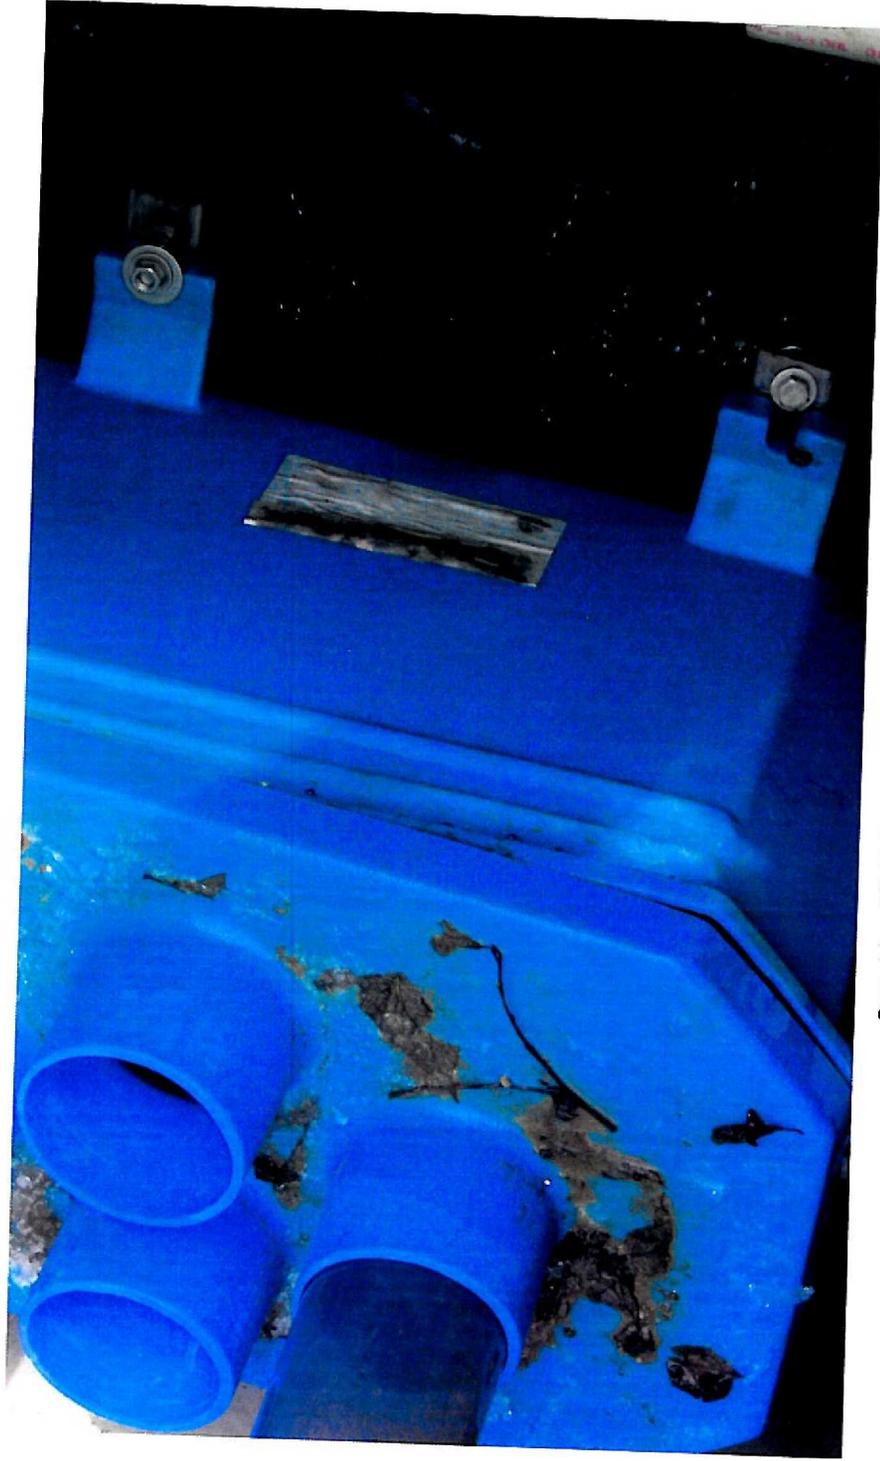
The post aeration was working. The effluent was clear.

Sunshine MHP 01/26/2009, dechlorination tank.
