November 13, 2012

**RE: GOODYEAR RIVERWALK  
SEIBERLING STREET LANDFILL  
SEIBERLING WAY  
NOTICE OF VIOLATION**

### **November 7, 2012 inspection**

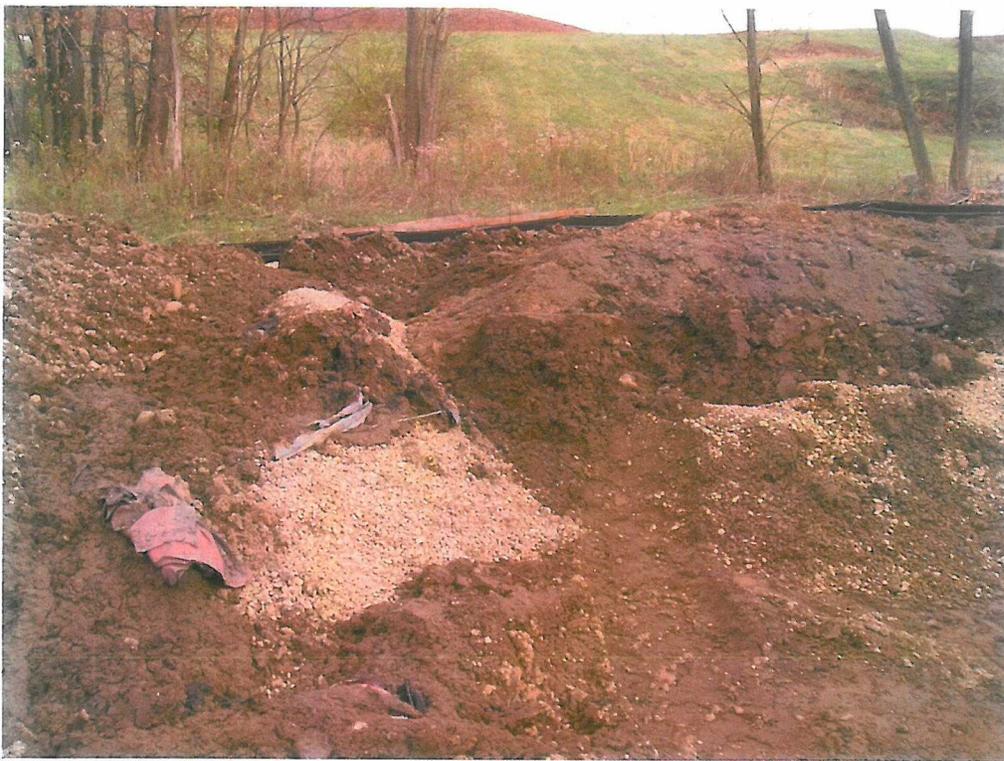
On the west side of the landfill where the proposed roundabout will be constructed, piles of grey discolored soil (possibly fly ash) commingled with waste were identified. Soil and brush were graded to the east side of the roundabout area and these identified waste piles were commingled in this general area. (See attached photos). The City is in violation of OAC Rule 3745-27-13(A) for not obtaining authorization from the director for construction activities on a waste disposal area once waste was encountered.

Waste found west of landfill in roundabout area DD November 7, 2012

The City may choose to sample the piles to determine if the material is fly ash, or if it is waste related to the landfill. If the material is not related to the landfill and the waste is deemed open dumping, then the City must apply cover to the waste piles until the waste is properly containerized before removing for disposal in accordance with OAC 3745-27-19(F), 3745-27-13(E)(10). Before removal and disposal of the waste, the City must comply with OAC 3745-27-13(H)(4) regarding characterization of the waste and letter of acceptance from the disposal facility.

If the City determines that the waste is related to the landfill, then the City must apply cover and properly dispose of the waste as mentioned above. Further, the City needs to obtain a Rule 13 authorization pursuant to OAC 3745-27-13(D)(1) and OAC 3745-27-13(E). As mentioned in the October 17, 2012 NOV letter, if the City proceeds without a Rule 13 authorization, and encounters more waste, the City must stop work immediately until the appropriate Rule 13 authorization is submitted and approved.

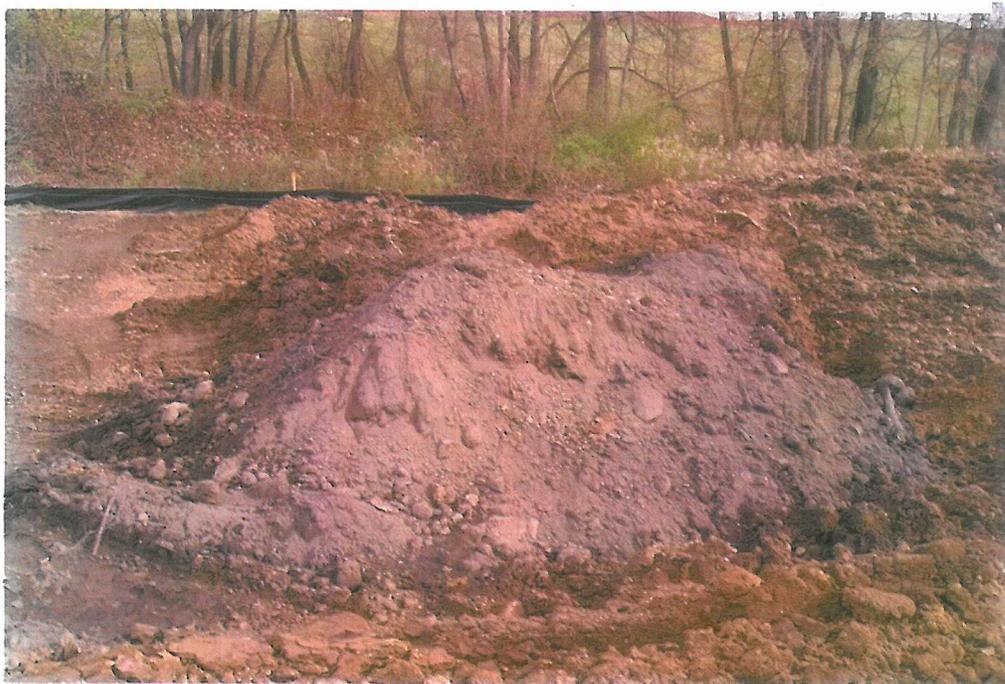
Waste found west of landfill in roundabout area DD November 7, 2012

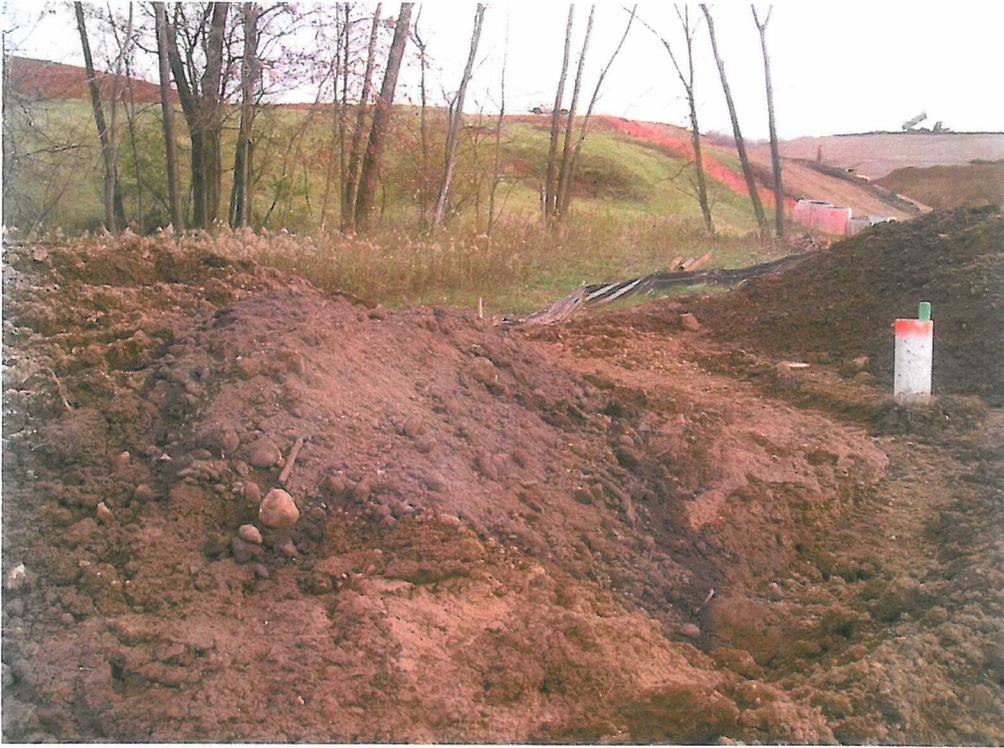
Waste found west of landfill in roundabout area DD November 7, 2012

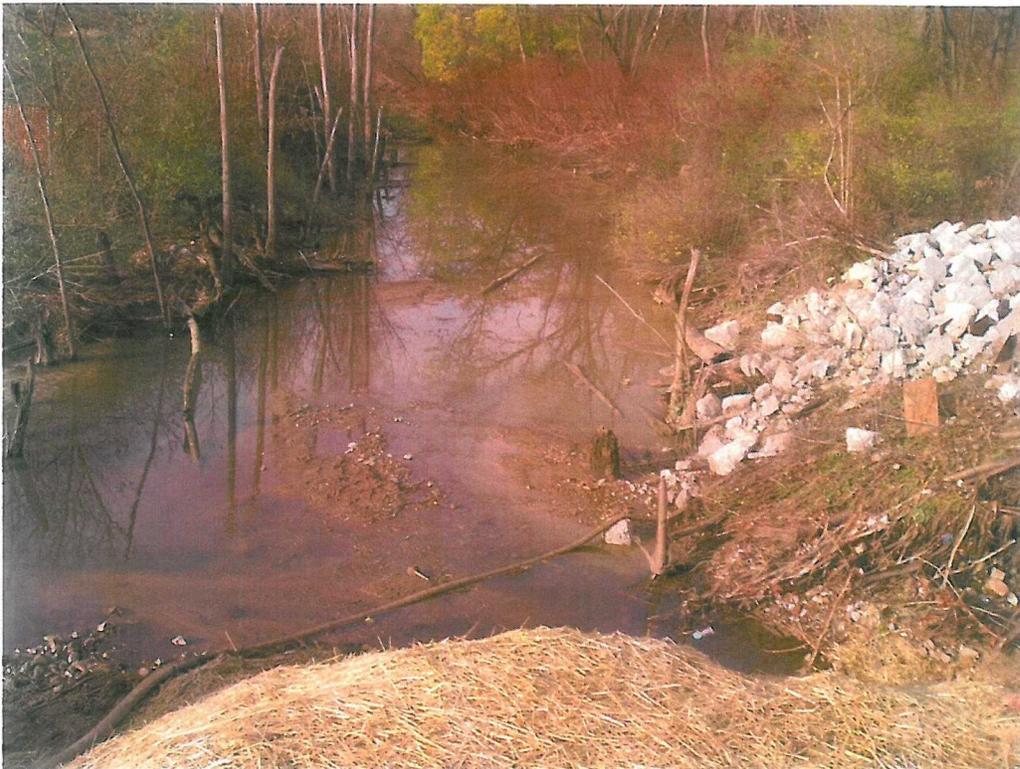
- a. **Detention Area 1 (east side pond):** Detention area 1, near Haley's Ditch, has been removed. The holding basin below detention area 1 has also been removed. The west side of the Haley's Ditch has a steel sheet pile wall that was installed to keep the liquid from entering Haley's Ditch. Most of the water had been removed from the holding basin. This area has installed steel pilings that will support the bridge. Accumulated sediments, from previous runoff from the project, could be seen on the bottom of the stream. See attached photo.

Sediments in Haley's Ditch looking north DD November 7, 2012

The City is in violation of **ORC Chapter 6111 and OAC 3745-27-13(H)(5)** for allowing sediment contaminated water to discharge from Detention Area 1 to Haley's Ditch. To achieve compliance, the City must comply with all corrective measures detailed in the November 5, 2012 letter from Phil Rhodes, Ohio EPA, NEDO-DSW.

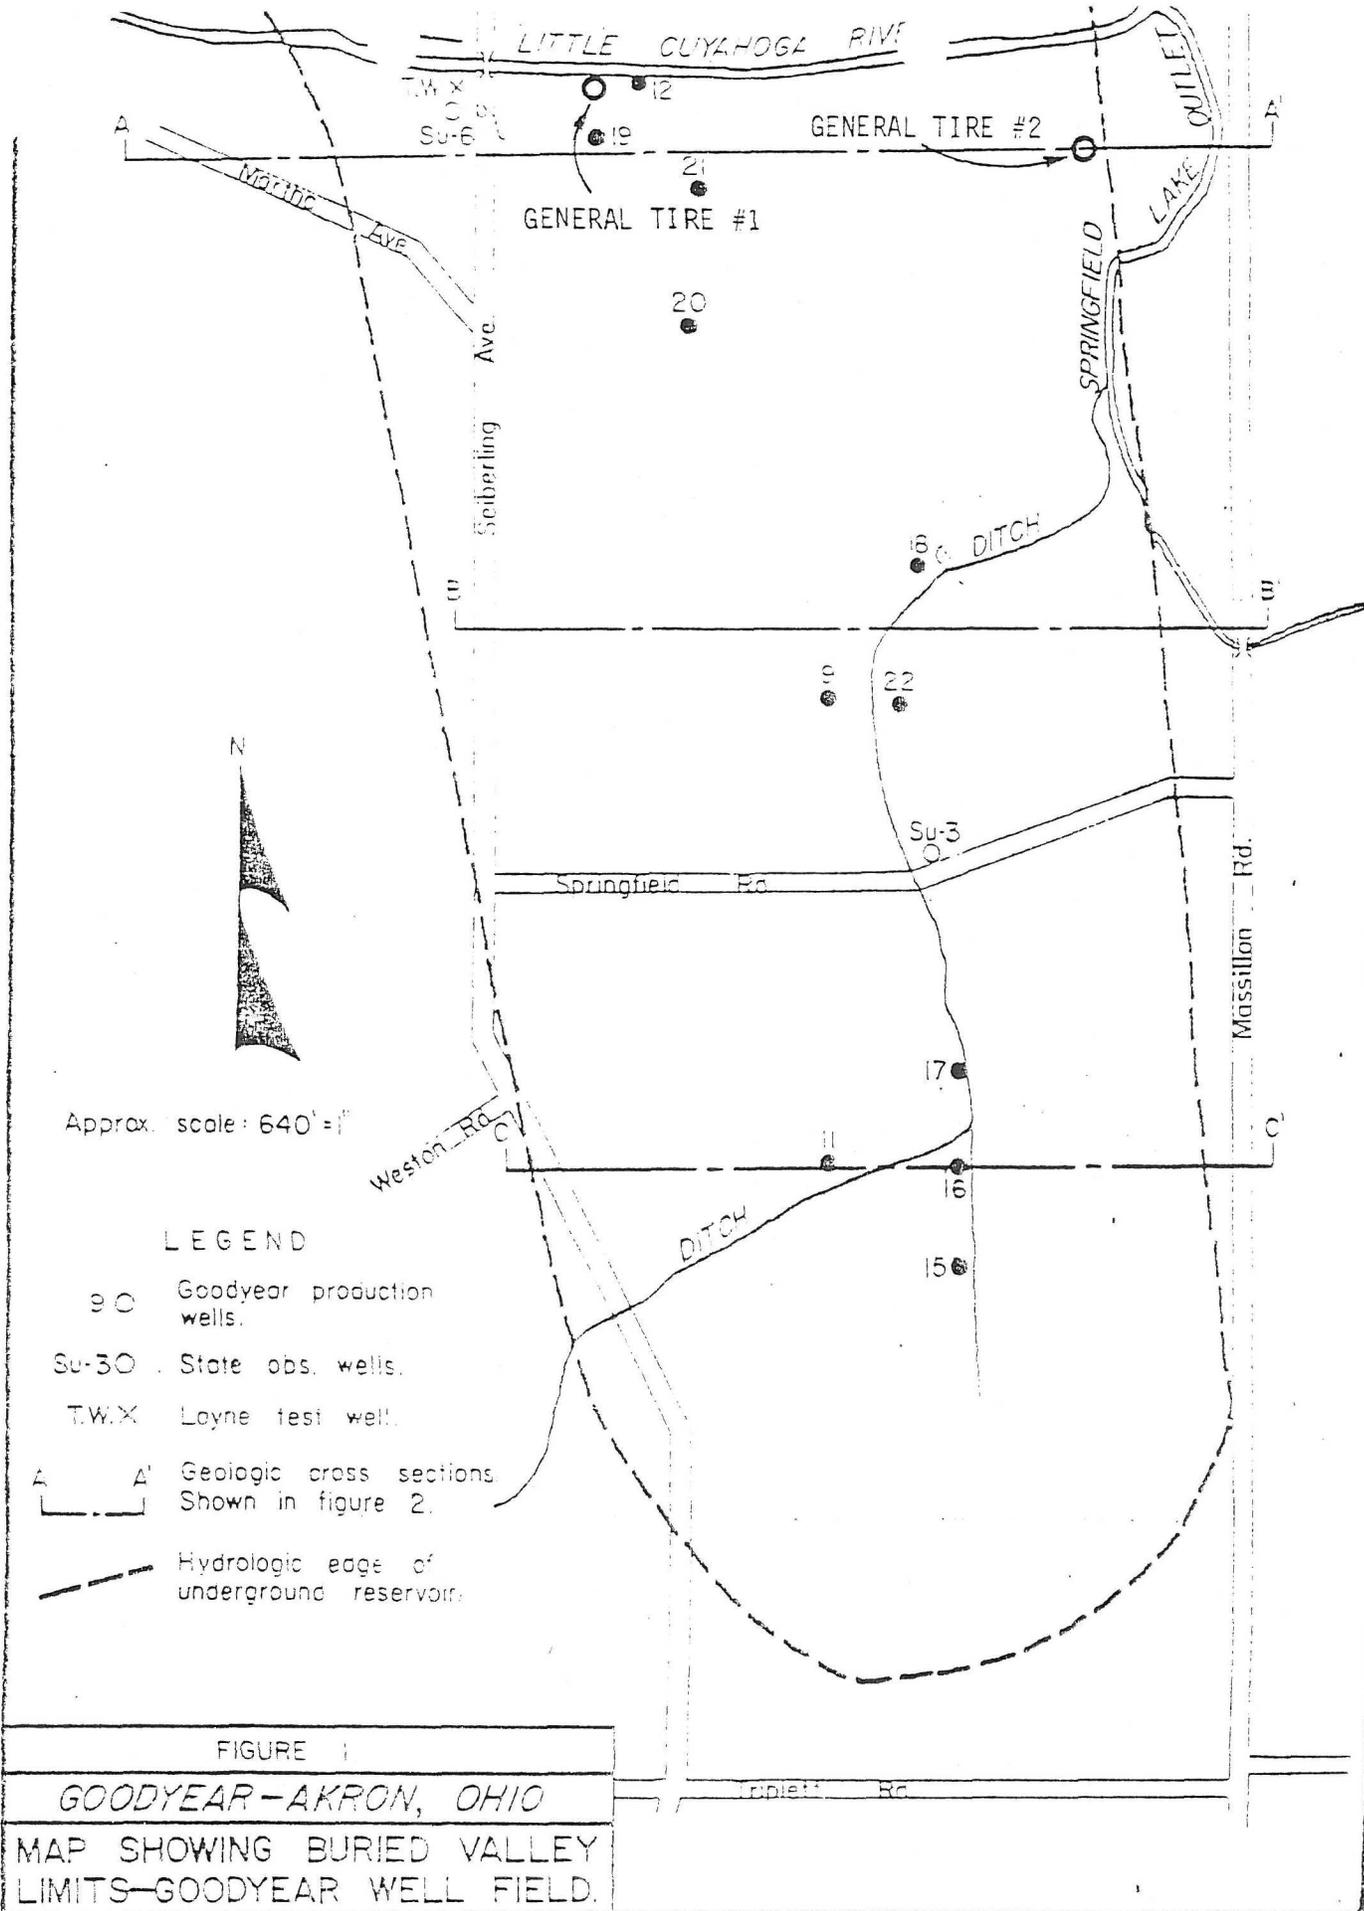
FIGURE 1

Figure 1 shows the location of the two wells with respect to the aquifer and the Little Cuyahoga River.

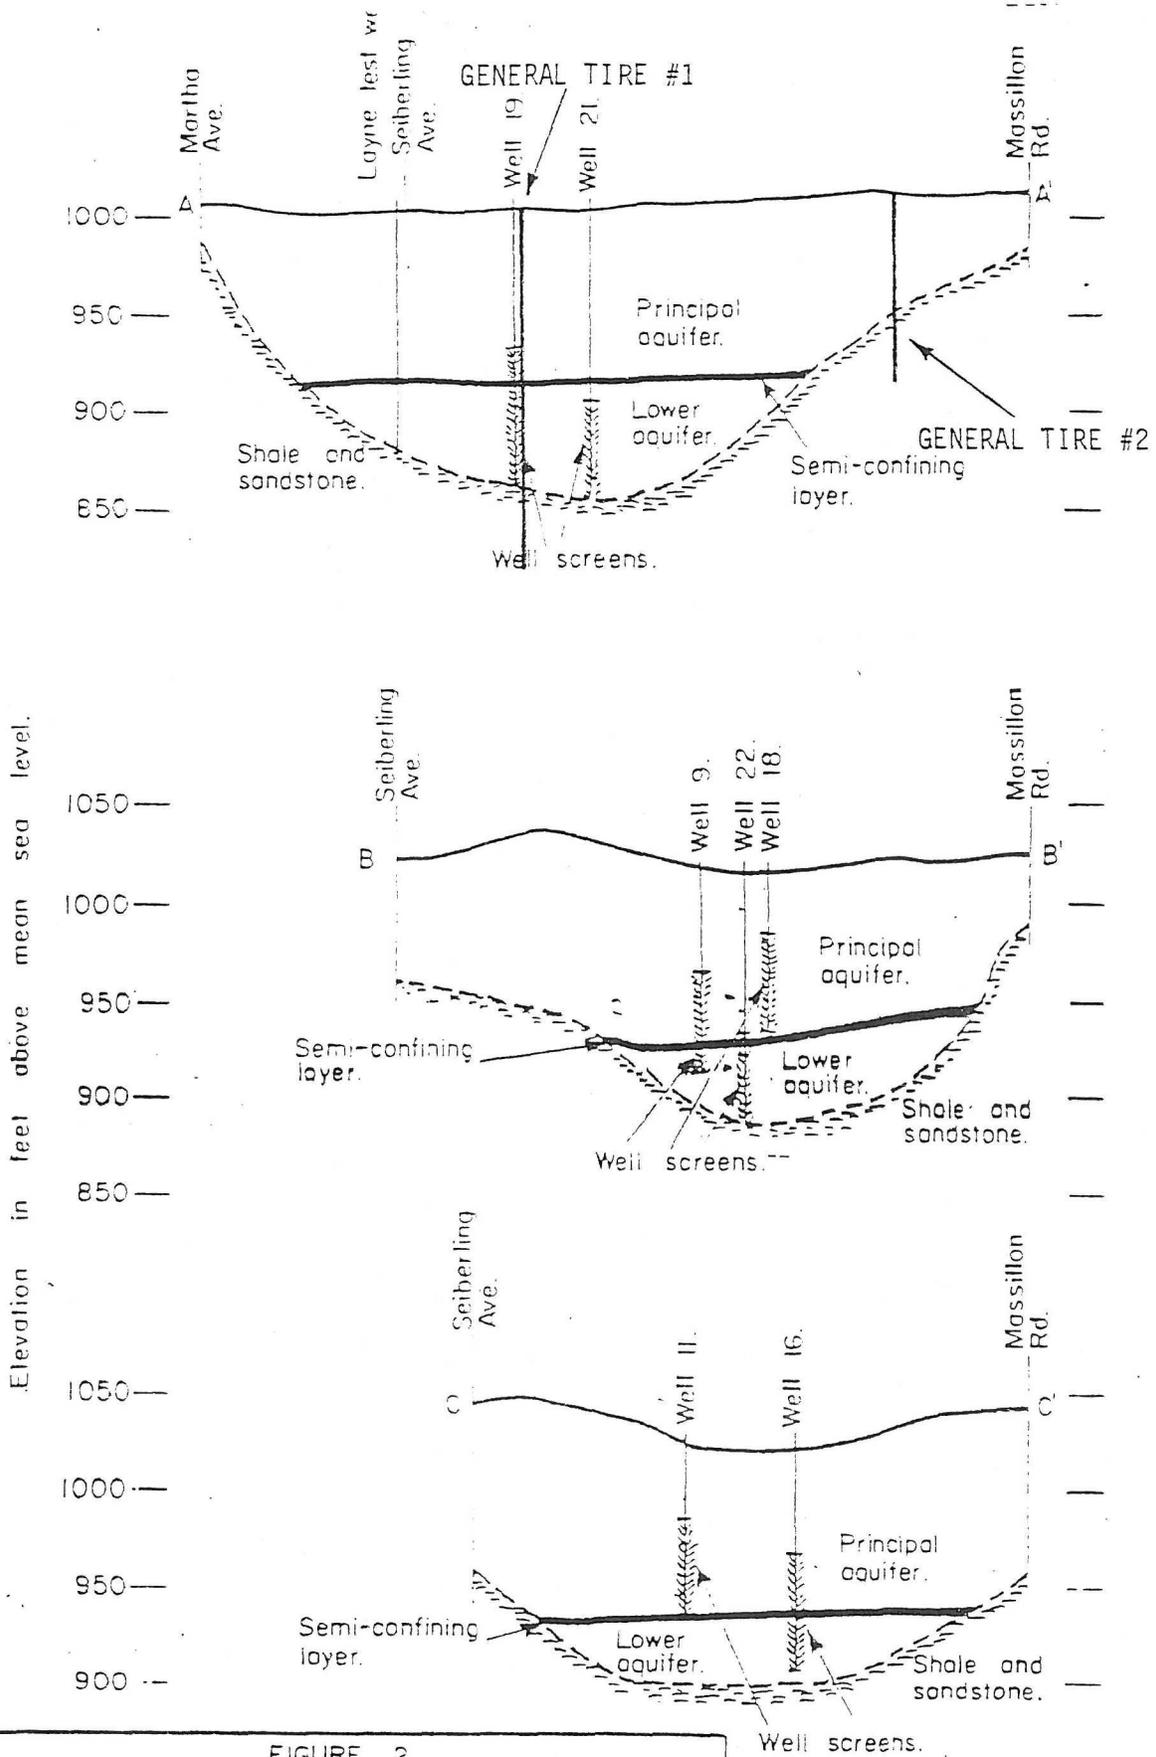
FIGURE 2.

The #2 well is located such that it will penetrate the aquifer on the Eastern slope of the original valley. There are no Goodyear water wells located close by to give good control for the depth to Bedrock. The upper cross-section shown in Figure 2 was taken from the report prepared by Lane Ohio. This cross-section would suggest a drilling depth of 62 feet is needed to penetrate the Bedrock, and a total of 102 feet of conductor pipe is recommended to be cemented to protect the aquifer. A cement basket may not be needed at this location, but one may be installed at a depth of about 40 feet.
