December 28, 2012

**RE: GOODYEAR RIVERWALK
SEIBERLING STREET LANDFILL
SEIBERLING WAY
NOTICE OF VIOLATION**

This letter provides a notice of violations and comments as identified during a recent inspection conducted by the Ohio Environmental Protection Agency (Ohio EPA). On December 11, 2012, Ohio EPA inspected the Seiberling Way road construction at Seiberling Street Landfill. An e-mail (attached) was sent on December 13, 2012 summarizing the inspection from December 11th. The construction project has been authorized by Ohio EPA through a Director's Authorization and Exemption Order approved November 2011, pursuant to Ohio Administrative Code (OAC) 3745-27-13 (November 2011 Rule 13).

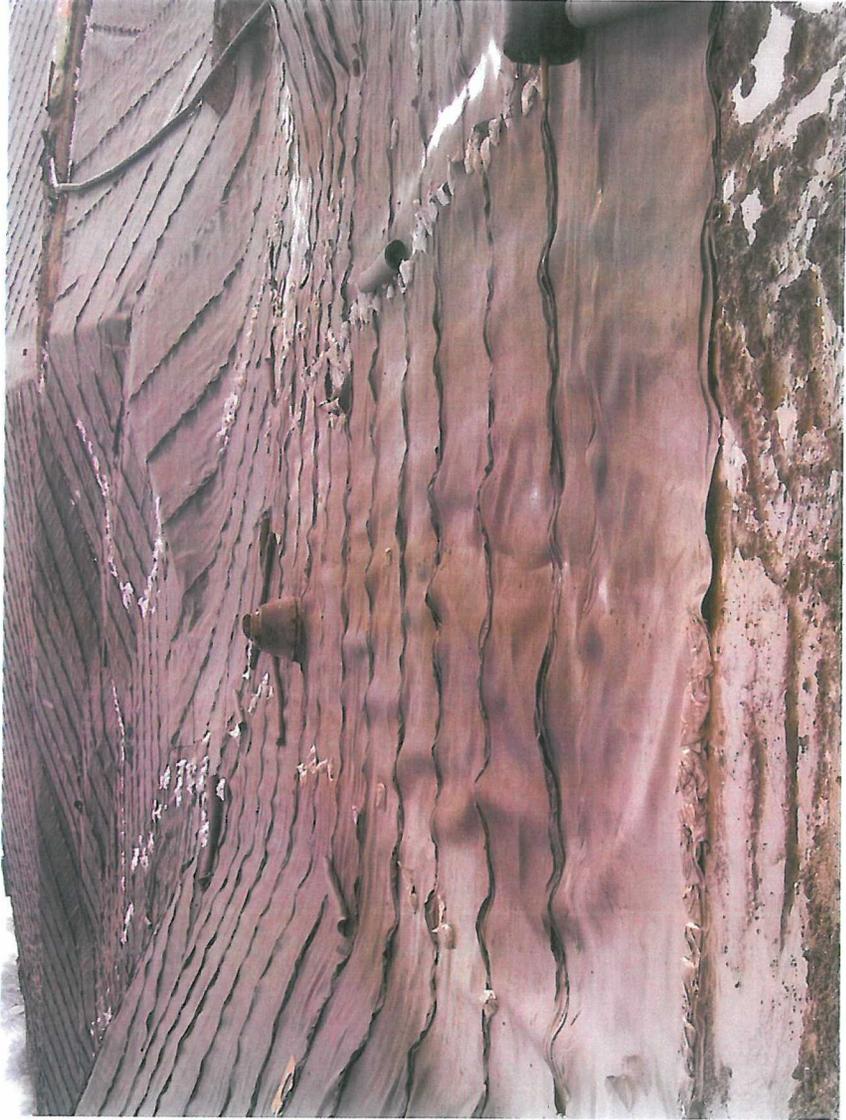
1. In several areas where the road will be constructed, the geocomposite layer and the subgrade (12-inches of intermediate cover) appear to have not been installed properly; see photos 1, 3, 4 & 8.

During the inspection, it was noted that soil mounds and/or tire ruts existed underneath the geocomposite on the west area of the road cut and near the storm sewer junction chamber. The subgrade in this area needs to be reworked, proof rolled, made smooth and free of ruts before the geocomposite is reinstalled. Regarding this requirement, Section 3 of the CQA plan states, in part, at page 3-2: "Visual examination and proof rolling of the subgrade shall be evaluated by Field E/T...to verify that the area is free of solid waste, and **have no abrupt change in grade**. The Field E/T shall document approved subgrade construction within daily reports prior to placement of cap system components." **Table 1 of the CQA Plan indicates that the subgrade is to have less than 2 inches of deflection.**

West area of road cut- geocomposite DD December 11, 2012 Photo 1

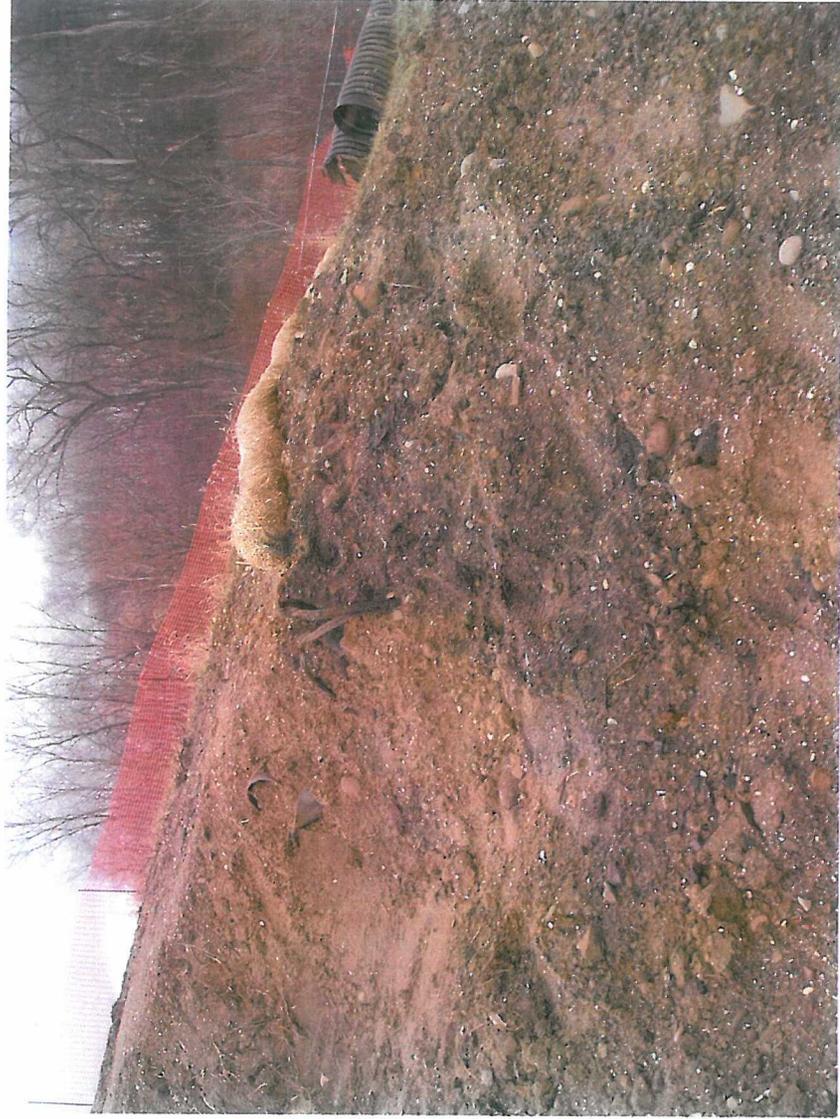
- a. **Northeast Slope near Haley's Ditch:** A small area of exposed waste was identified at the northeast slope; see photo 2. The City is in violation of condition 23 of the November 2011 Rule 13 authorization. To achieve compliance, the City must apply adequate daily cover to this area and any exposed waste at the site.

Waste exposed at northeast corner near Haley's Ditch DD December 11, 2012 Photo 2

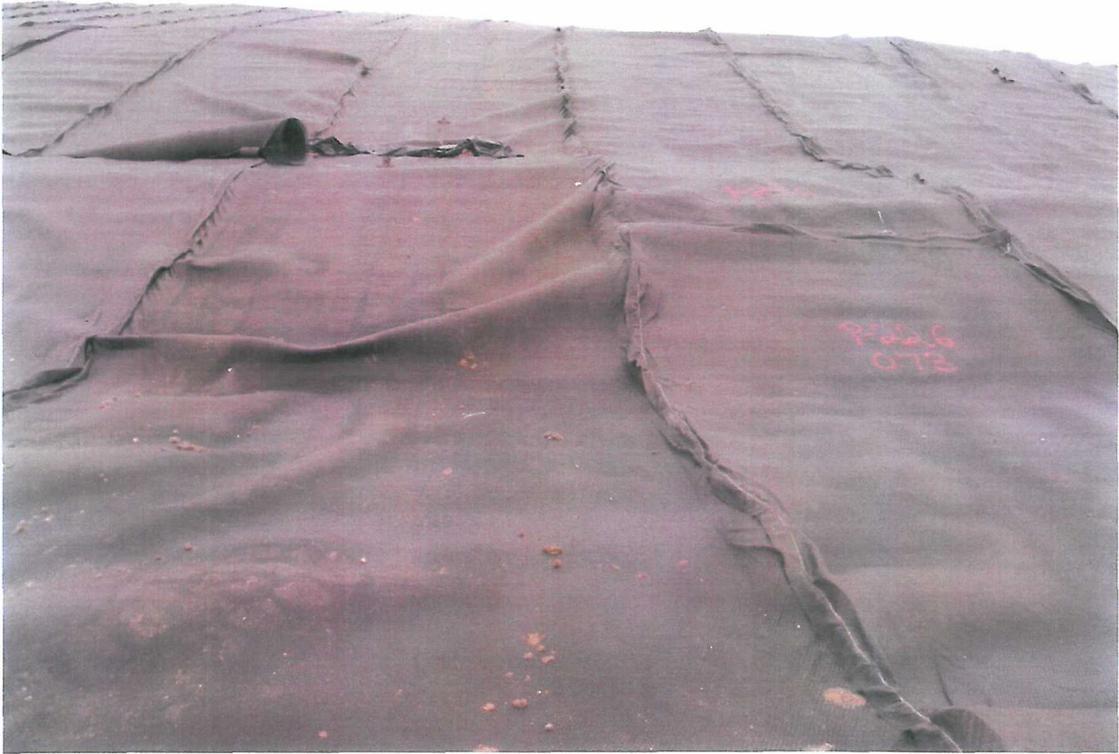
There were unfinished seams, large wrinkles in the finished (seamed) geocomposite panels, tears were identified in the finished seams, and rocks were left on the surface of the geocomposite. Page 3-4 of the CQA Plan states, "At completion, the geocomposite layer shall be smooth, without wrinkles, tears, or holes, and shall cover the total surface of the landfill cover system." The QA Engineer must inspect and approve every panel before placement of the recompacted soil barrier (RSB) layer.

Wrinkles in geocomposite north slope of waste mound AG December 11, 2012 Photo 3

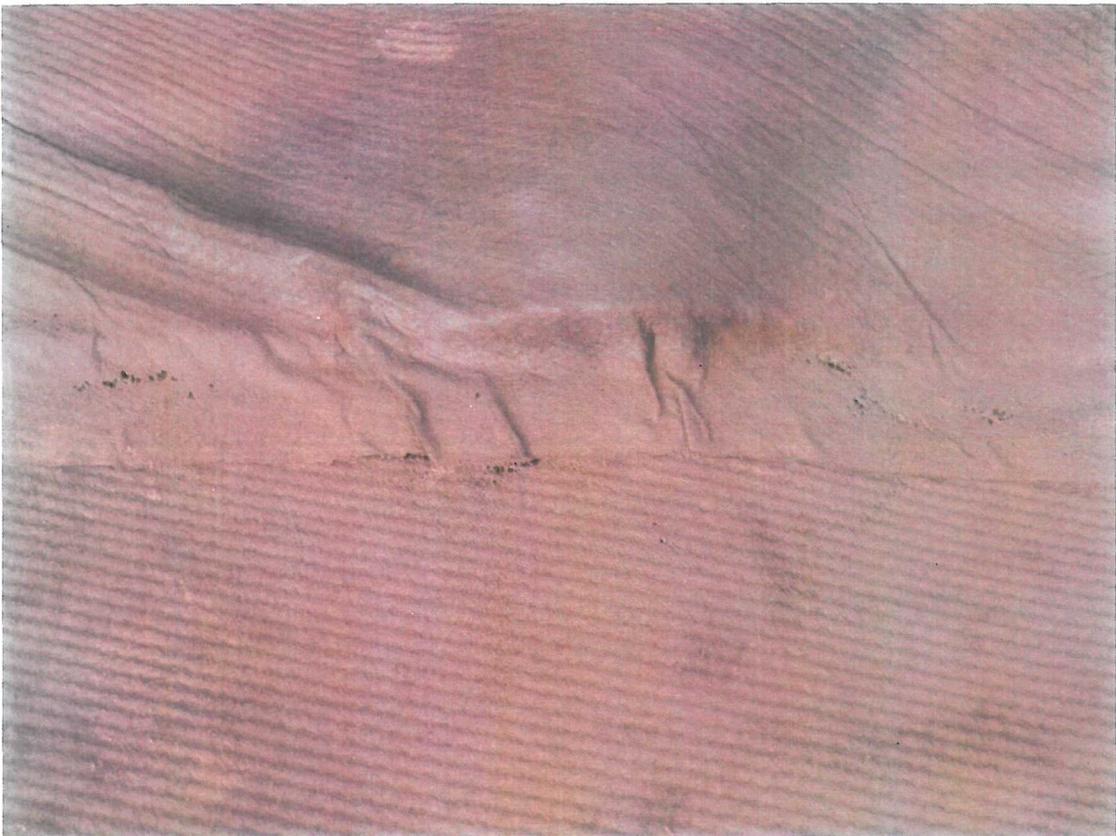
Tears in geocomposite AG December 11, 2012 Photo 4

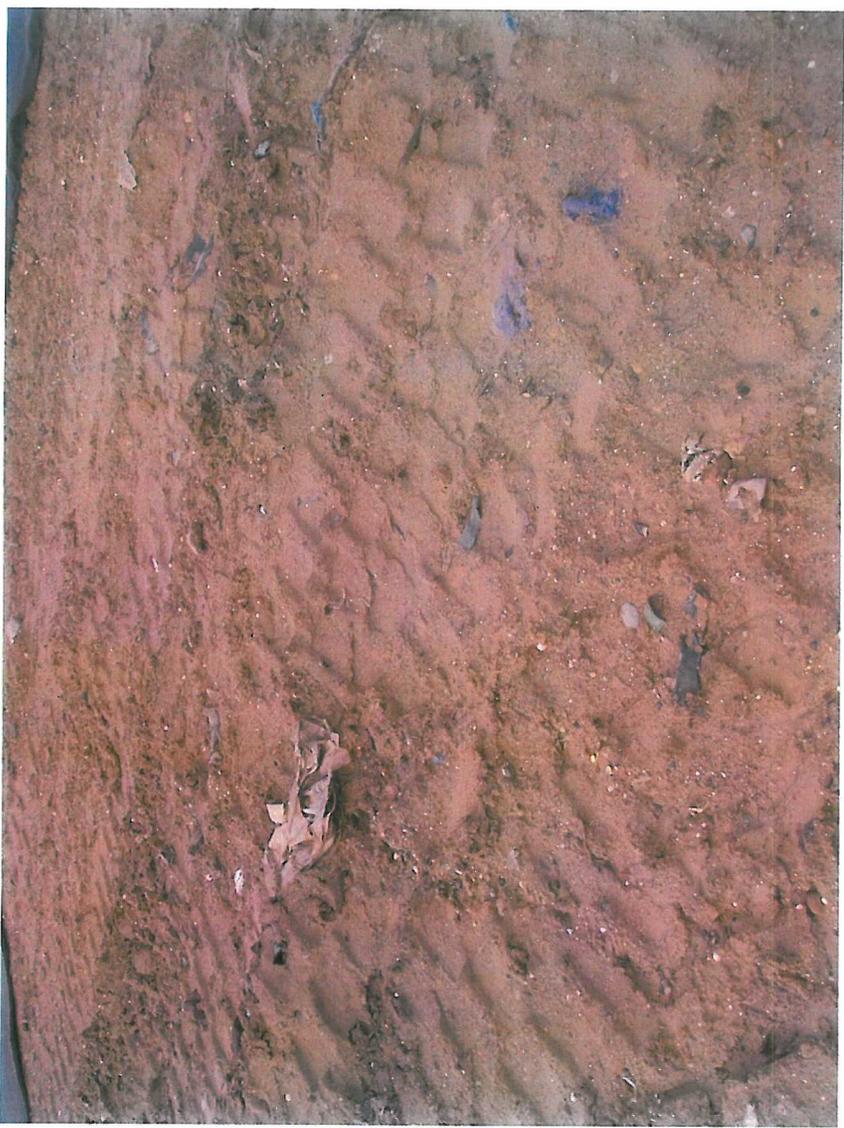
Photo 5

- b. **Waste Relocation Mound:** The northeast corner of the waste mound (near the creek) had flagging of waste; see photos 5 & 6. The geocomposite has already been placed in this area and may need to be removed due to the exposed waste. The QA Engineer is required to inspect and approve of the subgrade before geocomposite is placed. In addition, the Construction Quality Assurance Quality Control Plan (CQA plan) states that the subgrade shall consist of a minimum of at least 12-inches of soil.

Waste relocation mound-northeast slope-exposed waste

The City may not be in compliance with condition 24 of the November 2011 Rule 13 authorization for not adequately installing intermediate cover. This issue was discussed at the December 12th construction meeting and during our conference call on December 21, 2012. To achieve compliance, the City must repair the subgrade, and then verify and document that at least 12-inches of intermediate cover soils has been applied over all waste areas before installing geocomposite. Table 1 of the CQA Plan indicates that a required test for the subgrade (final lift of intermediate cover) is of the elevation by survey. An adequate demonstration of compliance with this construction specification must be included in the certification report.

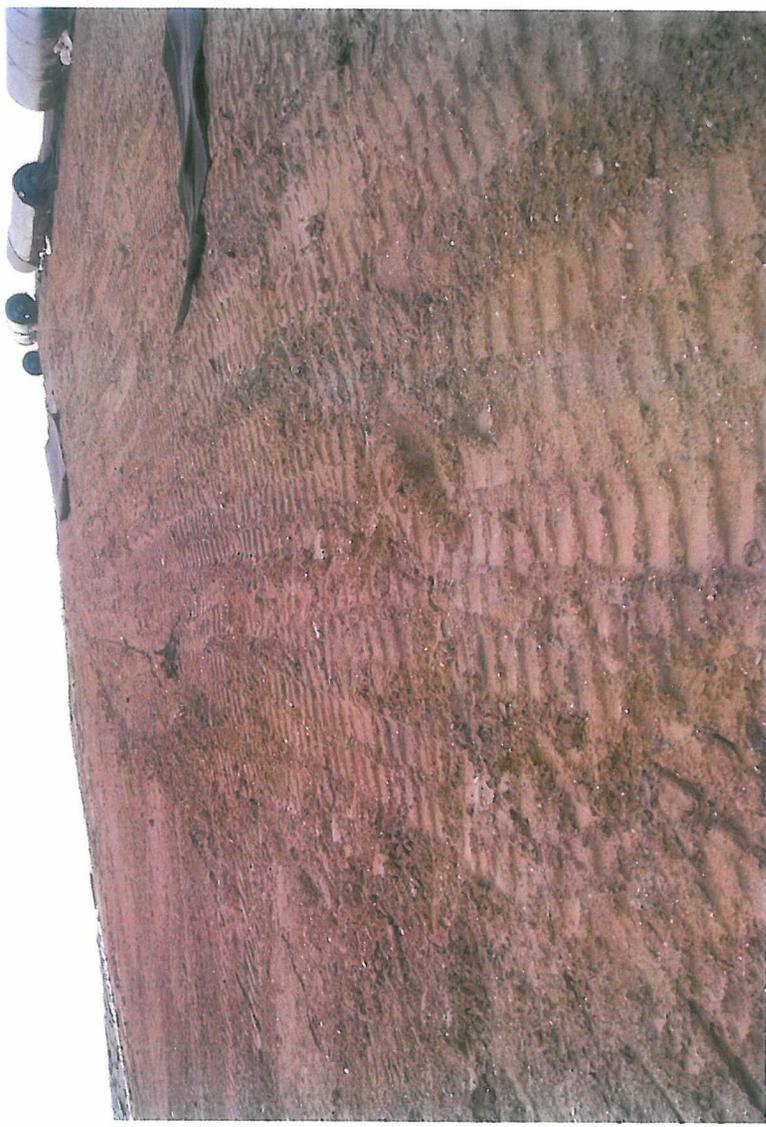
Photo 6

Waste relocation mound-northeast slope-subgrade

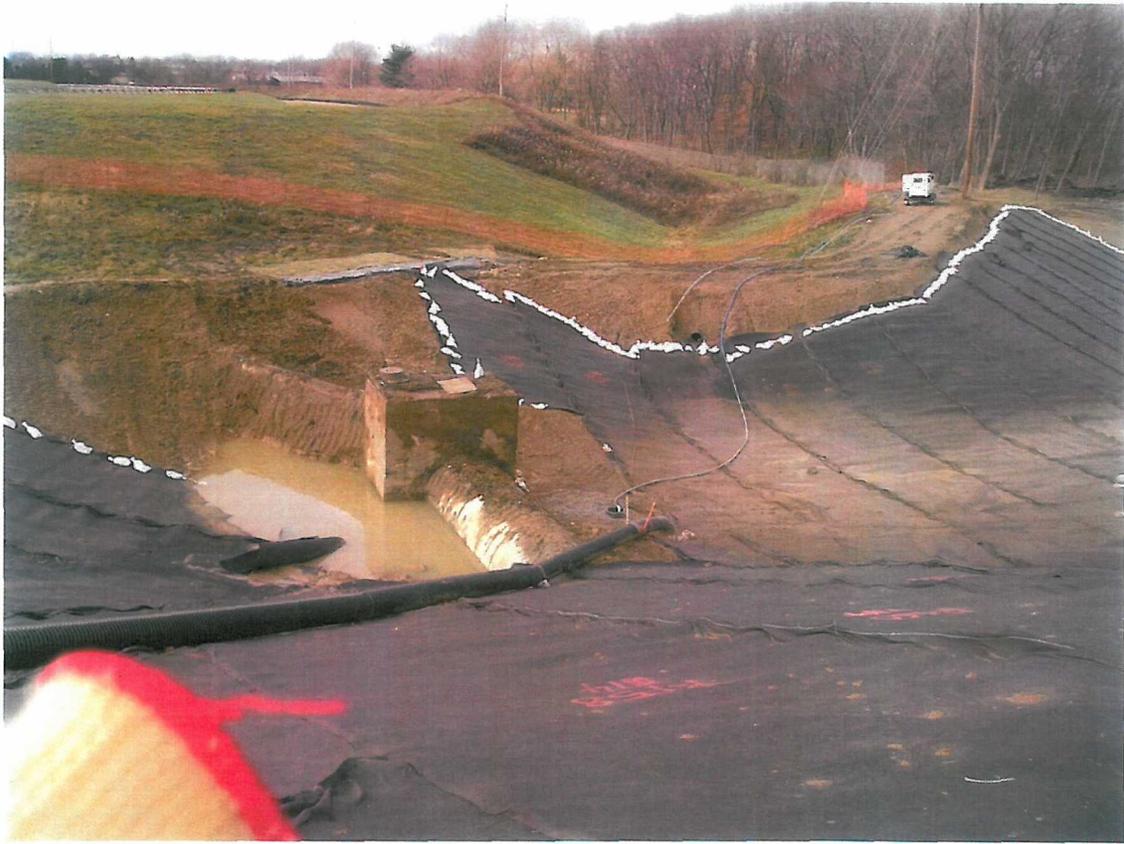
Photo 7

- c. **West side existing storm sewer junction box:** There was ponded water south of the existing junction box. This is not in accordance with the approved SWP3 and is a violation of the OAC 3745-27-13(H)(5) and Condition 22 of the November 2011 Rule 13 authorization. See photo 7.

Ponded water near junction box

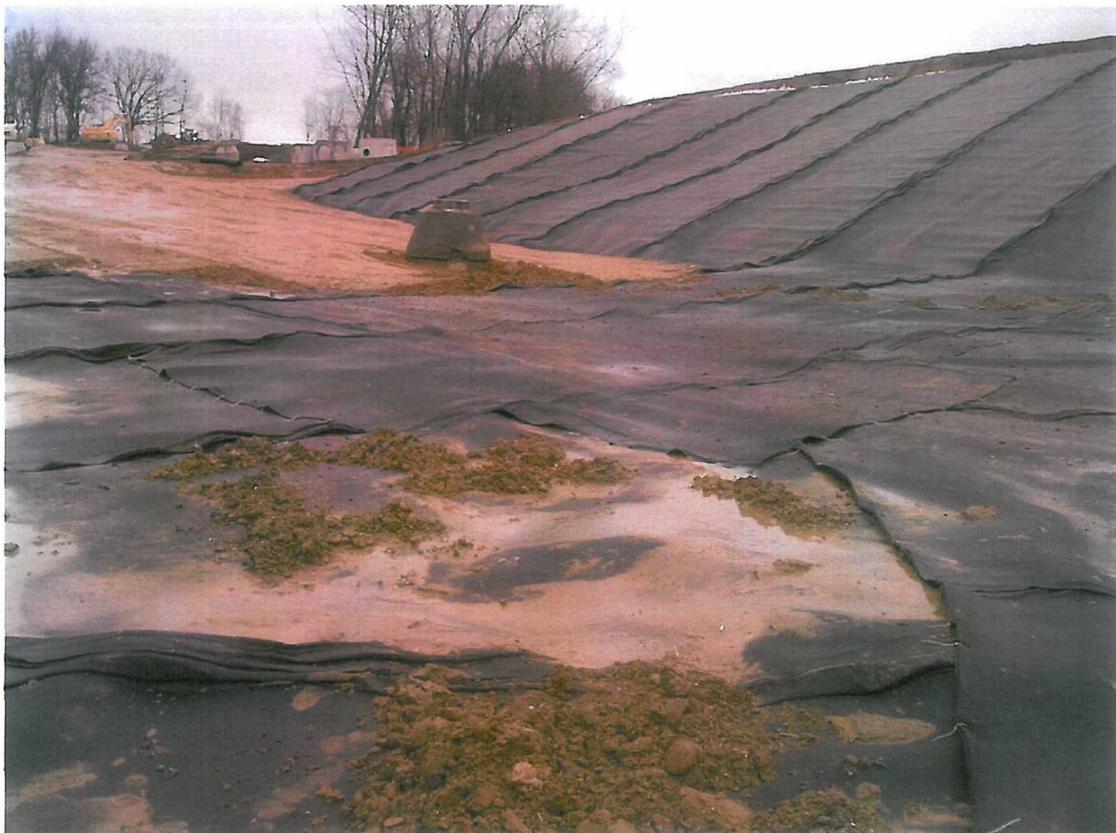
Photo 8

On December 18, 2012, the Ohio EPA visited the site and noted that clay had been placed above geocomposite on the west end. Concerns from the December 11th inspection still remain regarding the subgrade and geocomposite. See photo 8. Ohio EPA contacted Sitetech and was told that clay placement will be continuing and GSI would not be back at the site to repair the geocomposite. Ohio EPA contacted Sitetech and the City of Akron by phone and email to inform them of the concerns from the December 18th site visit; email attached.

West area of road cut-unfinished seams & soil placement

Ohio EPA discussed the above concerns during a site visit and a conference call held on December 21, 2012. As noted above and during the inspections, the observed conditions of the subgrade and geocomposite do not comply with the CQA Plan and must be repaired or the certification report cannot be concurred with by Ohio EPA. All repairs to the subgrade and geocomposite are to be documented with enough detail and photographs to show a before and after result as required in condition 8 of the November 2011 Rule 13 authorization. We suggest that photographs and adequate location identification be utilized at the site to document the repairs required.
