# Air Pollution Control Division

January 7, 2013

**Re: NOTICE OF VIOLATION  
REPEAT ASBESTOS VIOLATIONS  
Improper Demolition Activities relating to Asbestos Containing Material  
Stark Ceramics, 600 West Church Street, East Canton, Ohio 44730**

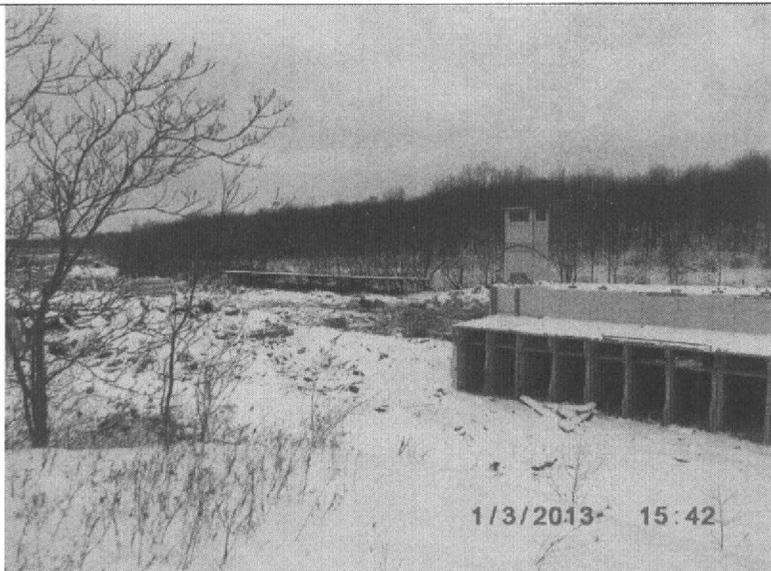
Facing southwest, view of remnants of buildings 10 and 11 in background (building 14 in foreground).

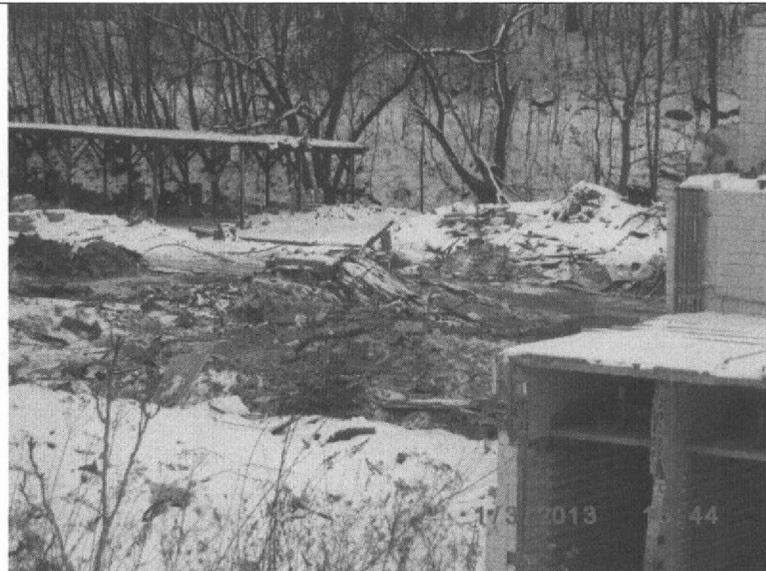
Facing southwest, view of debris pile located in southern footprint of buildings 10 and 11; note transite panels.

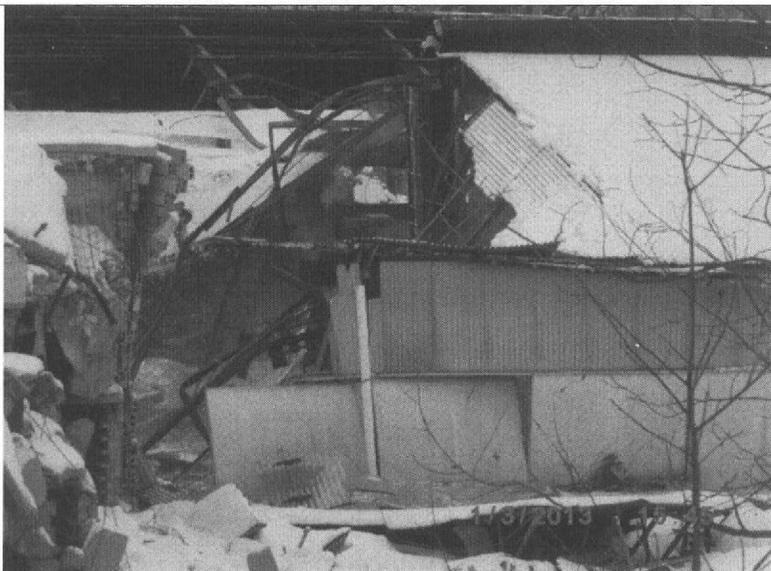
On or before January 3, 2013, asbestos-containing transite panels, which were formerly located on the roof and walls of buildings 10 and 11, were not removed and/or were improperly removed during demolition activities and subsequently broken into small pieces. The investigator observed active demolition on the northern portion of building 11, with transite roof and wall panels still present and thus broken during the demolition activities. Thus, these activities rendered the typical category II non-friable asbestos containing material (ACM) to now be considered friable and therefore regulated asbestos containing material (RACM).

Facing west, view during active demolition of northeast portion of building 11; note transite panels on roof and walls still present.

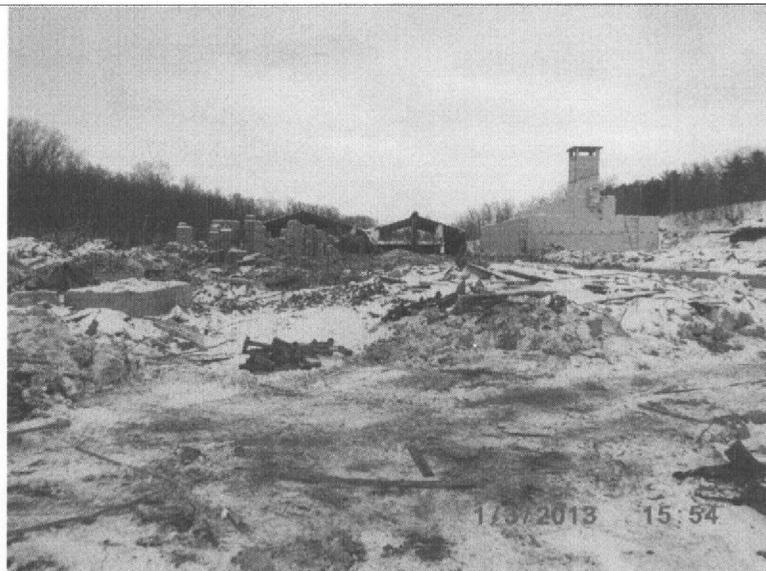
Facing north, view from approximate southern end of building 10 and 11 footprint.

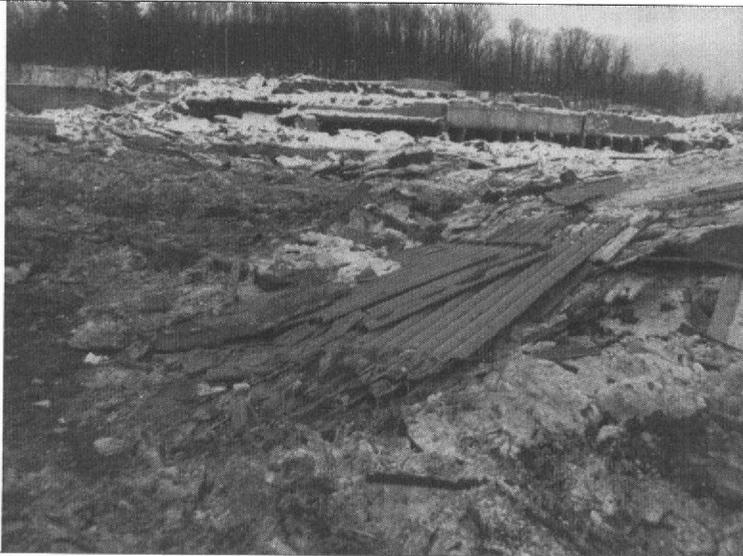
Small pieces of transite still remain onsite and were observed throughout the debris pile and building remnants from buildings 10 and 11. Since the transite pieces are now comingled in with other construction and demolition waste, the entire newly created demolition pile, estimated to be greater than 70,000 square feet and including but not limited to the footprints of buildings 10 and 11, is considered asbestos contaminated waste material. This new asbestos contaminated debris pile will need to be treated the same as the existing asbestos contaminated debris pile and will require the use of certified trained individuals for proper disposal at an EPA approved landfill.

Closer view of transite panels observed to have been broken and scattered amongst debris.

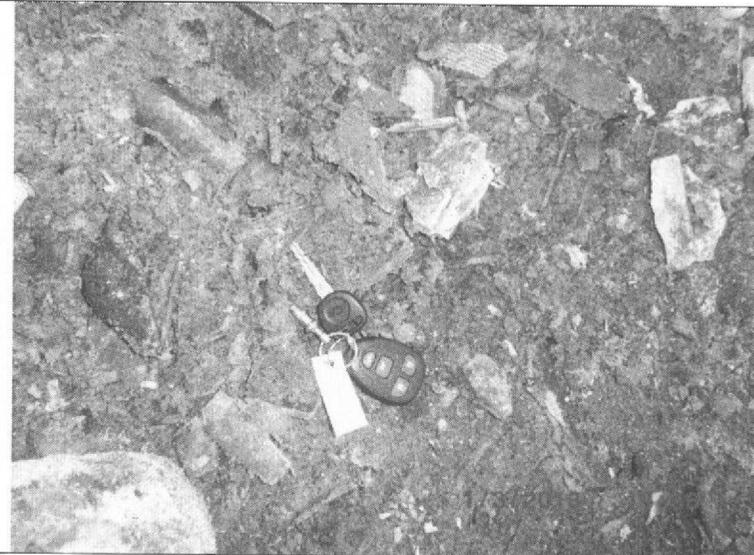
On or before January 3, 2012, buildings 10 and 11 were partially demolished without using proper work practices to minimize asbestos and dust emissions. On January 3 and 4, 2013, Canton APCD observed small fragments of transite on the ground and throughout the debris pile along with building remnants from buildings 10 and 11. There was evidence that some of the transite pieces on the ground, as well as portions of the debris pile, had been run over by heavy equipment. No water spray was observed during the demolition on the northern portion of building 11, which caused transite roof and wall panels to fall and break, and no water source was observed.

View of small fragments of transite located on ground.

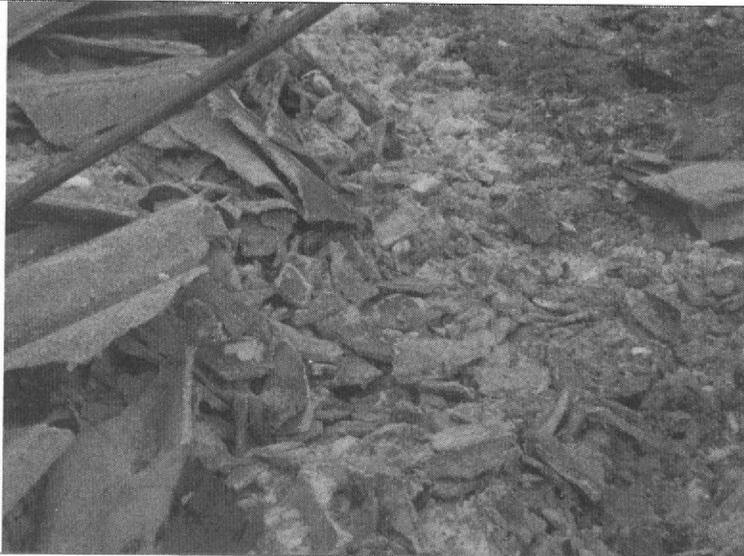
View of broken transite pieces on ground, which were apparently, ran over by with heavy equipment.

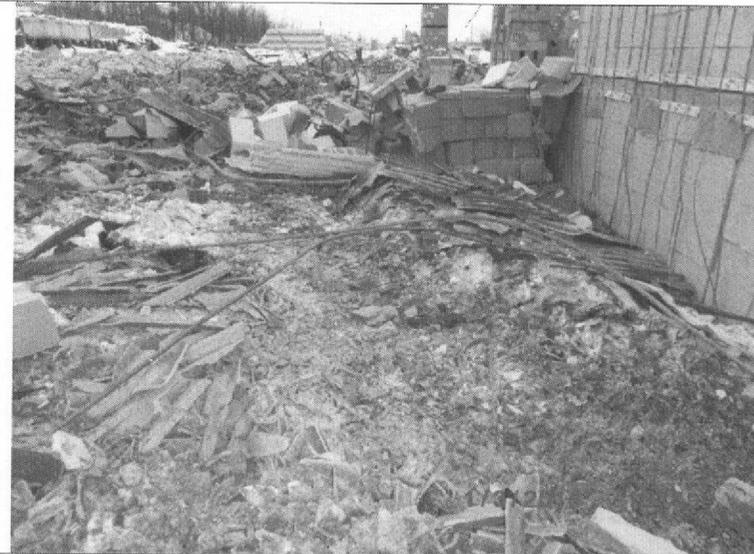
Additional view of broken transite pieces on ground, which were apparently ran over by with heavy equipment
