May 17, 2013

**RE: NOTICE OF VIOLATION  
3<sup>rd</sup> QUARTER FY 2013  
COMPREHENSIVE INSPECTION  
ELKRUN INDUSTRIES C&DD LANDFILL**

**ELKRUN INDUSTRIES INC. C&DD LANDFILL PHOTOS FROM FEBRUARY 27, 2013**  
**INSPECTION**

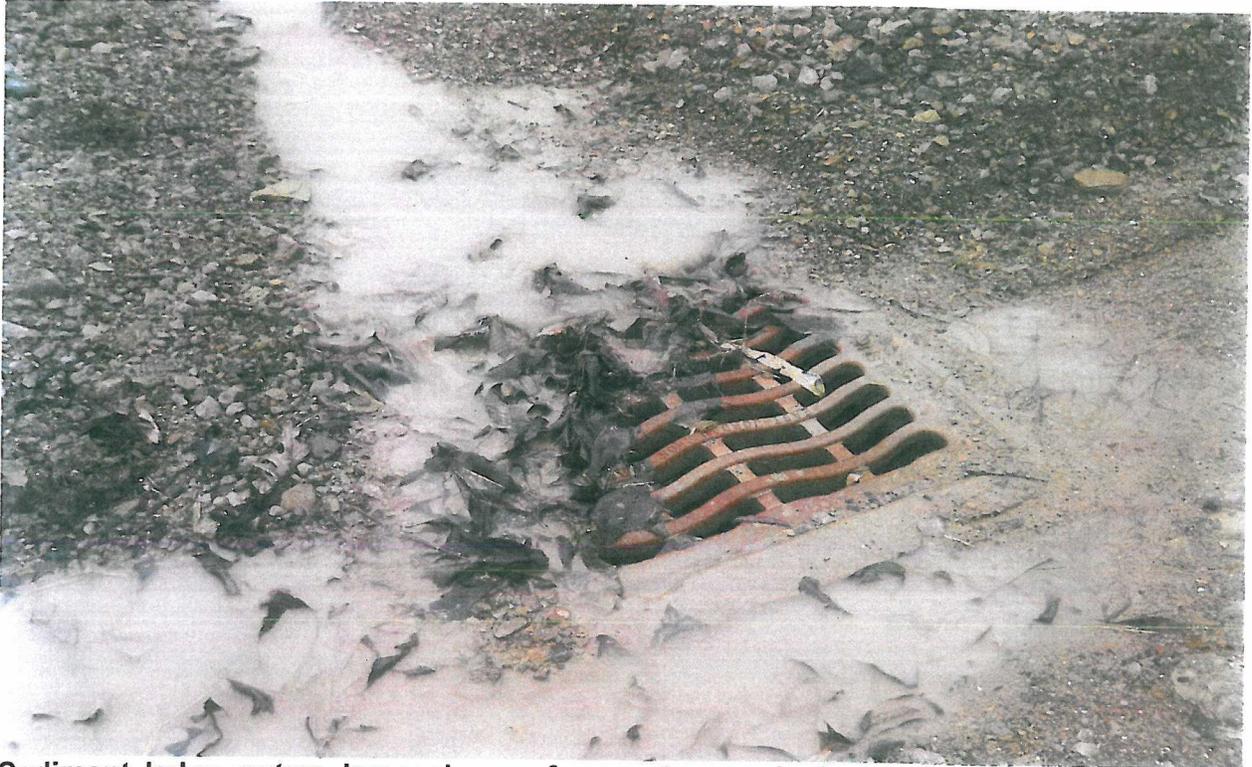
1. **Surface Water/Water Pollution.** During this inspection, surface water laden with sediment was observed running along the sides of the access road, over the unpaved access road, and both behind the office trailer and along the north side of the scales prior to running into drains that drain underneath State Route 7 and into an unnamed tributary to Turkeyfoot Run. Leachate was also observed running down the side of the yellow leachate tank located on the north side of the access road, across the ground on the north side of the scales, out to concrete pad at the entrance to the facility, and into the grate which drains underneath State Route 7 and into an unnamed tributary to Turkeyfoot Run.

The owner/operators of Elkrun failed to control surface water at the facility and allowed surface water laden with sediment to flow into waters of the state, and, because it failed to properly manage leachate at the facility. The owner/operators of Elkrun allowed leachate to flow into the waters of the state. Failure to control surface water and leachate, and allowing water pollution to occur has resulted in violations of the following:

**Sediment laden waters bypassing surface water ponds & entering storm drain which drains underneath State Route 7**

In order to return to compliance with these rules, the owner(s) or operator must immediately cease causing water pollution, and comply with the facility’s surface water pollution prevention plan, the facility’s current operating license, and all applicable laws and regulations.

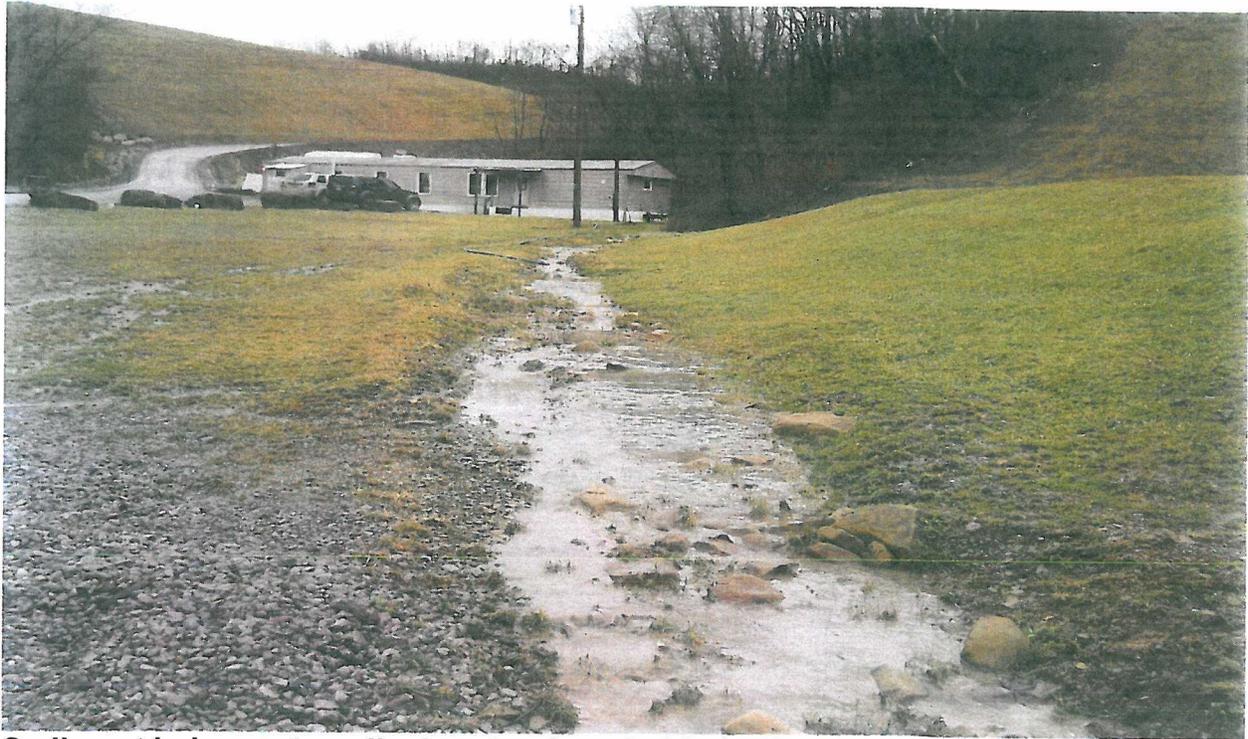
**Sediment laden waters discharging from behind office trailer into storm drain.**

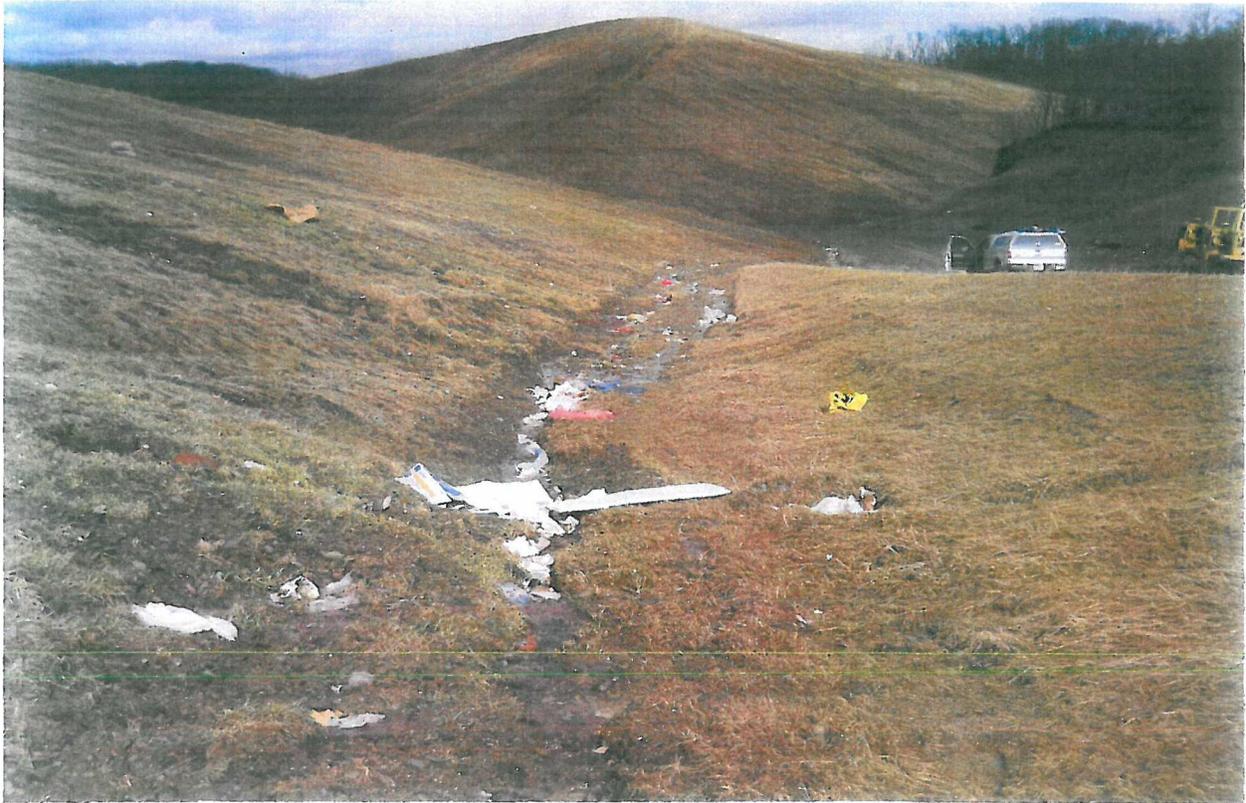
2. **Engineered Components.** During this inspection, surface water diversion ditches located at the toes of various slopes around the facility were observed to be not functioning as intended. Ditches were observed to have been eroded through the cover soils and prior capped/certified areas into emplaced debris. Silting and scouring has occurred in many of these surface water ditches. The ditches have also meandered and have left their original channels and either created new non-engineered channels, or have widened to the point where they are no longer functioning properly. Failure to maintain surface water ditches at the facility has resulted in violations of the following:

3. **Litter.** During this inspection, litter was observed scattered in the facility's surface water channels, on landfill side slopes, and in areas located to the east of waste placement. Elkrun is in violation because it failed to employ all reasonable measures to collect, properly contain, and dispose of scattered litter at the active licensed disposal area of the facility. Failure to employ all reasonable measures to collect, properly contain, and dispose of scattered litter at the active licensed disposal area of the facility has resulted in a violation of the following:

**1) Scattered litter in surface water ditch; 2) Failure of engineered component (ditch).**

In order to return to compliance with these rules, the owner(s) or operator must immediately repair all damage to or failure of the surface water ditches at this facility. Repairs shall include correcting silting and scouring of the ditches, as well as correcting the conditions that are causing the silting or scouring. The facility owner(s) or operator shall also re-construct any ditches that require reconstruction in order to ensure that they are functioning as intended.

In order to return to compliance with this rule, the owner(s) or operator must immediately employ all reasonable measures to collect, properly contain, and dispose of scattered litter at the active licensed disposal area of the facility, and remove and properly dispose of all scattered litter in all areas of the landfill facility and surrounding property.

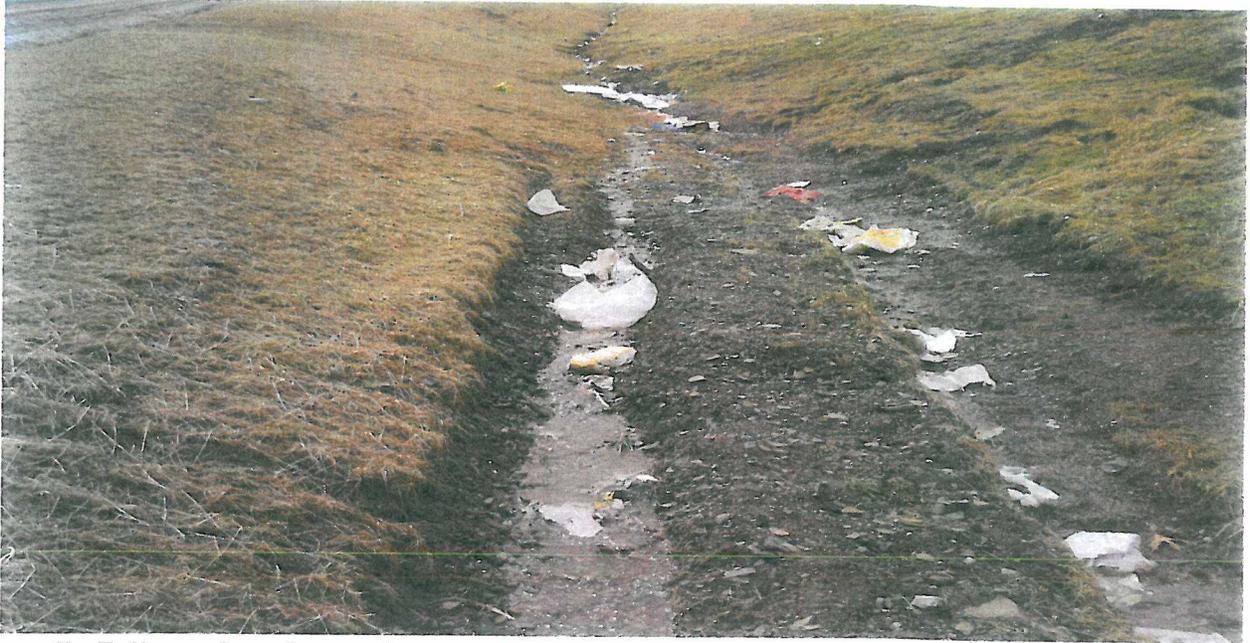
**1) Failure of engineered component (ditch); 2) Scattered litter in surface water ditch.**

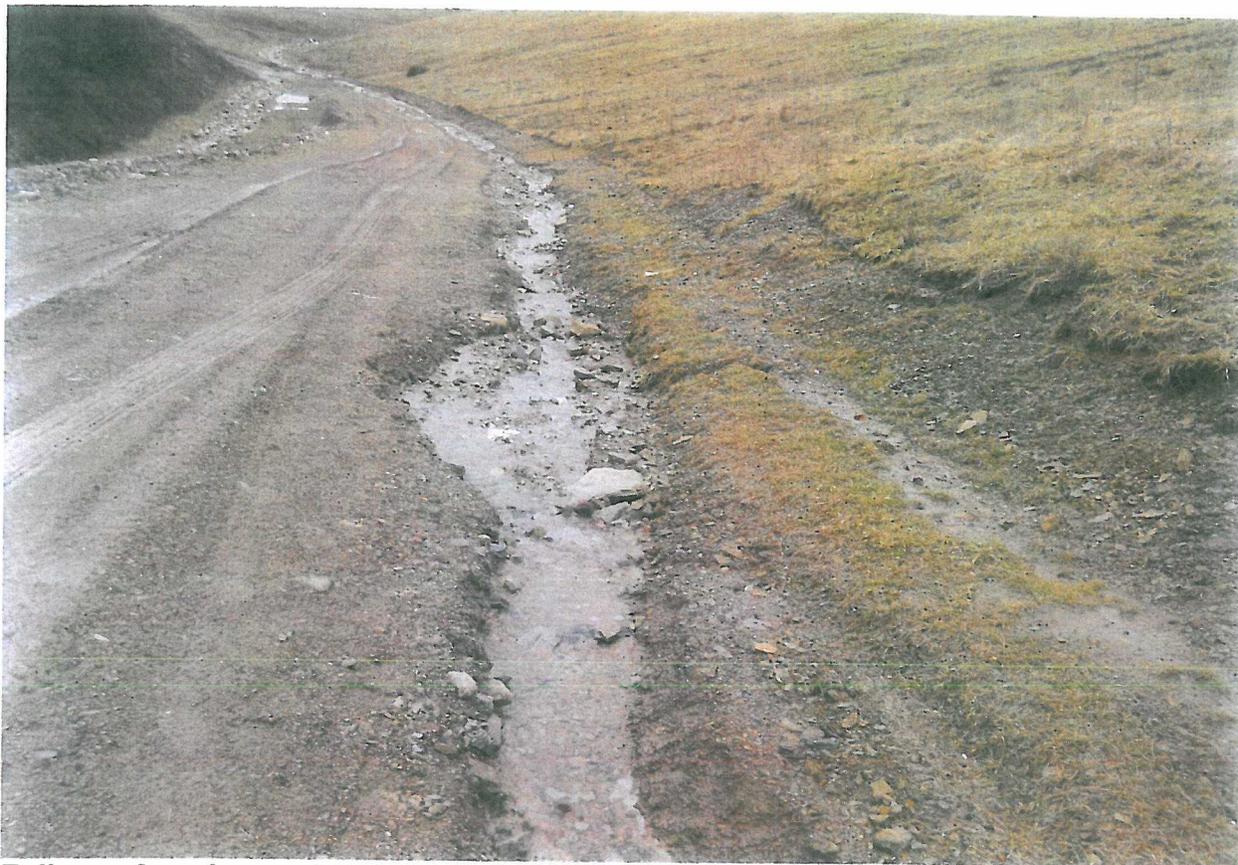
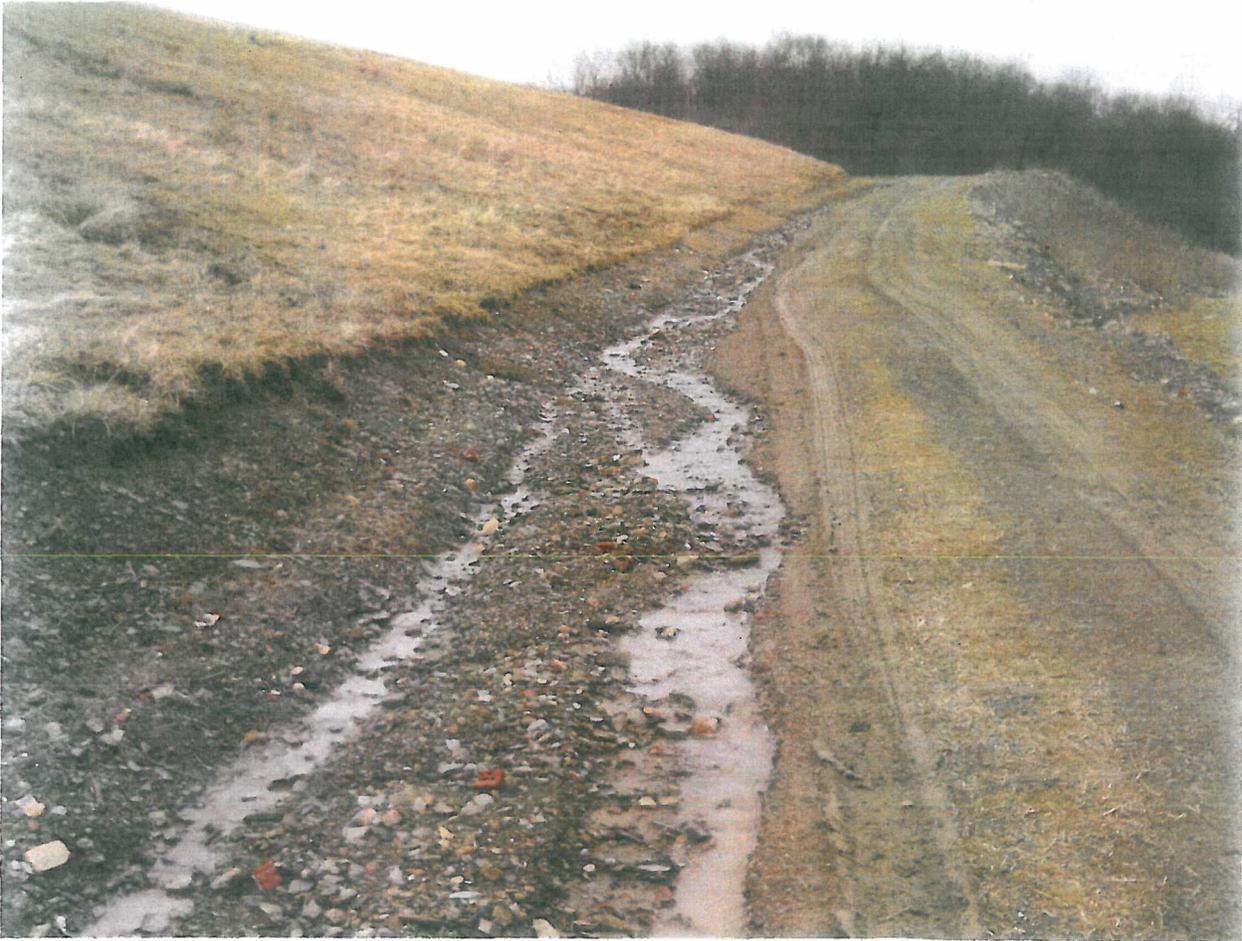
**Failure of engineered components (ditch & cap) in northern certified/capped area.**

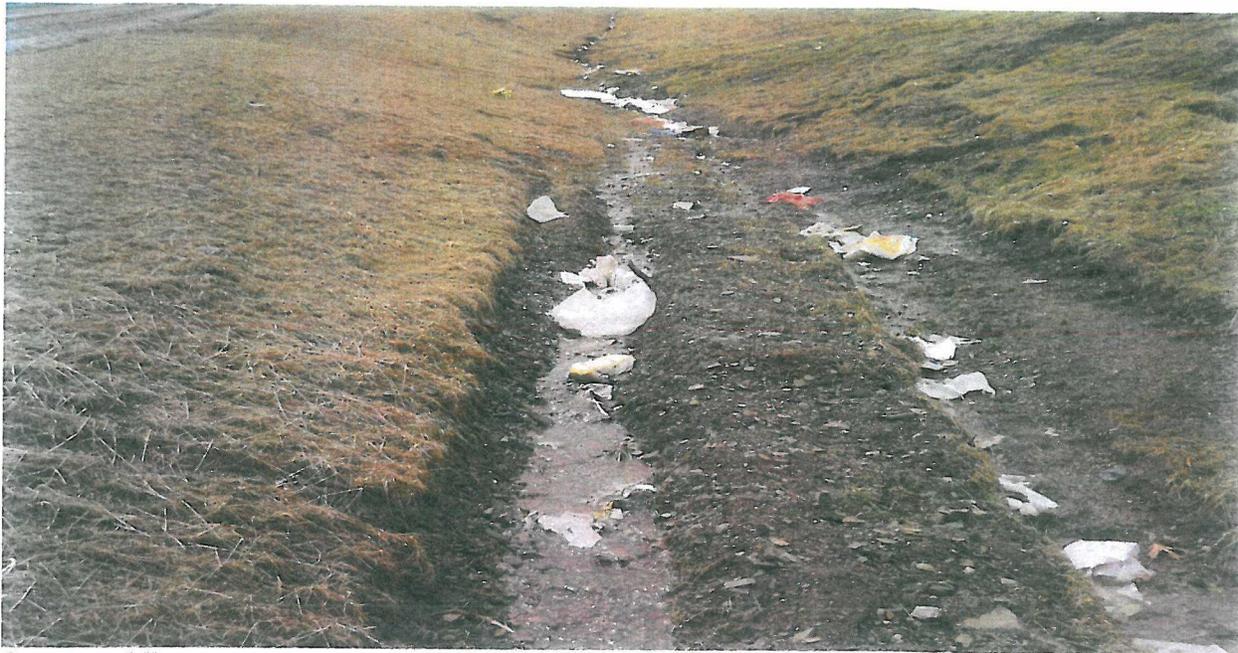
**Scattered litter on eastern side of southern expansion area in failed engineered ditch.**

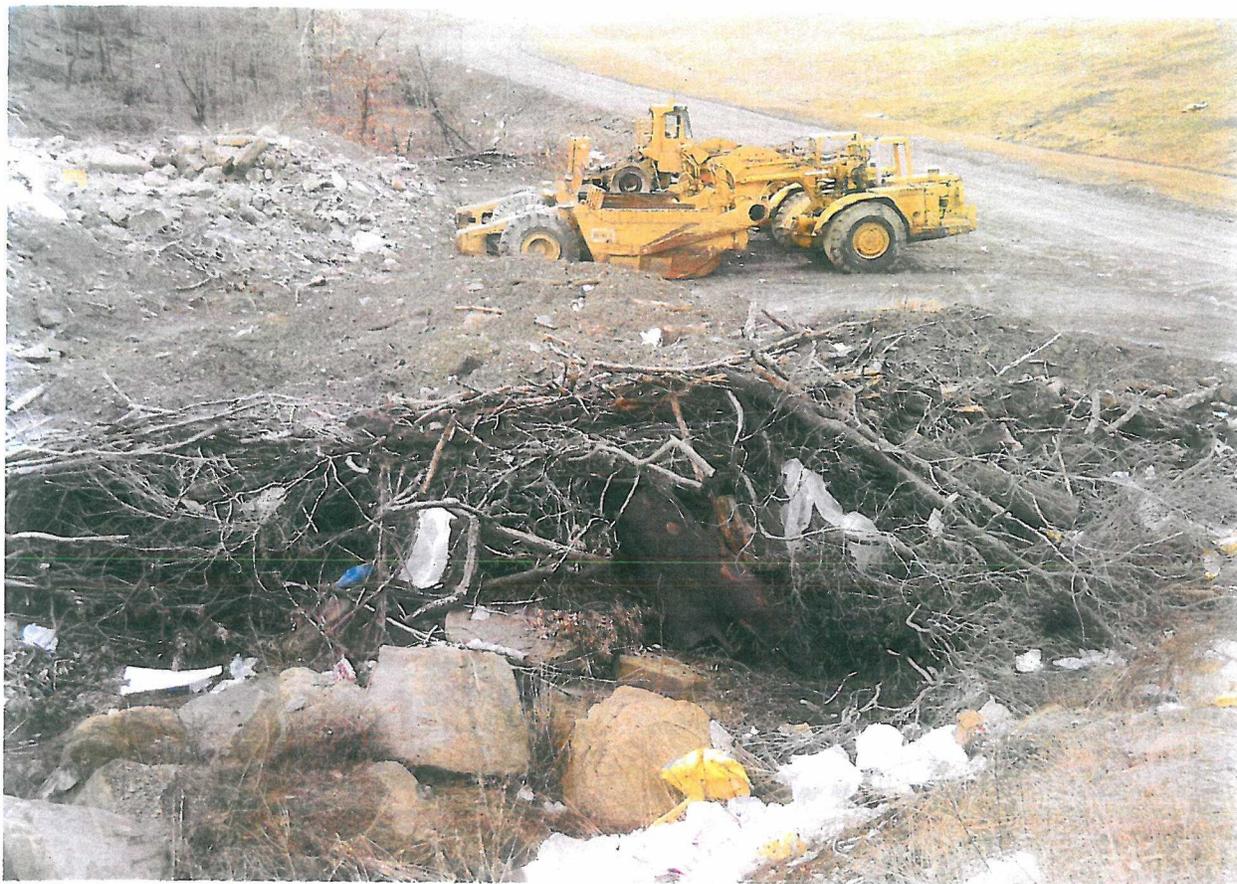
**Scattered Litter east of southern expansion area outside ALDA.**

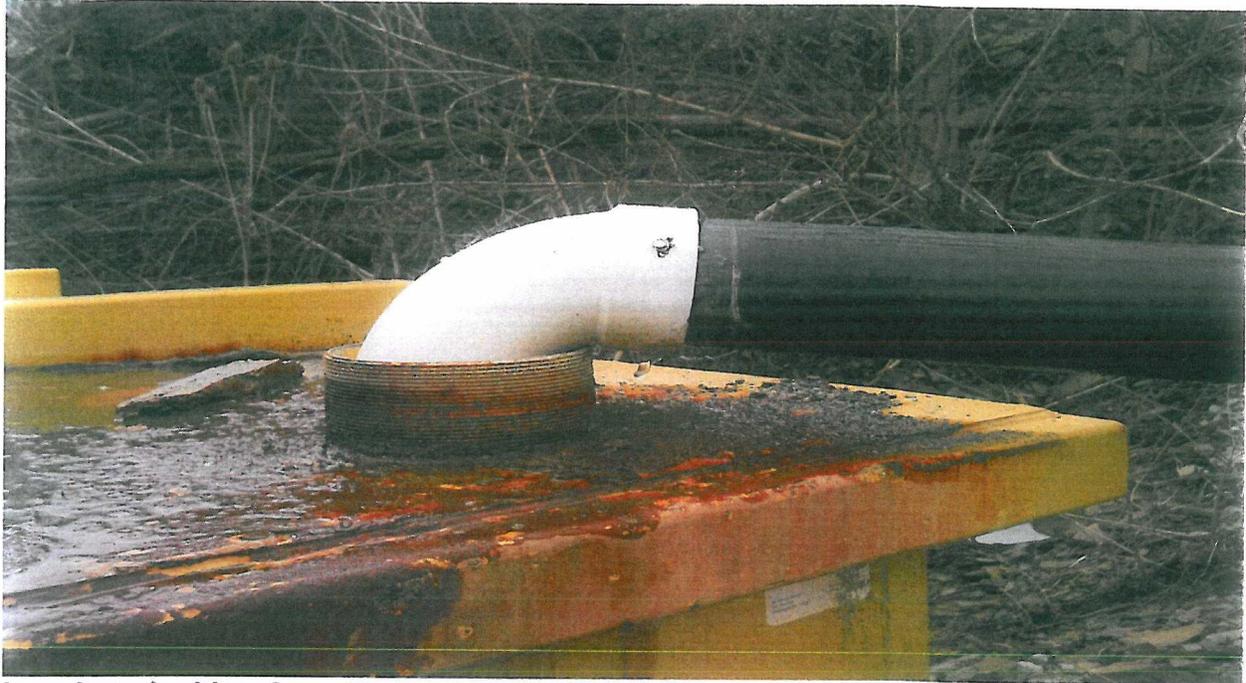
4. **Leachate.** During this inspection, leachate was observed leaking from the pipe leading into the yellow leachate tank located on the north side of the access road, north of the office trailer. Specifically, leachate was observed leaking from the connection between the black leachate pipe and the white elbow that sits inside the top of the tank. The leachate then flowed onto the top of the leachate tank, down the side of the leachate tank, across the ground on the north side of the scales, out to the concrete pad at the entrance to the facility, and into the grate which drains underneath State Route 7 and into an unnamed tributary to Turkeyfoot Run. The owner/operators of Elkrun failed to operate and maintain the leachate collection system and to manage and dispose of leachate in accordance with applicable regulations at the facility. Failure to operate and maintain the leachate collection system and to manage and dispose of leachate in accordance with applicable regulations at the facility has resulted in a violation of the following:

**Leachate leaking from leachate tank piping directly to ground surface.**

In order to return to compliance with this rule, the owner(s) or operator must immediately operate and maintain the leachate collection system and manage and dispose of leachate in accordance with applicable regulations.

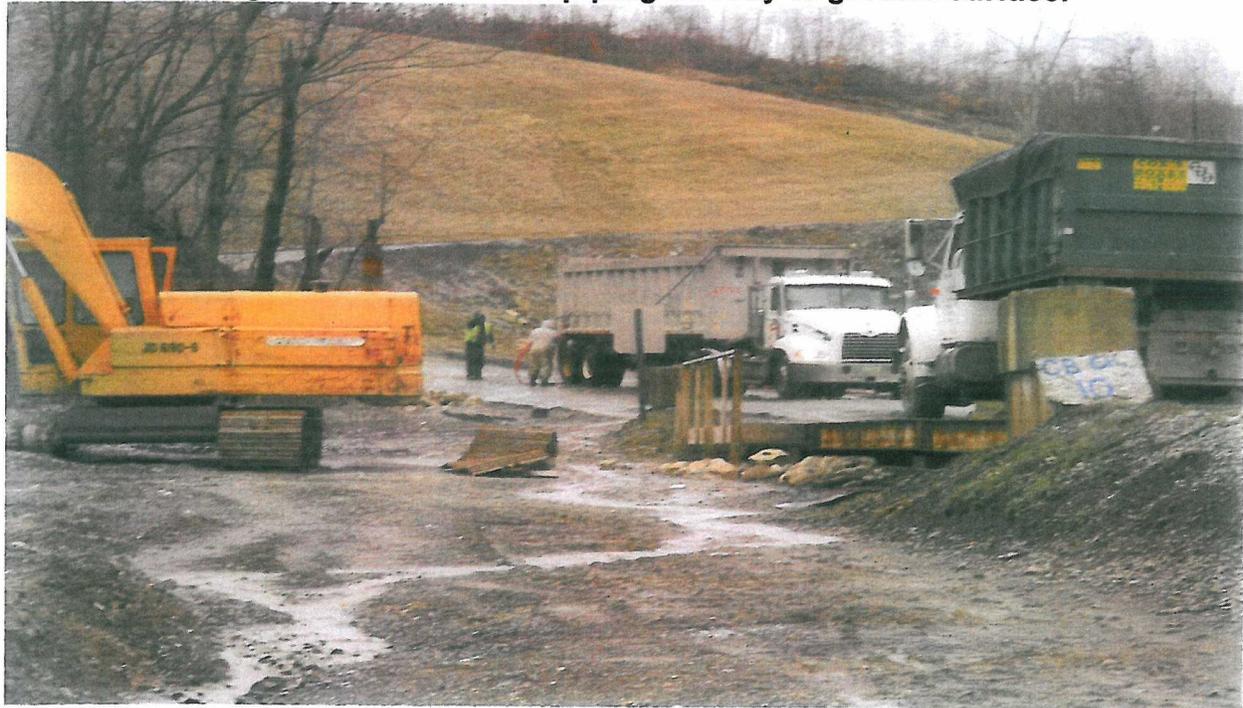
**Leachate flowing from leachate tank near scale, directly to waters of the state.**

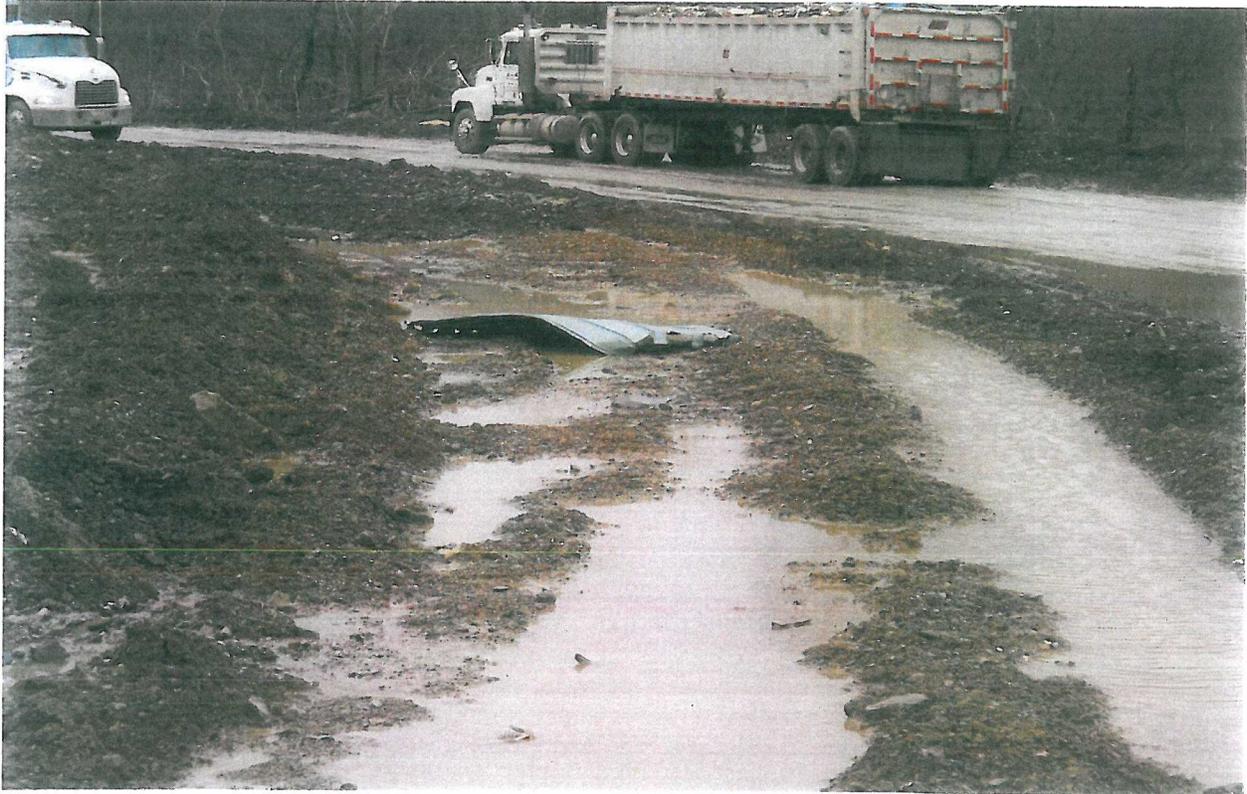
5. **Ponded Water.** During this inspection, ponded water was observed in various locations on the active licensed disposal area of the landfill, within the limits of current waste placement. Ponded water was observed within the facility access road leading to the facility working face, as well as along the sides of the facility access road. Failure to grade the facility and provide drainage systems to ensure minimal infiltration of water through the cover material and to correct the conditions causing the ponding have resulted in violations of the following:

**Ponded water areas along northern area of southern expansion area.**

In order to return to compliance with these rules, the owner(s) or operator must immediately grade the facility and provide drainage systems to insure minimal infiltration of water through the cover material and correct the conditions causing the ponding.

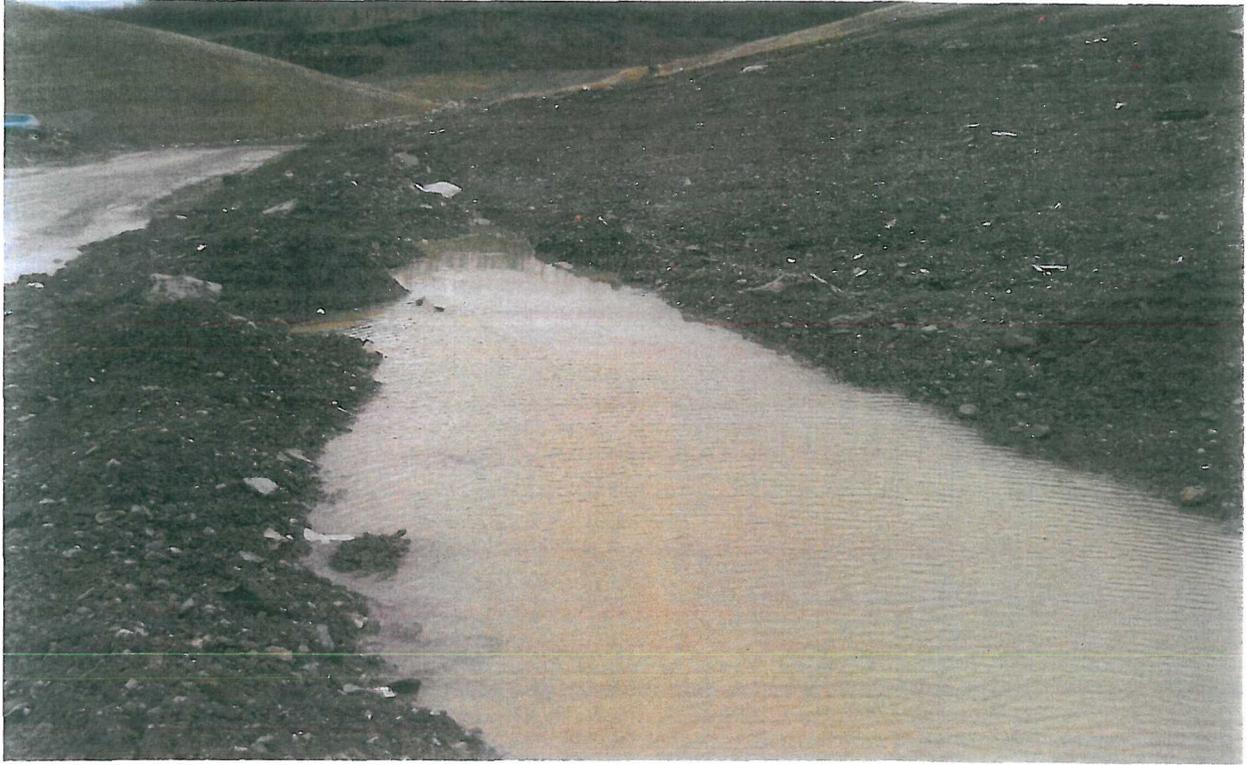
**Ponded water areas.**

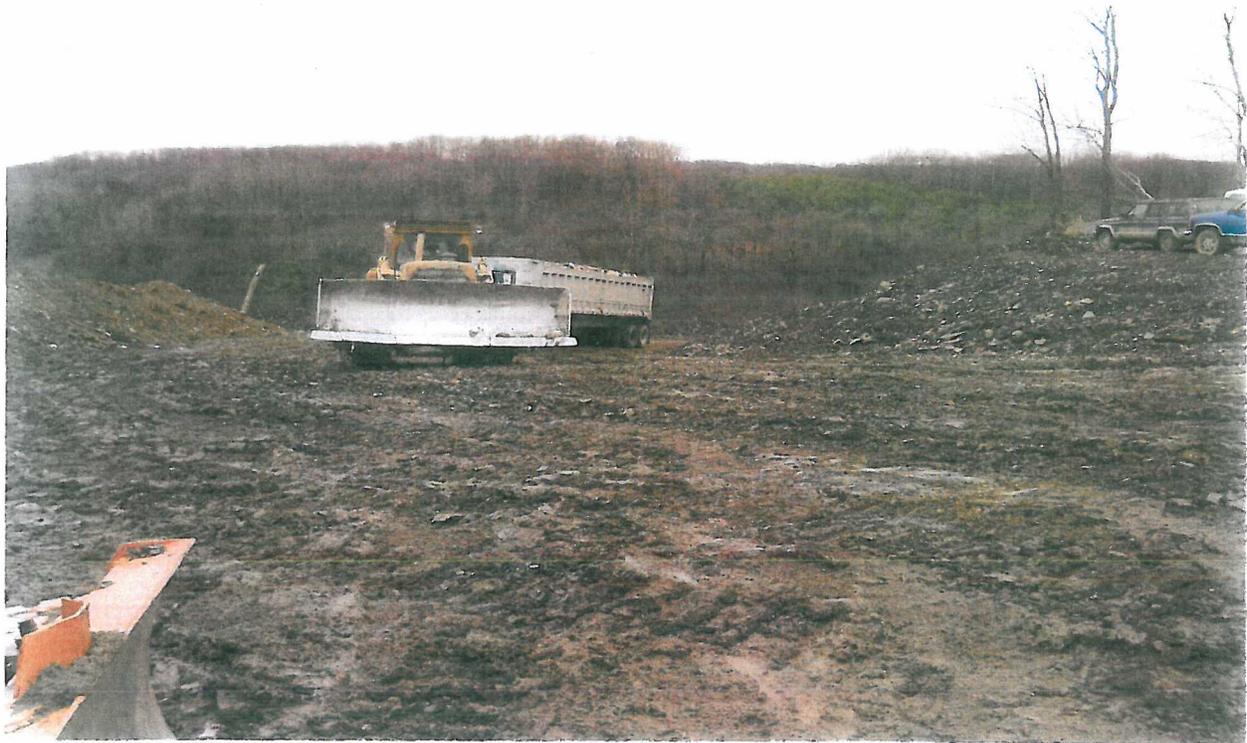
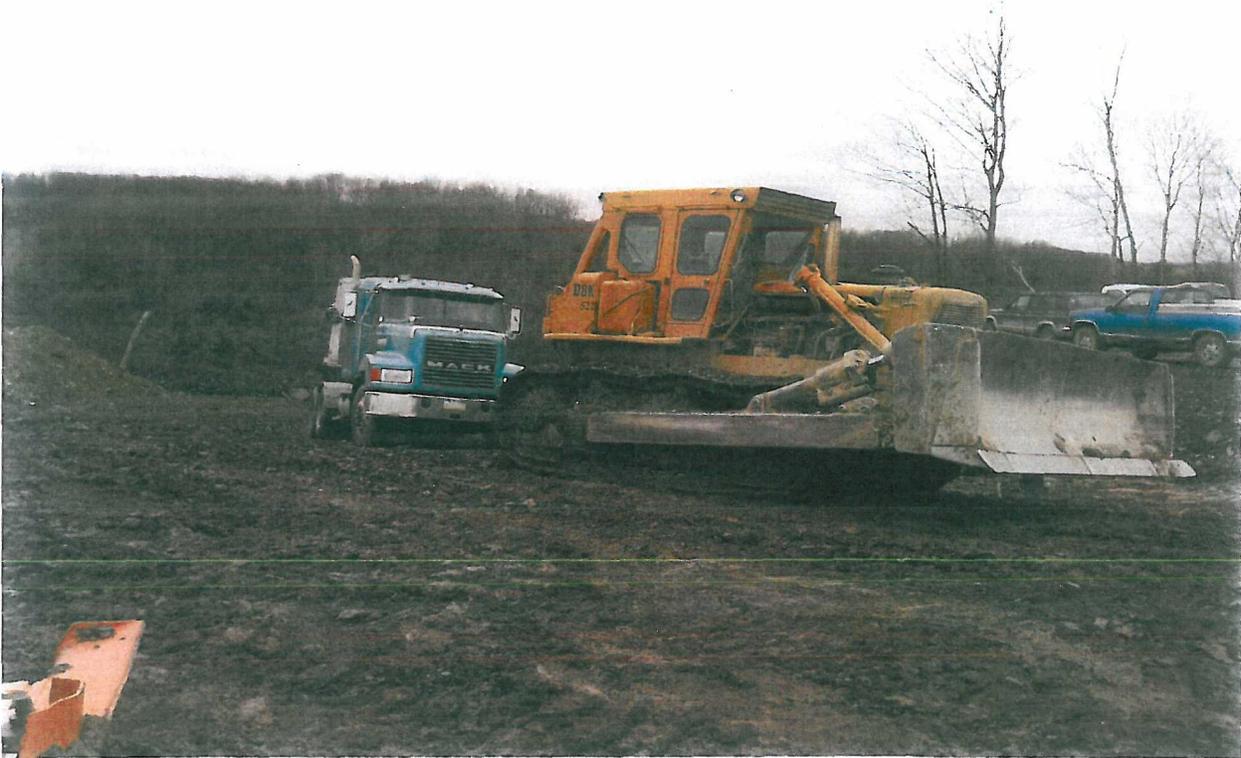
6. **Inclement Weather.** During this inspection, facility access roads were in extremely poor condition. It was observed during this inspection that the facility operator actually had to pull a fully loaded semi up the hill in order to get it to the facility unloading zone. Failure to ensure that preparations for inclement weather were made and to maintain all-weather access roads leading to the facility unloading zone and working face have resulted in a violation of the following:

**Truck being pulled to working face in southern expansion area.**

In order to return to compliance with this rule, the owner(s) or operator must immediately ensure that preparations for inclement weather are made and that all weather access roads leading to the facility unloading zone and working face are maintained.

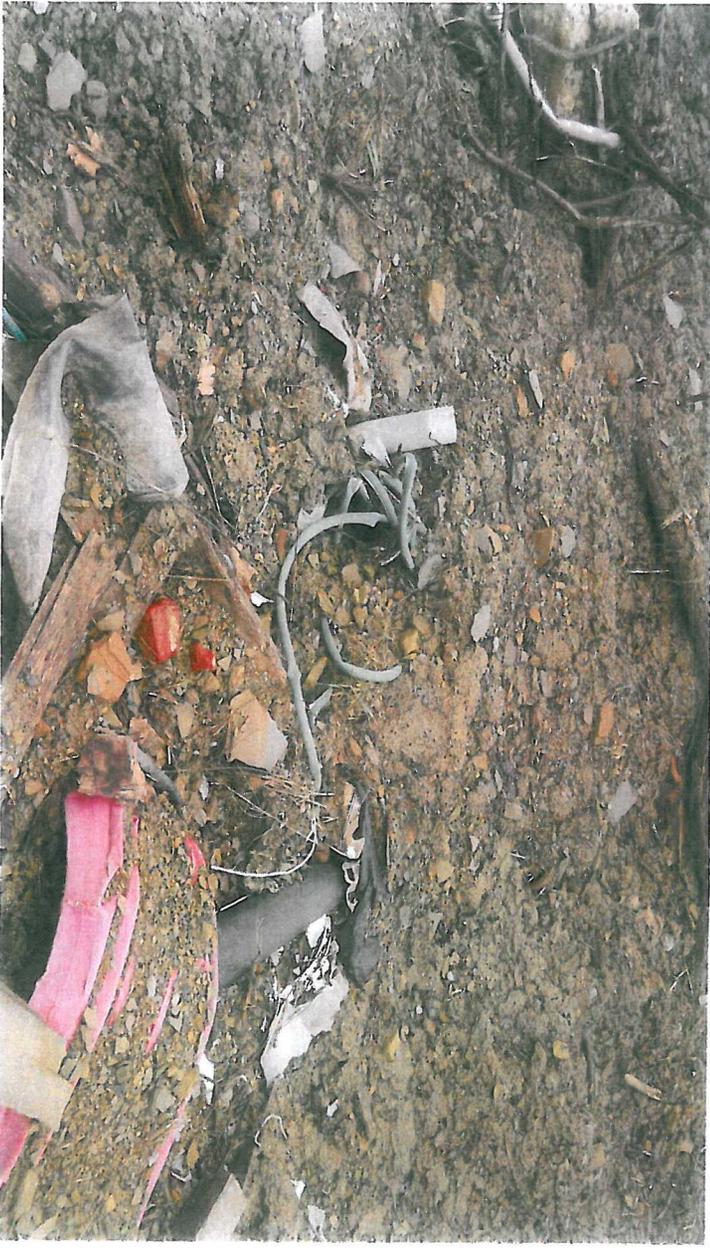
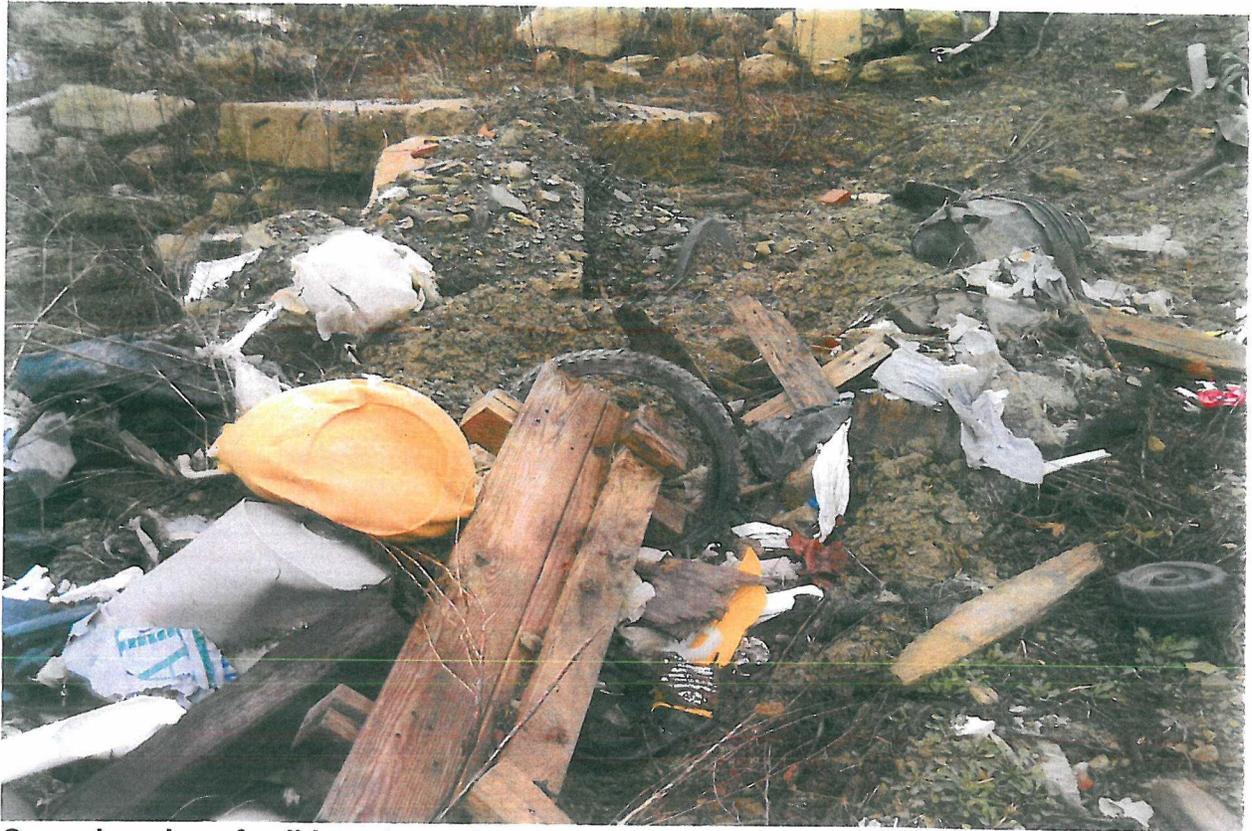
7. **Open Dumping of Solid Waste.** During this inspection, open dumping of solid waste was observed in an area of the facility located to the southwest of the current working face. Solid wastes observed open dumped at this location included, but were not limited to, a toy car tire, a bicycle tire, plastic piping, a garden hose, a sliding board, plastic buckets, and various other solid wastes. These solid wastes were observed to be both open dumped on the ground and partially buried with soil. The open dumping of solid waste observed at this location has resulted in violations of the following:

**Open dumping of solid waste on the southwest area of facility outside ALDA limits.**

In order to return to compliance with these rules, the owner(s) or operator must immediately remove all unlawfully disposed solid wastes from this facility and properly dispose of them at a licensed solid waste disposal facility. Receipts providing proof of disposal at a licensed solid waste facility must be provided to Ohio EPA. The owners of this property must also take all necessary measures to prevent additional solid waste from being open dumped on this property.

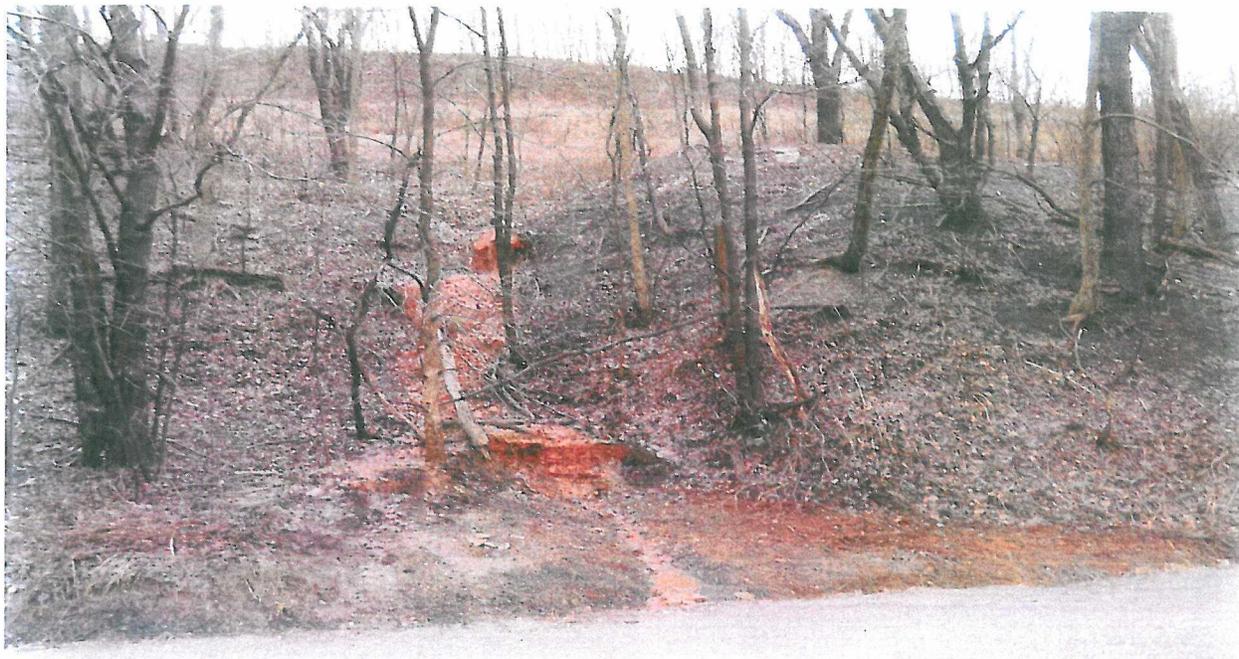
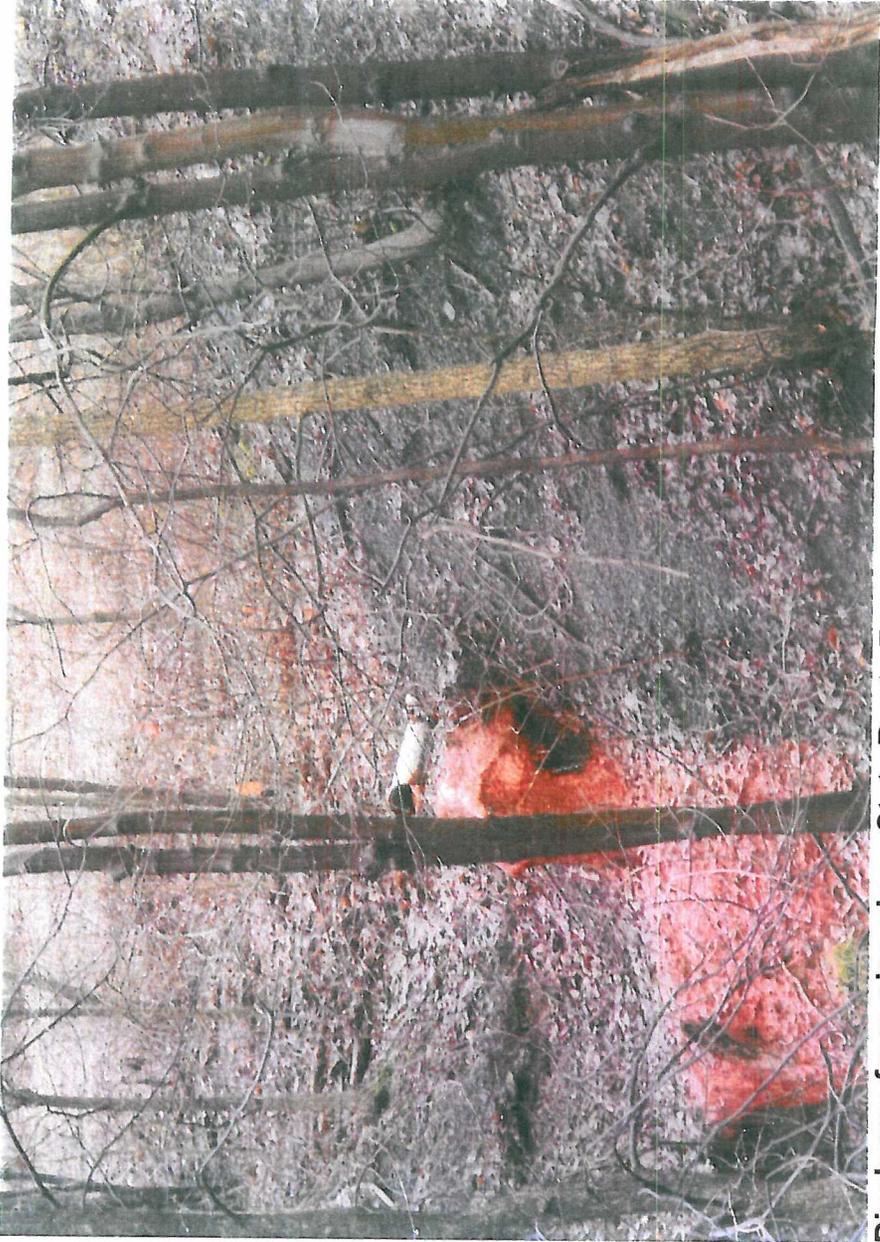
6. On the northwest corner of the property, along State Route 7, an undocumented pipe located in the hillside is discharging large volumes of water to the roadside right-of-way. Due to the proximity of the landfill as well as past mining activities at this property, this effluent must be sampled for all potential contaminants from the site. The results of the analysis of this water will allow Ohio EPA to confirm whether an unauthorized discharge exists from this facility.

**Discharge from pipe along State Route 7.**
