**RE: Reconnaissance Inspection/Notice of Violation,
Village of Pleasant Hill WWTP, 1PB00026*LD**

NPDES Compliance Inspection Report

Section B: Facility Data		
Name and Location of Facility Inspected	Entry Time	Permit Effective Date
Village of Pleasant Hill WWTP 317 Monument Street Pleasant Hill, OH 45359	9:00 a.m.	April 1, 2013
	Exit Time	Permit Expiration Date
	10:12 a.m.	March 31, 2013
Name(s) and Title(s) of On-Site Representatives		Phone Number(s)
Mr. Jeff Derksen, WWTP Superintendent		(937) 974-8337 (Mobile)
Name, Address and Title of Responsible Official		Phone Number
Mayor and Council Village of Pleasant Hill 8 High Street; PO Box 557 Pleasant Hill, OH 45359		(937) 676-3241

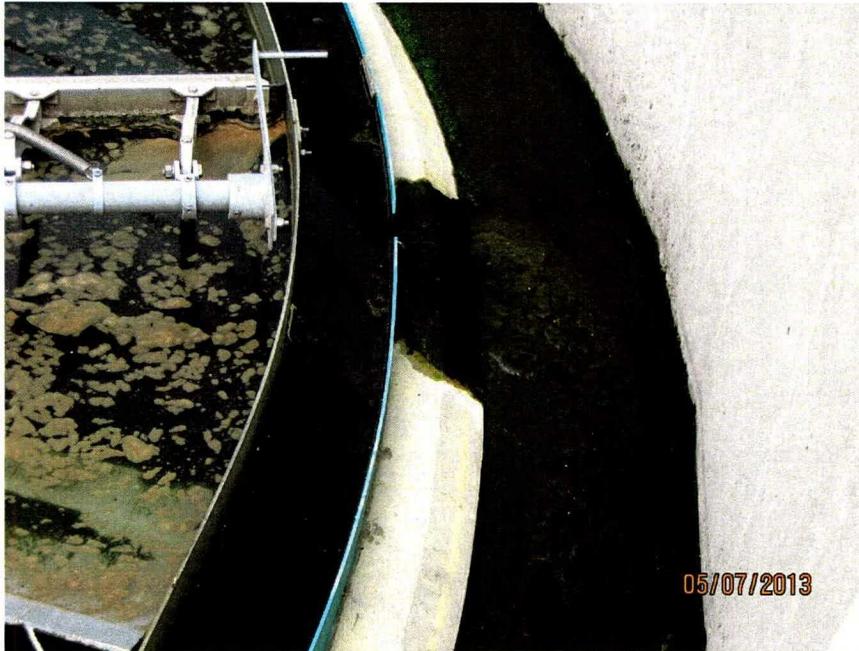
The occurrence of solids exiting the WWTP is a violation; hence this Notice of Violation. Mr. Derksen described the challenges faced in managing this condition. He indicated that the cleaning interval was about once per week. It is believed the condition leading to solids exit is caused by excessive algal growth at the clarifier location and resultant sloughing of this growth. This sloughing is believed to be the source for the observed solids exiting the UV chamber. Based upon discussions with Mr. Derksen, it is believed that this will be an on-going challenge faced by the WWTP. Please note that removal of the solids is necessary and that any washing should be conducted in a fashion that does not allow the transport of any loosened materials to a downstream location.

The inspection was conducted in response to observations of solids exiting the clarifier and the Ultraviolet (UV) Disinfection Chamber by Water Quality Personnel from the Division of Surface Water, Ohio EPA. On May 7, 2013, Diana Zimmerman and Hugh Trimble, both of Ohio EPA, were at the WWTP in relation to the forthcoming Stillwater watershed sampling effort. Please see Photos 1 and 2 for views of the solids of concern.

Photo 1 - Clarifier Weir Discharge - Note Solids in Channel. Photo from May 7, 2013.

Please provide a written response to this Notice of Violation. It is asked that a brief description of measures to be undertaken to address the solids problem be part of the response. The response is to include measures that will be taken to prevent solids migration beyond the clarifier during cleaning activities. I ask that this response be provided by July 12, 2013. If you should have any questions and/or comments, please email me at glen.vonderembse@epa.ohio.gov or call me at (937) 285-6033.

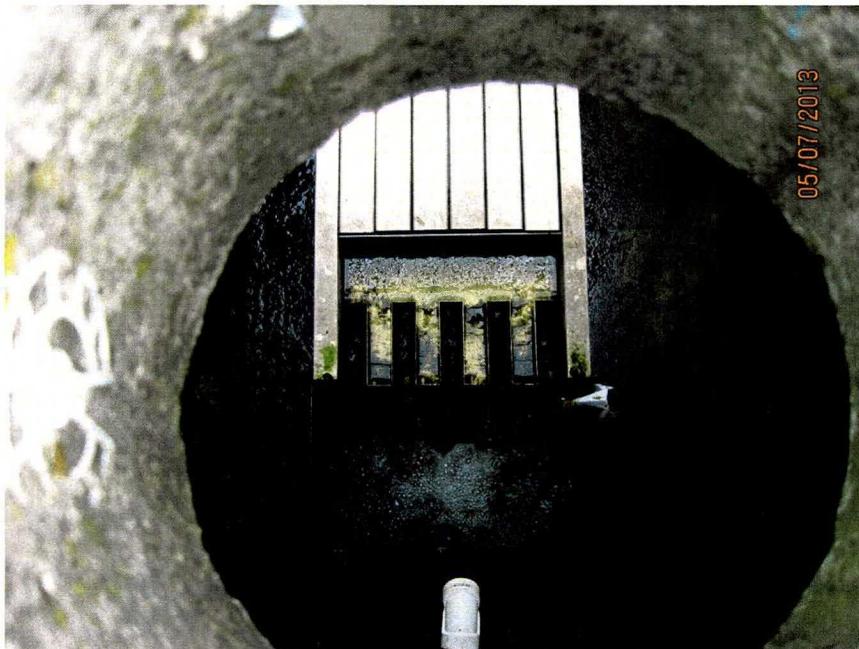
Photo 2 - Leveling Weir after Ultraviolet Disinfection. Note solids within the weir. Photo taken May 7, 2013

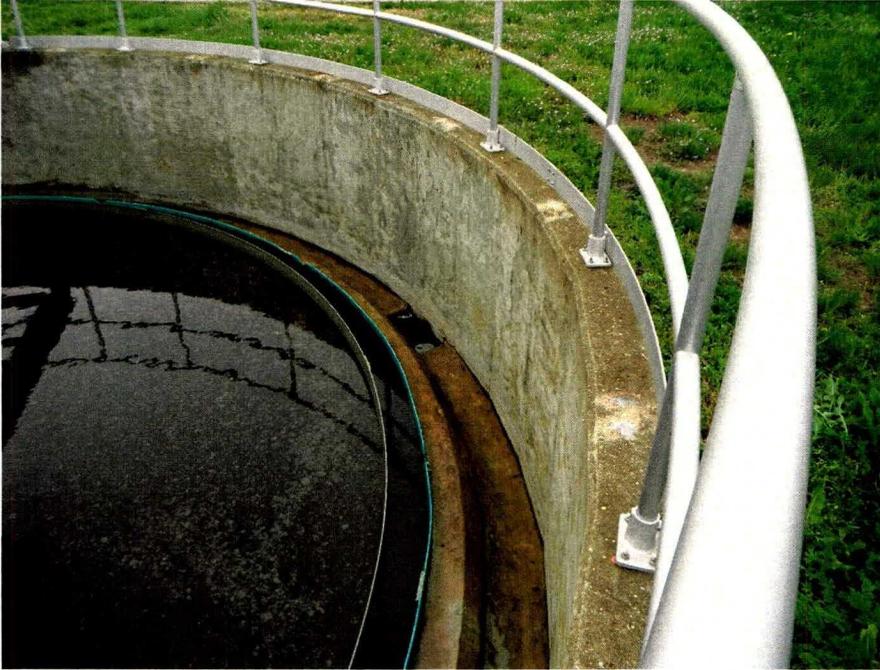
In response to their observations, I performed a Reconnaissance Inspection of the WWTP on May 10, 2013. Mr. Jeff Derksen, Operator of Record, met me at the plant. At the time of inspection, I observed no solids leaving the clarifier nor any at the leveling weir downstream of the UV disinfection unit. Please see Photos 3 and 4.

Photo 3 - Clarifier Weir and Channel. No solids present. Photo taken May 10, 2013.

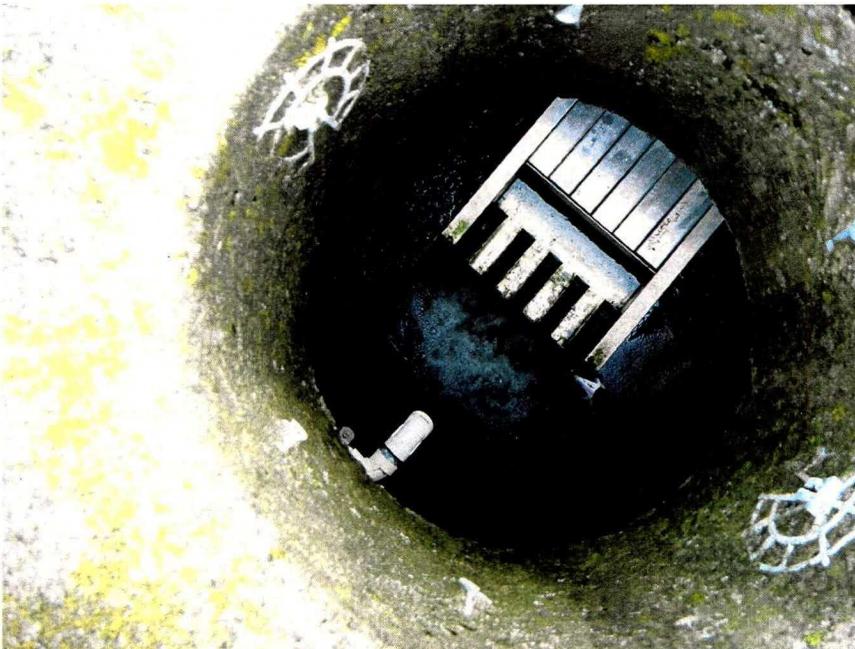
Photo 4 - Leveling Weir after Ultraviolet Disinfection. No solids within the weir. Photo taken May 10, 2013.
