August 26, 2013

**RE: NOTICE OF VIOLATION
NICKY BLVD. LANDFILL
CUYAHOGA COUNTY
NOTICE OF VIOLATION**

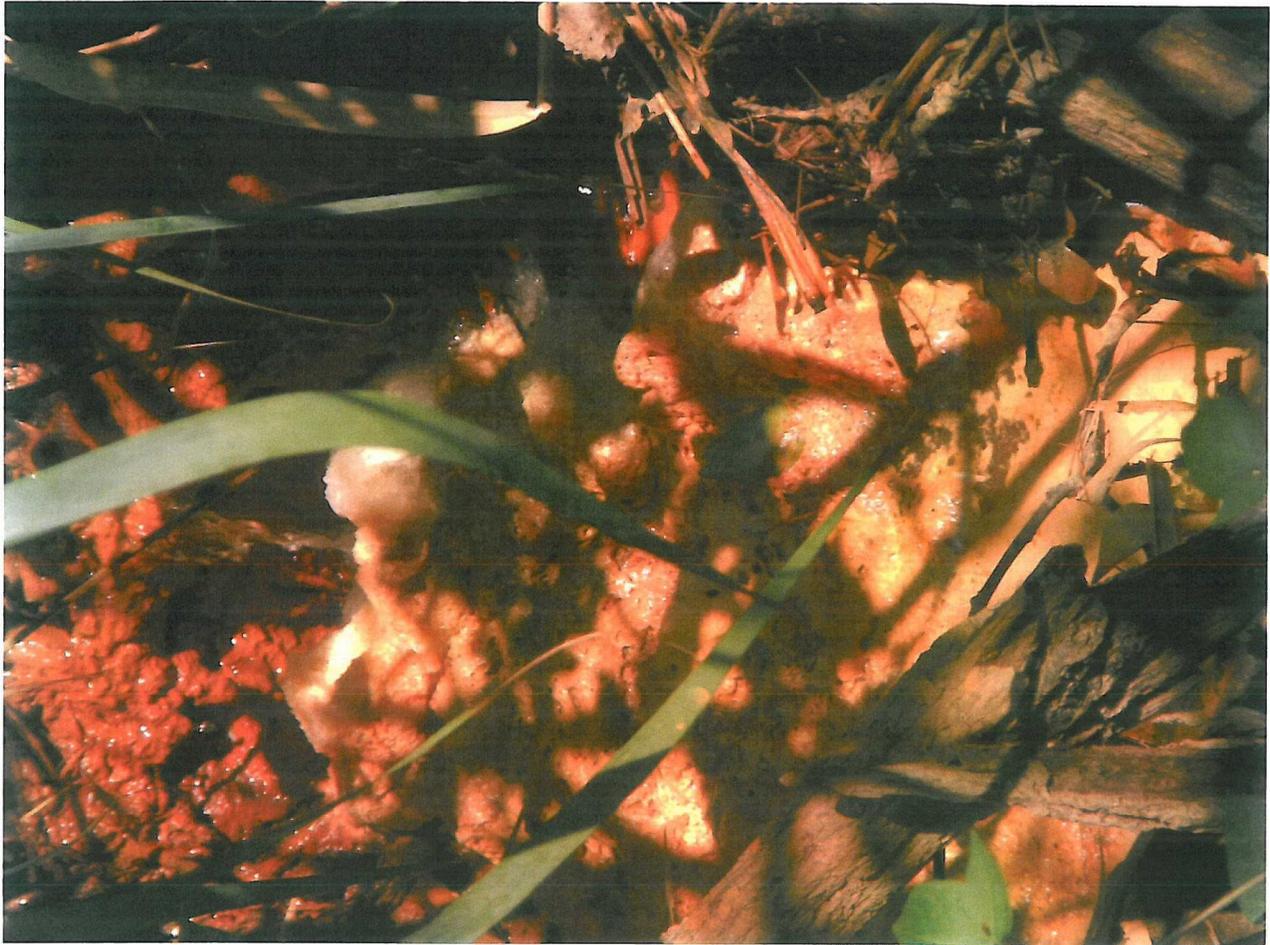
Appendix A: Picture 1

Numerous leachate outbreaks from the landfill were observed entering the stream at the base of the southwest slope. Several of these outbreaks had a steady and consistent high flow rate. A rust colored stain was observed in the water, soil and rocks around the area of the outbreaks (see pictures # 1-). The stream discharges to a culvert that goes under the nearby railroad, and flows ultimately to the Cuyahoga River. The owner/operator has failed to control surface water run-on, failed to maintain the cap system, failed to maintain the surface water management system and failed to construct a cap system which minimizes infiltration and leachate production. The owner/operator is in violation of the above rule for not collecting, treating and disposing of leachate, and for not taking action to minimize, control or eliminate conditions which contribute to the production of leachate.

Picture of leachate outbreak coming from the landfill and draining into the stream
Taken by Dan Bogoevski, Ohio EPA
Nicky Boulevard – 8/21/13

To return to compliance with OAC Rule 3745-30-10(C)(3), the owner/operator must immediately take action to collect and dispose of the leachate. The owner/operator must also correct all surface water control systems and cap system violations and take actions necessary to minimize leachate production, including but not limited to, making improvements to the cap and surface water control systems and construction of a leachate collection system.

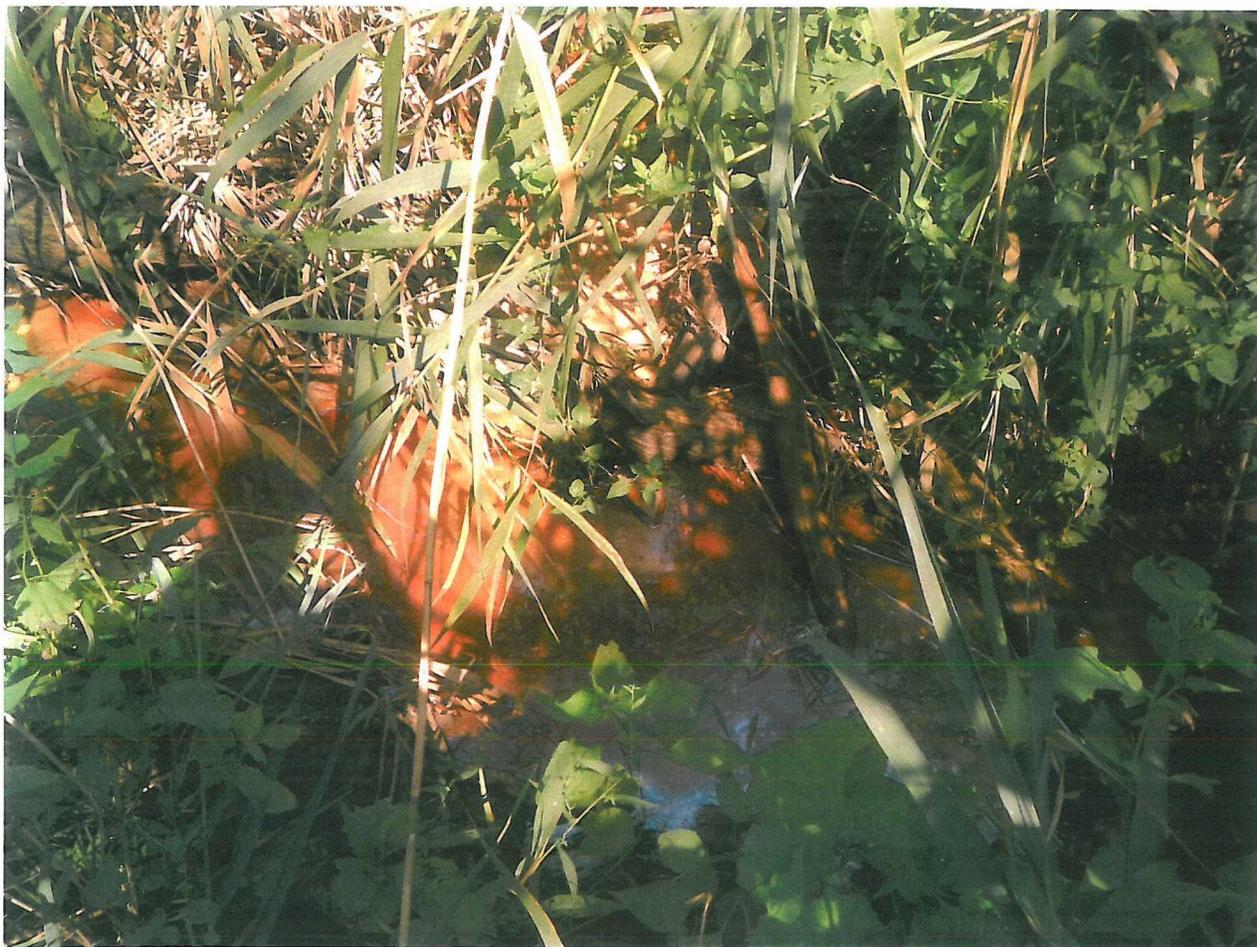
Appendix A: Picture 2

Picture of leachate outbreak coming from the landfill and draining into the stream
Taken by Dan Bogoevski, Ohio EPA
Nicky Boulevard – 8/21/13

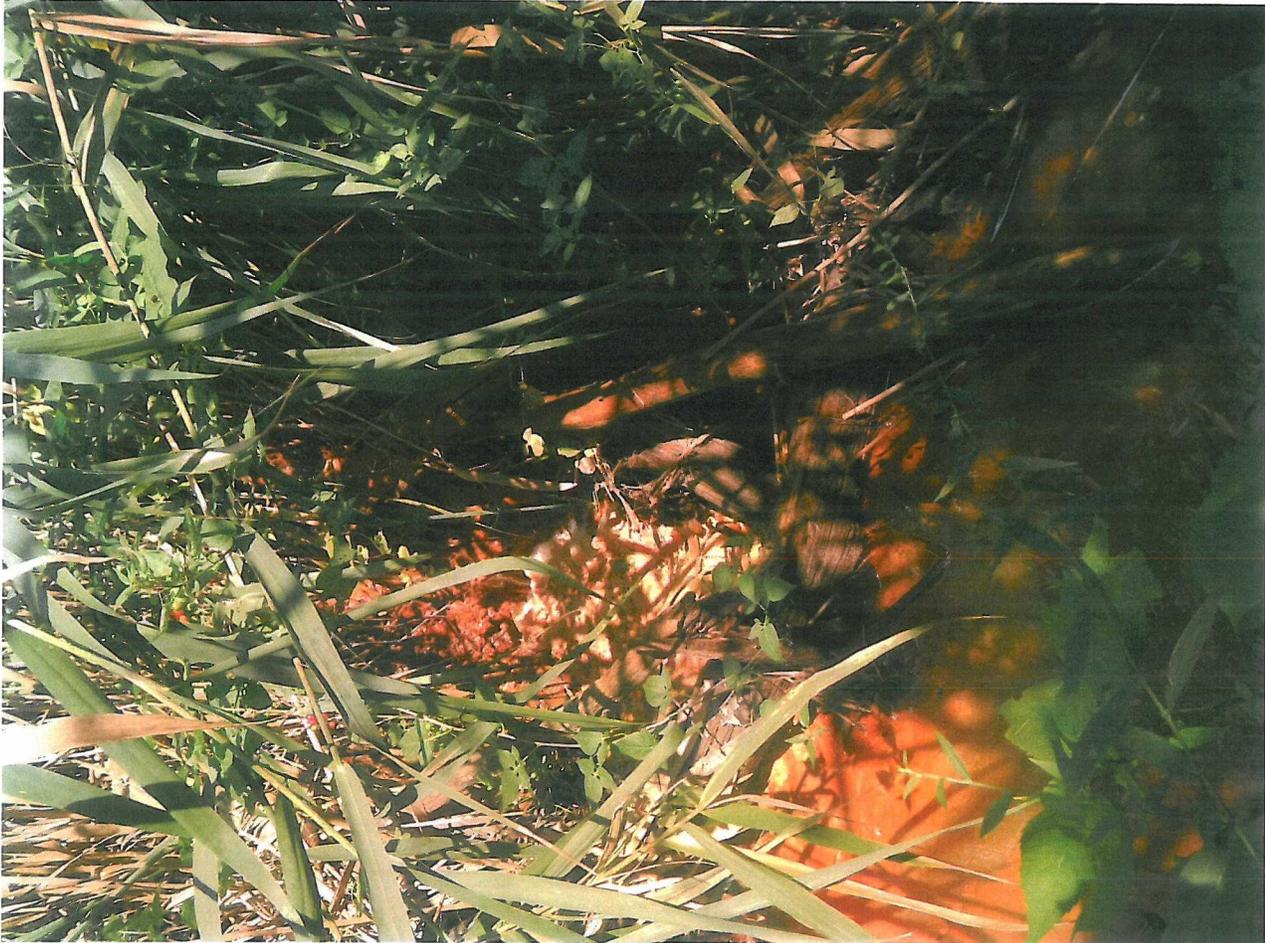
Appendix A: Picture 3

Picture of leachate outbreak coming from the landfill and draining into the stream
Taken by Dan Bogoevski, Ohio EPA
Nicky Boulevard – 8/21/13
