**Environmental  
Protection Agency**

November 21, 2011

RE: WAYNE COUNTY  
CITY OF ORRVILLE  
CONSTRUCTION STORM WATER  
JM SMUCKER COMPANY  
PROJECT HERITAGE PH 1 & 2

On November 9, 2011, I performed a compliance inspection of storm water best management practices (BMPs) at the above referenced sites. I was accompanied on my inspection by Todd Surrena also of the Ohio EPA, Division of Surface Water. While on site, we met with Dave Olson and Derrick Helie of the Dennis Group and Darren Alber of Dennis Alber Excavating Inc. Our records indicate that runoff from Project Heritage is authorized under the Ohio EPA General Storm Water National Pollutant Discharge Elimination System (NPDES) Permit for Construction Activities #3GC05067\*AG (Phase I) and #3GC05655\*AG (Phase II).

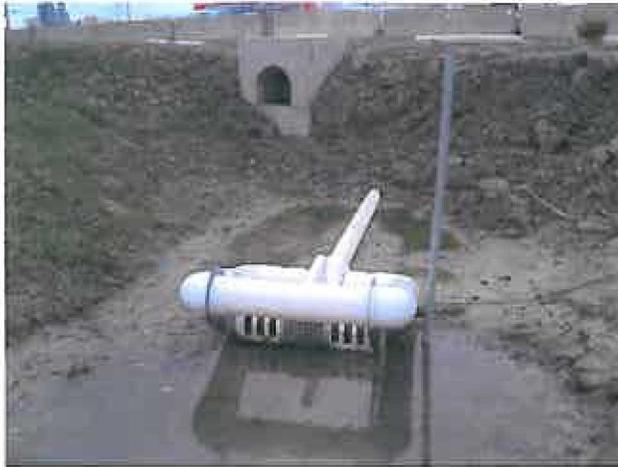
- A skimmer device has been installed in SB-2, however it has not been attached to the outlet structure as shown in the detail drawing contained in the SWPPP. As a result, it will not rise and fall with the elevation of water in the basin. Please re-install the skimmer as shown in the detail drawing contained in the SWP3. In addition, the sediment storage volume of SB-2 has not been established. The skimmer must float on a pool of water to prevent it from getting stuck to the bottom of the sediment basin. By excavating the sediment storage volume, you will create the pool necessary for the skimmer to float. Please establish the sediment storage volume of SB-2. Note that slight modification may be required from the detail drawing contained in the SWPPP to ensure that the skimmer floats on a pool of water.

**Fig 1 (LEFT).** The skimmer has not been attached to the outlet structure of SB-2 as needed to ensure it rises and falls with changes in water elevation in the pond. In addition, there is no sediment storage volume to create the pool of water needed to ensure that the riser floats.

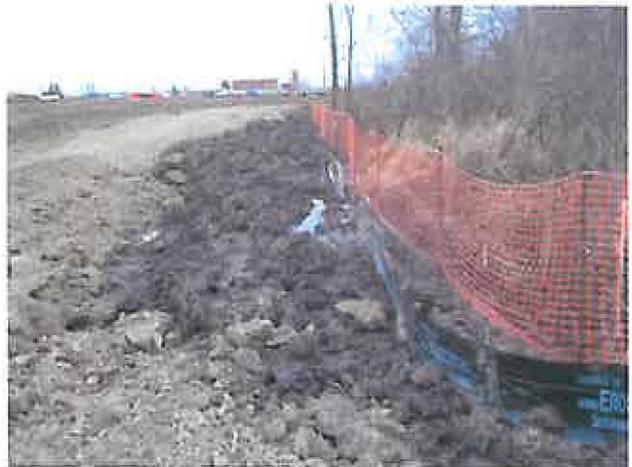
- Silt fence is required along Wetland E. Please install silt fence to protect the wetland from sediment-laden runoff.
- Silt fence along the east perimeter of the site (includes both Phase I and Phase II areas) requires maintenance. Please repair sections of silt fence which have been knocked over or have come off the stakes so that runoff can pond along the silt fence.

**Fig 2 (RIGHT).** Perimeter silt fence has been installed along the wetlands on the east side of the project but some sections require maintenance.

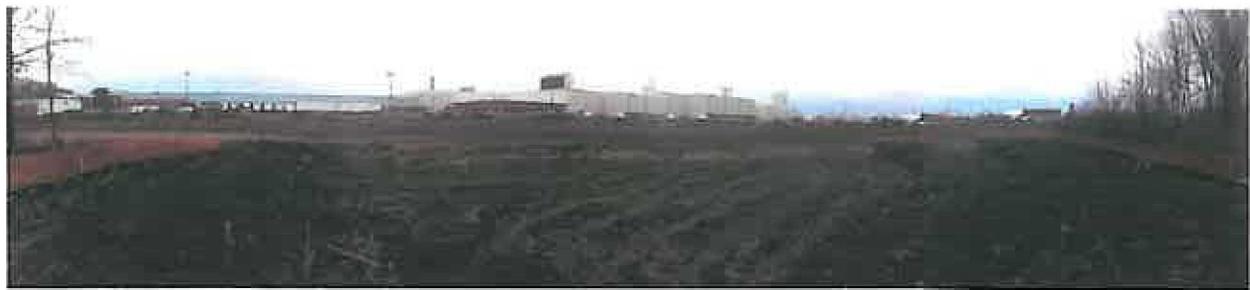
- Sediment Traps #1 (ST-1) and #2 (ST-2) as shown on the SWP3 for Phase II have not been completed, yet the drainage area tributary to these structures has been disturbed and grading is occurring. Part III.G.2.d.i of the NPDES permit requires the implementation of sediment ponds within seven (7) days from the start of grubbing and prior to grading. Please complete the construction of these sediment ponds per the detail drawings contained in the SWP3.

**Fig 3.** A view of the site from ST-2. The site is grubbed and is being graded, yet ST-2 has not been installed.

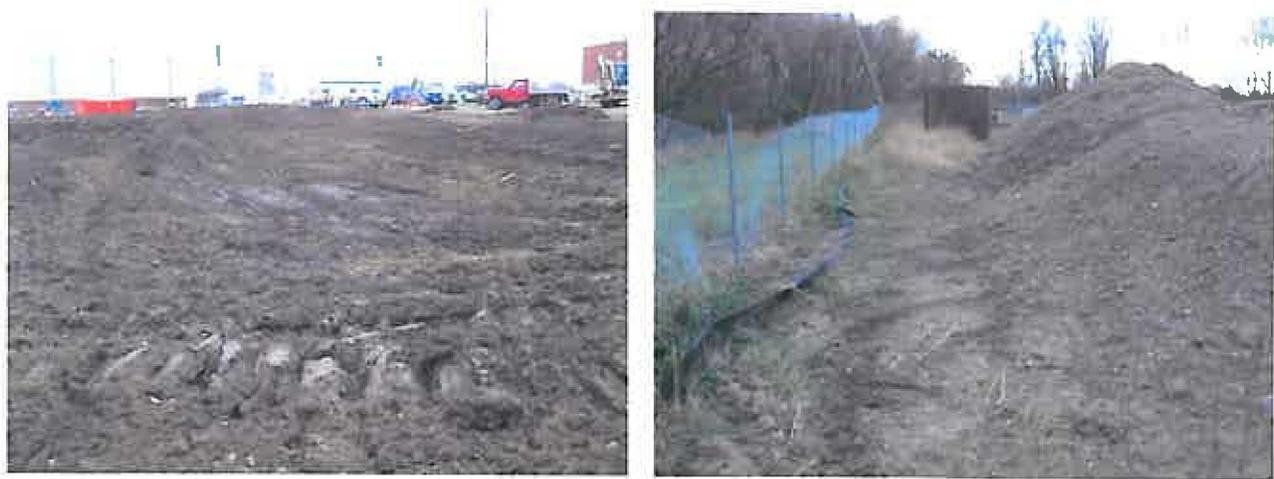
**Fig 4 (LEFT).** View of site from ST-1. ST-1 has not been established yet the tributary drainage area has been grubbed and graded.

**Fig 5 (RIGHT).** Silt fence on the east side of the site near SB-1 is down and needs repair. Soil stockpiles must be stabilized if they will be idle for 21 days or longer.

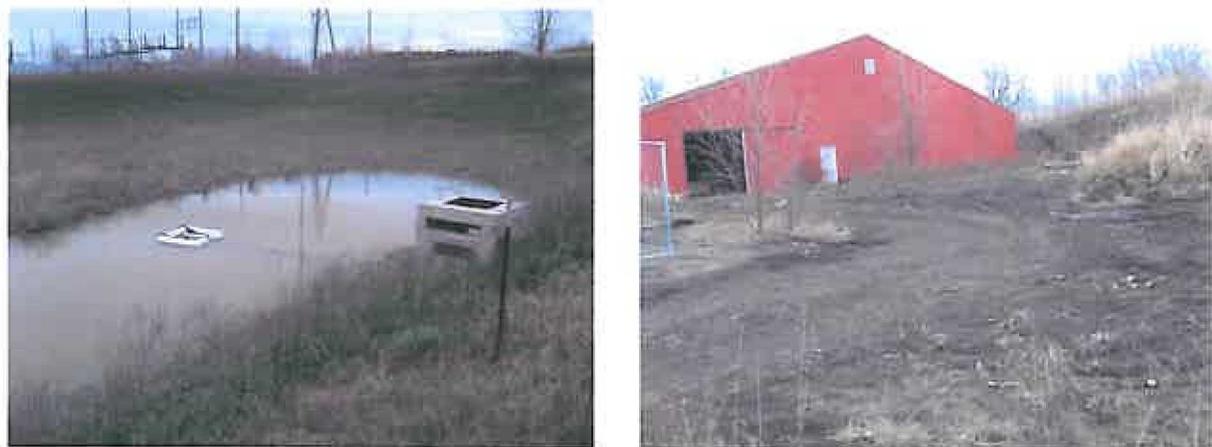
- Disturbance has occurred to establish a staging area around the Red Barn. This area is not shown on the SWPPP for either Phase I or Phase II of this project. Please amend the SWPPP to include the disturbance of the Red Barn area and provide appropriate

**Fig 6 (LEFT).** SB-1 is installed and is functioning as intended.

**Fig 7 (RIGHT).** Earth disturbance around the Red Barn. No sediment and erosion controls have been provided.

sediment and erosion controls to prevent sediment-laden discharges to the adjacent wetland area.

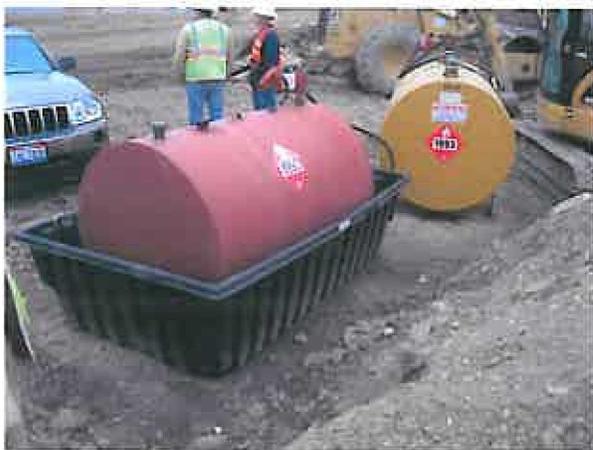
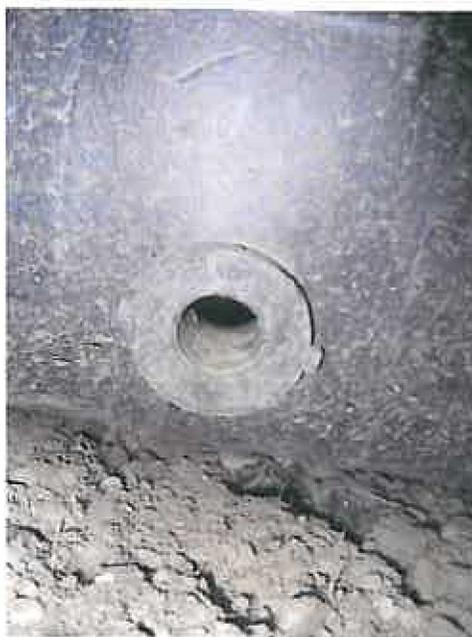
**Fig 8 & 9.** All fuel tanks should be stored in secondary containment or be double-walled. A spill kit should be available nearby. The red fuel tank is in containment, but closer inspection reveals the drain plug is missing.

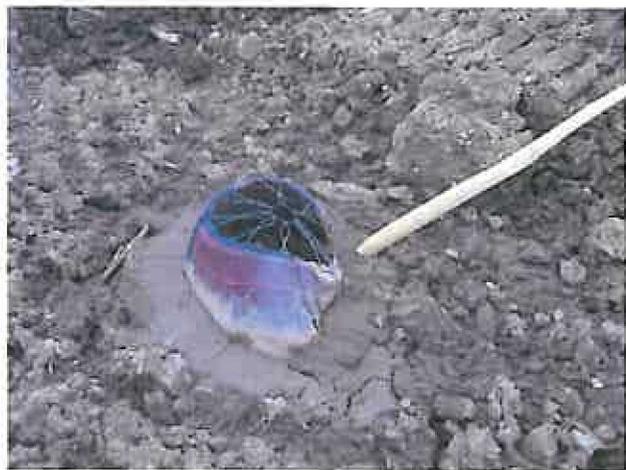
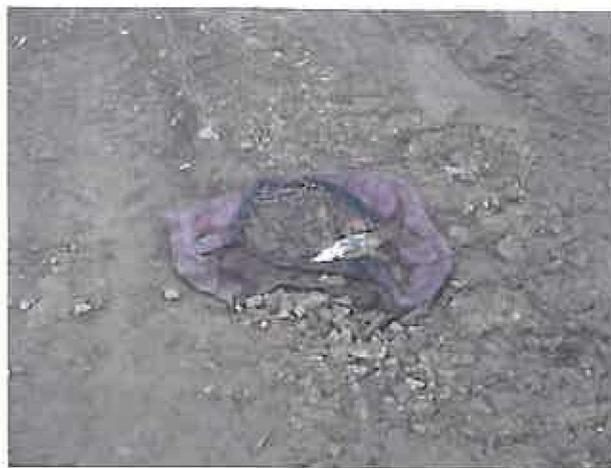
- Inlet protection on Mill Street requires maintenance. Please replace Dandy Bags which have been developed holes or tears.
- Inlet protection along the entrance drive off Strawberry Lane also requires maintenance. Construction vehicles have crushed the inlet protection that had been installed. Mr. Alber indicated that this is an on-going struggle. It may be prudent to better mark storm drain inlet protection so as to make it more visible. You may also want to consider sanctions for subcontractors who damage BMPs.

**Fig 10 & 11.** More attention must be paid to maintenance of storm drain inlet protection and protecting it from construction vehicles. Crushed inlet protection was observed across the site. The photo on the left shows an inlet on the north side of the site, while the photo on the right shows an inlet along the access road off Strawberry Lane. The NPDES permit requires BMPs to be inspected by the permittee once every 7 days and within 24 hours of a 0.5-inch or greater rainfall. It further requires repair and replacement of inlet protection within 3 days of inspection whenever that inspection reveals that maintenance is required. Please ensure that your inspector is aware of these requirements.

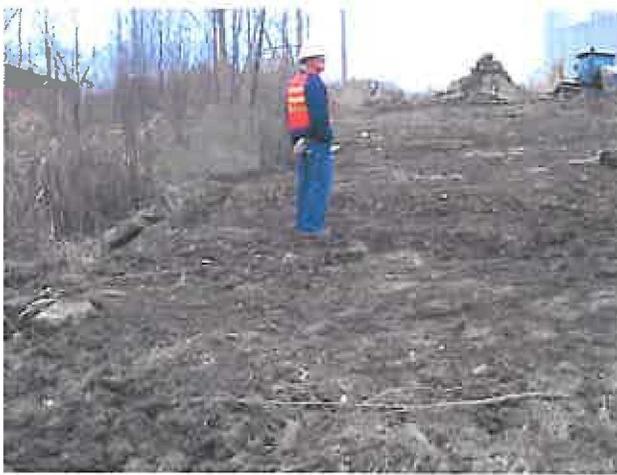
- Sediment Trap #3 (ST-3) has not yet been established. This is because a stockpile from Phase I is located in the area where ST-3 is to be located. Please establish ST-3 as shown in the SWP3 as soon as the stockpile has been removed.

**Fig 12 (LEFT).** Silt fence has not been installed along Wetland E. ST-3, which will be located in this area, has not yet been installed.

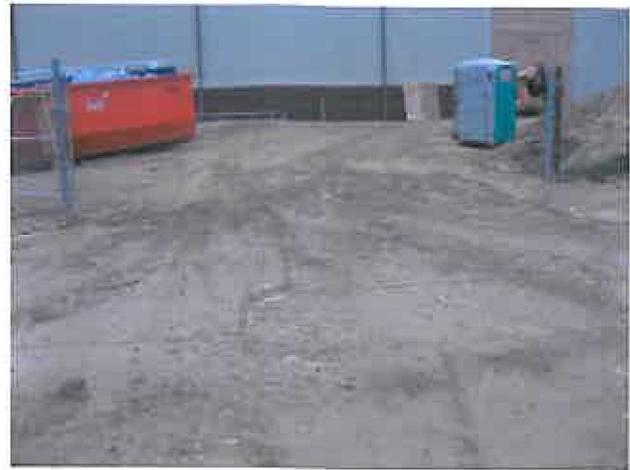
- Construction vehicles are still making use of the construction entrance off Mill Street. This entrance requires maintenance to minimize off-site tracking onto Mill Street. Please redress the entrance with stone as needed. In addition, the diversion (water bar) across the drive has been removed because it may damage delivery vehicles. Please re-establish the diversion as soon as practical.

**Fig 13 (RIGHT).** Sediment is being tracked onto Mill St. The construction entrance off Mill St. needs to be redressed with stone and the diversion (water bar) needs to be re-installed.

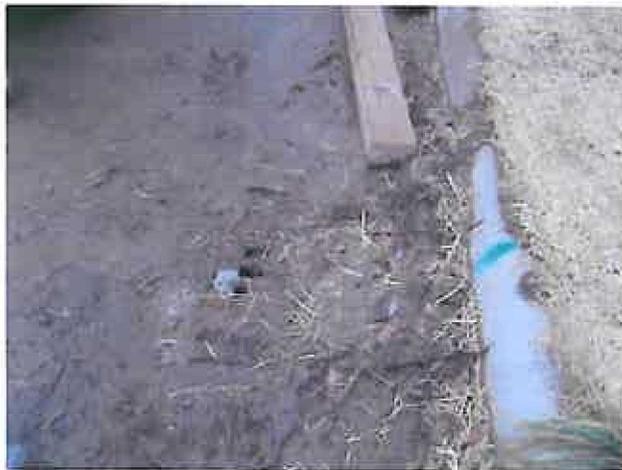
**Fig 14 (LEFT).** Storm drain inlet protection on Mill St. requires maintenance. The Dandy Bag has developed holes and must be replaced. Accumulated sediments should be removed from time to time to allow the Dandy Bag to function when needed.

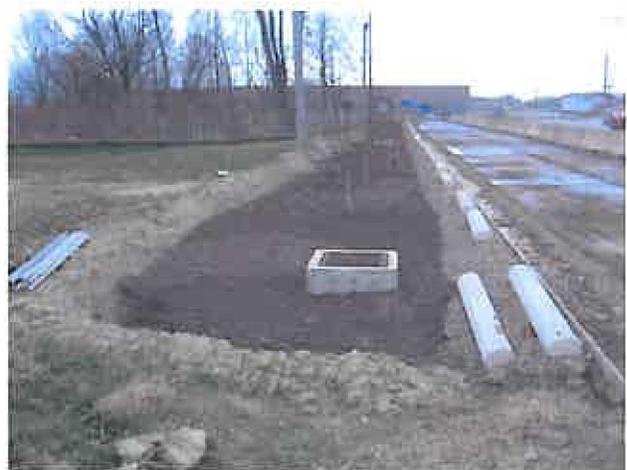
- The bioretention cell associated with Phase I of this project has been installed along the north side of the employee parking lot. However, we are concerned that construction vehicles are using the pavement tributary to the bioretention cell as an access road. Construction vehicles are tracking sediment onto the pavement. This sediment will then wash into the bioretention cell when it rains, which will likely lead to failure of the bioretention cell. We discussed several options for either (a) relocating the access road out of the drainage area tributary to the bioretention cell, (b) preventing construction vehicles from tracking sediment onto the pavement or (c) diverting sediment-laden flows away from the bioretention cell and toward SB-2. Mr. Alber and Mr. Helie agreed to review the various options to determine which was most practical to implement. Please identify the selected option and confirm that it has now been put into practice.

**Fig 15 (RIGHT).** The bioretention cell along the employee parking lot has been installed, but contractors are using the pavement immediately adjacent to it as an access road. Mud tracked onto pavement by the trucks will flush into the bioretention cell when it rains. This will lead to failure of the cell.
