**Environmental
Protection Agency**

RE: MAHONING COUNTY
YOUNGSTOWN IRON & METAL, INC.
NPDES PERMIT NO. OHR000004
OHIO EPA PERMIT NO. 3GR00727*DG
INDUSTRIAL STORM WATER INSPECTION

NOTICE OF VIOLATION

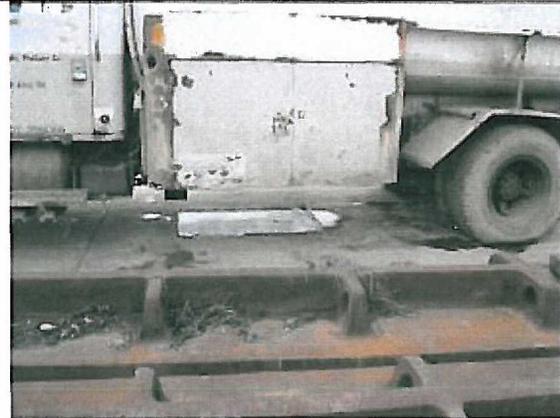
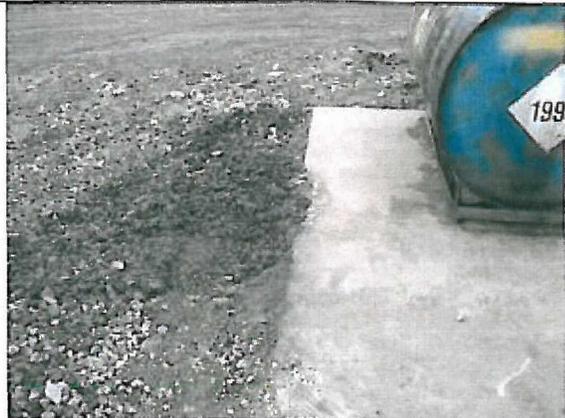
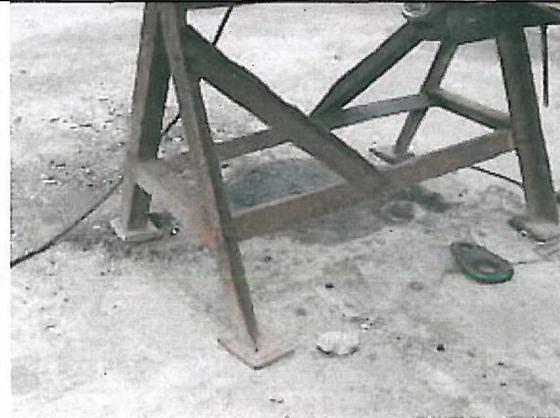
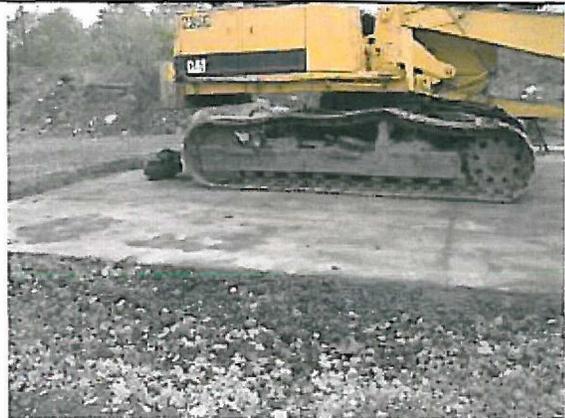
The implementation of spill prevention and response procedures continues to require significant improvement throughout the facility. Ohio EPA documented oil spills and leaks associated with the "mobile maintenance area" (Figures 1 to 4), oil saturated soils and gravel materials throughout the facility (Figures 2, 4, and 5 to 6), an uncovered dumpster leaking oil resulting from the disposal of oil saturated booms and absorbent pads (Figure 7), a sheer engine leaking oil (Figure 8), the acceptance of scrap materials leaking fluids (Figure 9), a spill of transmission fluid within a "storm pit" (Figure 10), and storm water runoff containing oil sheens throughout the facility (Figures 11 to 14).

Drip pans and absorbent pads are being utilized by the facility within the "mobile maintenance area;" however, the implementation of these BMPs are not preventing or eliminating the potential to discharge pollutants to "waters of the State." Specifically, drip pans were not capturing all of the leaks from vehicles requiring maintenance (Figure 1); secondary containment is not provided around fifty-five gallon drums (Figures 15 to 16) and ground level and above ground storage tanks (Figures 2 and 3) where liquids are transferred to or extracted from and are stored in locations exposed to precipitation events; and the absorbent pads were being blown away by the wind (Figure 17).

Figure 1 - Oil spills and leaks associated with the "mobile maintenance area" continue to occur at the facility. Picture taken October 31, 2011.

Figure 2 - Oil spills and leaks associated with the "mobile maintenance area" continue to occur at the facility. Picture taken October 31, 2011.

Figure 3 - Oil spills and leaks associated with the "mobile maintenance area" continue to occur at the facility. Picture taken October 31, 2011.

Figure 4 - Oil spills and leaks associated with the "mobile maintenance area" continue to occur at the facility. Picture taken October 31, 2011.

- All BMPs detailed within the facility's SWP3 must be immediately implemented to prevent the discharge of pollutants to "waters of the State." In addition, Ohio EPA strongly recommends that the "mobile maintenance area" be enclosed to prevent precipitation events from contacting leaking vehicles and vehicles that require maintenance to eliminate the potential to discharge of pollutants to "waters of the State."

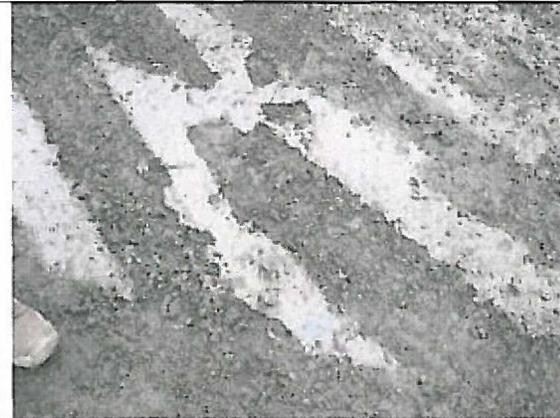
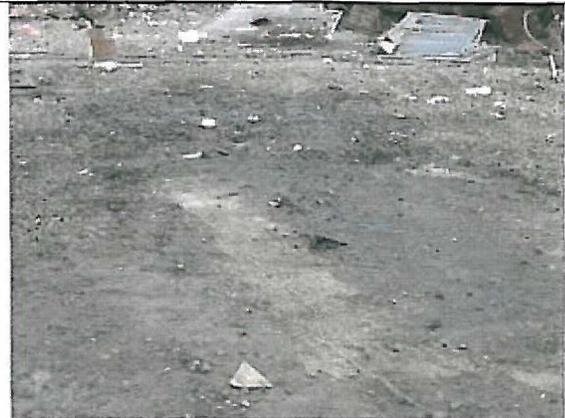
Figure 5 - Oil saturated soils and gravel materials are present throughout the facility. Picture taken October 31, 2011.

Figure 6 - Oil saturated soils and gravel materials are present throughout the facility. Picture taken October 31, 2011.

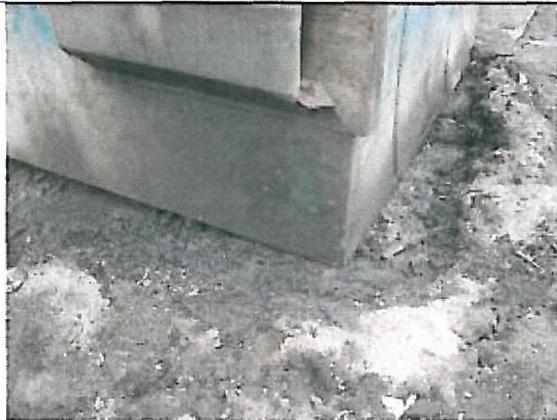
Figure 7 - An uncovered dumpster was leaking oil from the disposal of oil saturated booms and absorbent pads. Picture taken October 31, 2011.

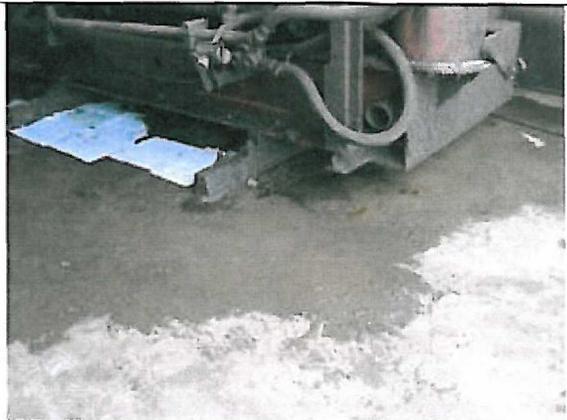
- The sheer engine is leaking oil onto the floor of the sheer engine building (Figure 8). Precipitation events are able to contact the sheer engine and leaked oil via holes that

Figure 8 - A shear engine is leaking oil. Picture taken October 31, 2011.

- Appropriate BMPs must be immediately implemented to address the discharge of pollutants from the sheer engine building.
- The discharge of the white fluid to the storm sewer system must be eliminated.
- The SWP3 must be revised and implemented at the facility. A copy of the revised SWP3 must be submitted to my attention for review within thirty days of receiving this NOV.

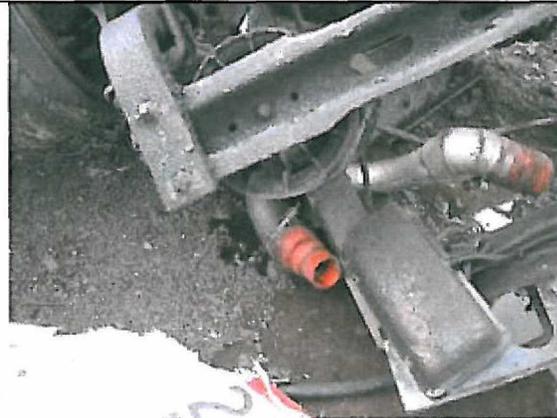
Figure 9 - Scrap materials that are leaking fluids are being accepted. Picture taken November 16, 2011.

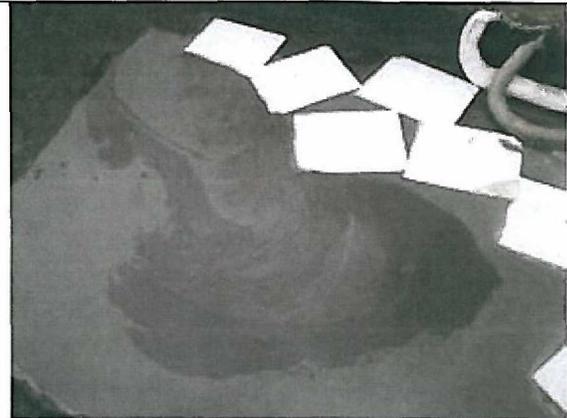
- The control of oil being discharged via storm water runoff continues to require significant improvement throughout the facility. Oil and transmission fluid were being discharged into the storm sewer system serving the facility in numerous locations (Figures 10 to 14). Although large quantities of booms and absorbent mats have been utilized in numerous locations within the storm sewer system, monitoring data provided by the facility via a letter of response dated November 16, 2011, reported that the effluent being discharged on October 3, 2011, had an oil and grease concentration of 26.4 mg/L. No sampling data appears to have been collected from "Discharge #2."

Figure 10 - A spill of transmission fluid within has a "storm pit" that discharges to "waters of the State." Picture taken November 16, 2011.

- Since the clogged storm sewer line has been repaired, the facility must move forward on installing the oil and water separators necessary to address the continuing discharges of oil and grease into the facility's storm sewer system and "waters of the State."

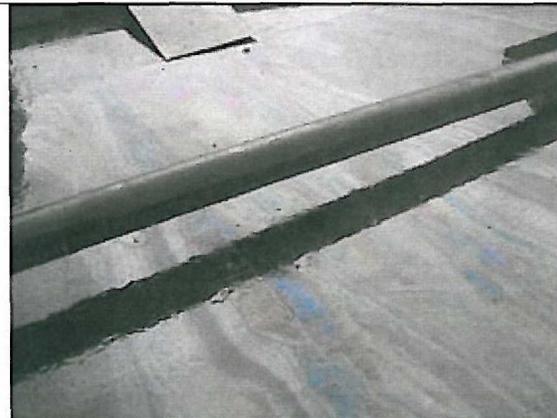
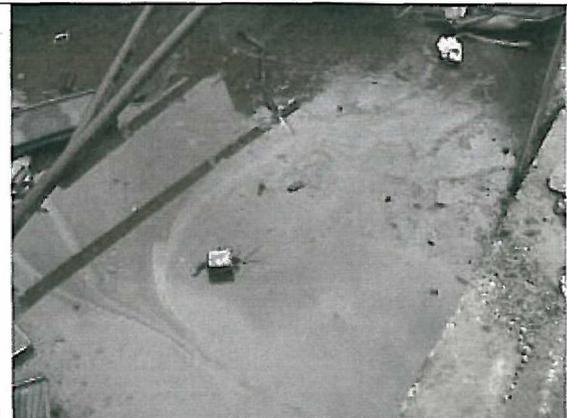
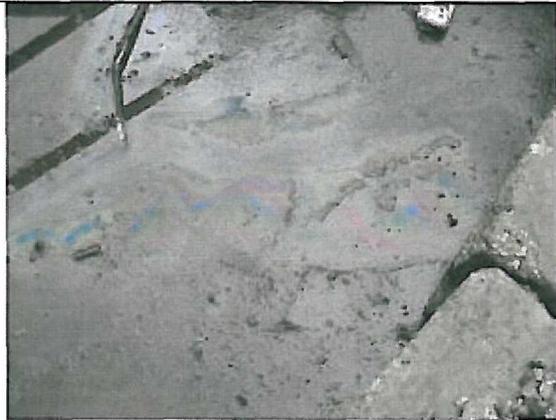
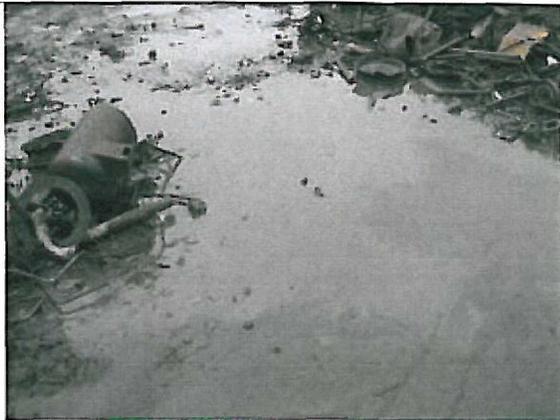
Figure 11 - Storm water runoff containing oil sheens is present throughout the facility. Picture taken November 16, 2011.

Figure 12 - Storm water runoff containing oil sheens is present throughout the facility. Picture taken November 16, 2011.

Figure 13 - Storm water runoff containing oil sheens is present throughout the facility. Picture taken November 16, 2011.

Figure 14 - Storm water runoff containing oil sheens is present throughout the facility. Picture taken November 16, 2011.

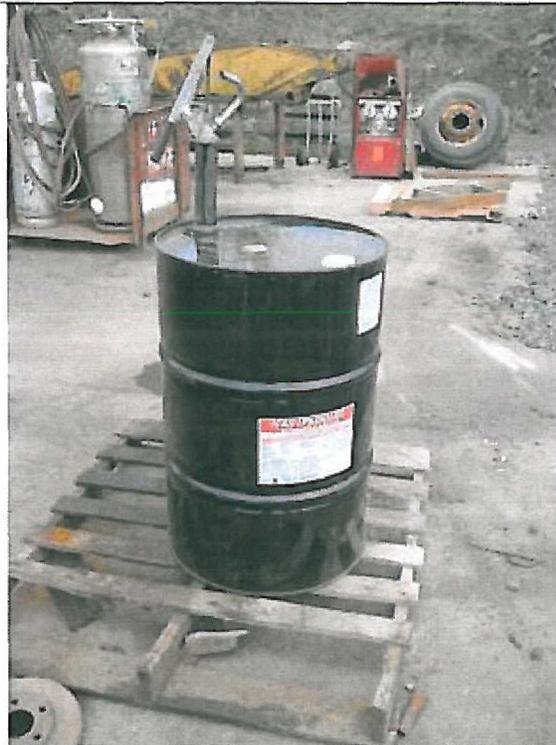
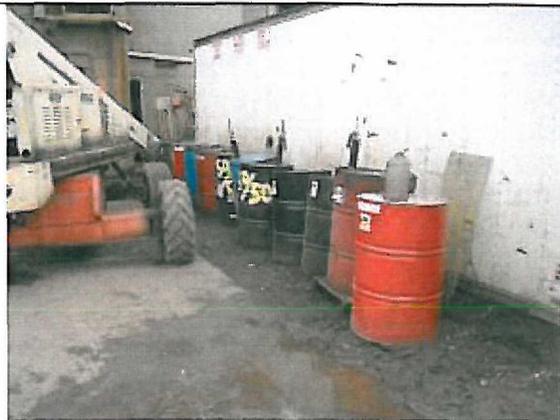
Fifty-five gallon drums where liquids are transferred to or extracted from are stored in locations exposed to precipitation events do not have secondary containment to prevent discharges of pollutants “waters of the State.” Mr. Grimes stated that he was aware of the lack of secondary containment. A work order had not been generated through Maintenance Connection to address the deficiency.

Figure 15 - Secondary containment is not provided around fifty-five gallon drums where fluids are extracted. Picture taken October 31, 2011.

Figure 16 - Secondary containment is not provided around fifty-five gallon drums where fluids are extracted. Picture taken October 31, 2011.

- Secondary containment must be implemented on all fifty-five gallon drums and ground level and above ground storage tanks where liquids are transferred to or extracted from

in storage locations exposed to precipitation events. The facility must submit a compliance schedule that includes the date(s) when secondary containment will be implemented.

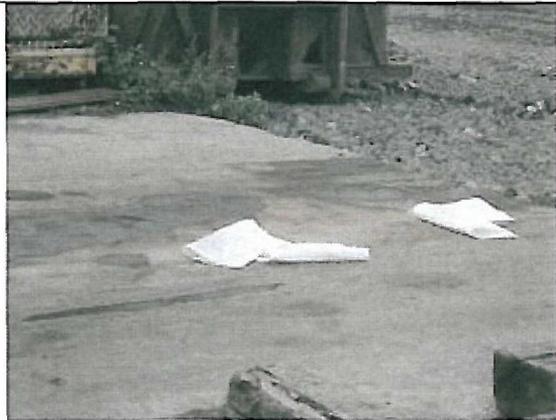
Figure 17 - Absorbent pads were being blown away by the wind. Picture taken October 31, 2011.

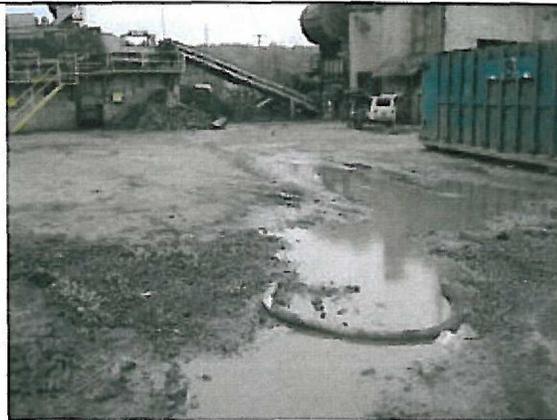
The facility currently discharges contact cooling water associated with the sheer radiators to "waters of the State" (Figure 18). New radiators were purchased on September 2, 2011, which, according to Mr. Grimes, will eliminate the cooling water discharge. Mr. Grimes previously stated that the new radiators will be installed by the first couple weeks of December 2011.

Figure 18 - Contact cooling water is being discharged by the facility. Picture taken October 31, 2011.

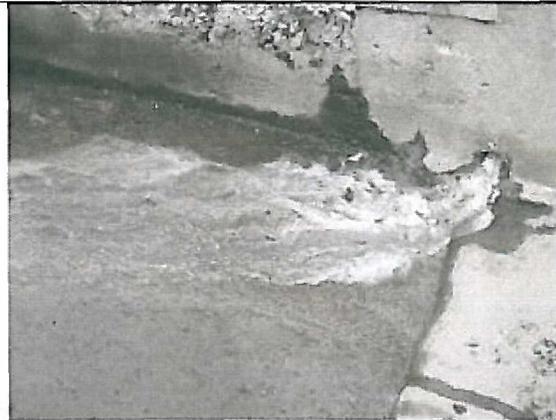
A discharge of white fluid is occurring within the storm sewer system located west of the northern shredder conveyer (Figure 19). Mr. Grimes stated that the white fluid is being discharged from the "pig tail pit."

Figure 19 - A discharge of white fluid is occurring within the storm sewer system. Picture taken October 31, 2011.

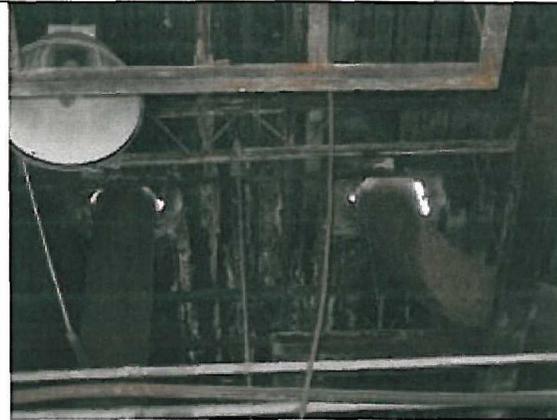
Figure 20 - Precipitation events are able to contact the sheer engine and leaked oil via holes that are present in the roof. Picture taken October 31, 2011.

are present in the roof (Figure 20). A hole has also been drilled within the northern wall of the sheer engine building to drain the floor to the storm sewer system (Figures 21 to 22). Ohio EPA strongly recommends that the roof of the sheer engine building be repaired and the hole drilled within the northern wall be eliminated.

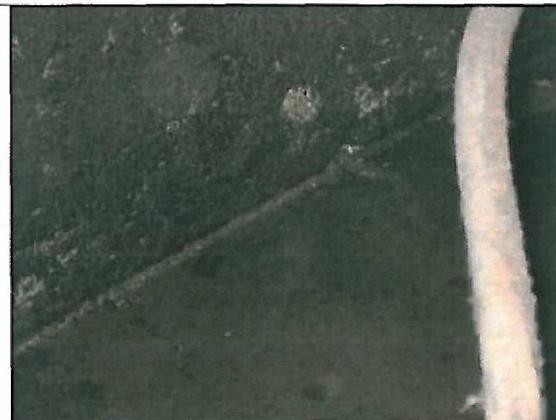
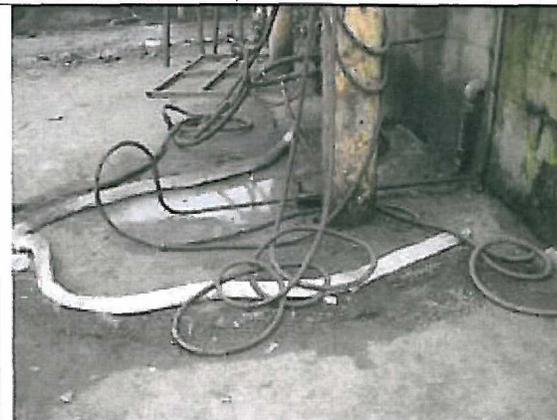
Figure 21 - A hole has also been drilled within the northern wall of the sheer engine building to drain the floor to the storm

Figure 22 - A hole has also been drilled within the northern wall of the sheer engine building to drain the floor to the storm

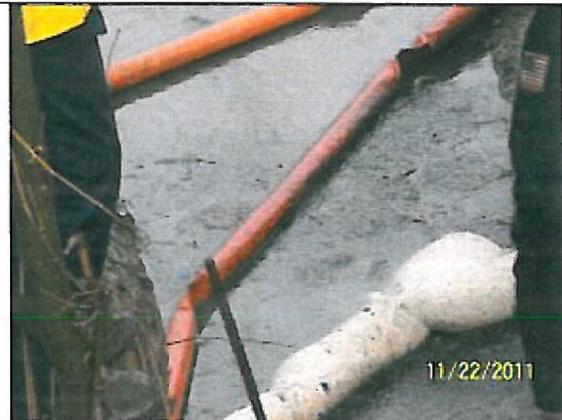
On November 22, 2011, Ohio EPA’s Division of Environmental Response and Revitalization (DERR) responded to a discharge of oil to the Mahoning River. The source of the oil was from the recently unclogged storm sewer line located under your facility, Norfolk Southern Railroad property, and V&M Star (Figure 23). Booms placed immediately downstream of the facility documented a discharge of oil had occurred (Figure 24).

Figure 23 - A discharge of oil to the Mahoning River was occurring. Picture taken November 22, 2011.

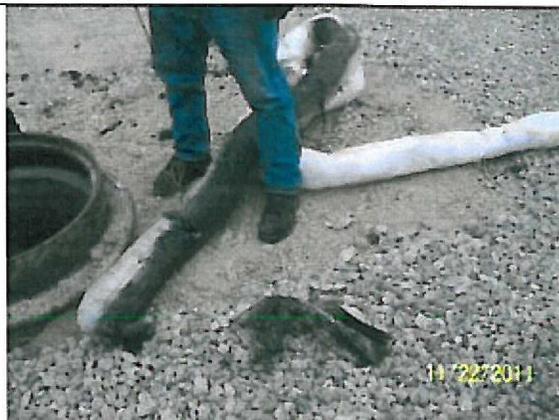
Figure 24 - Booms placed immediately downstream of the facility documented a discharge of oil had occurred upstream of V&M Star.

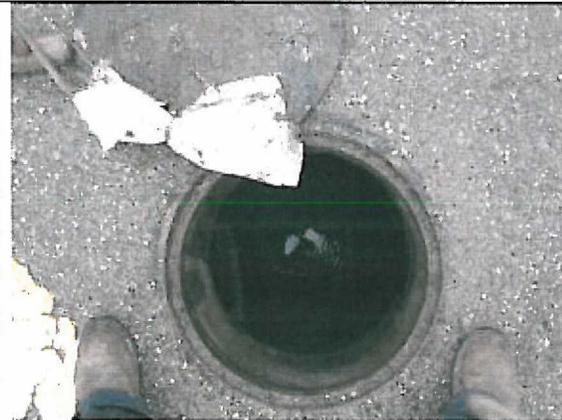
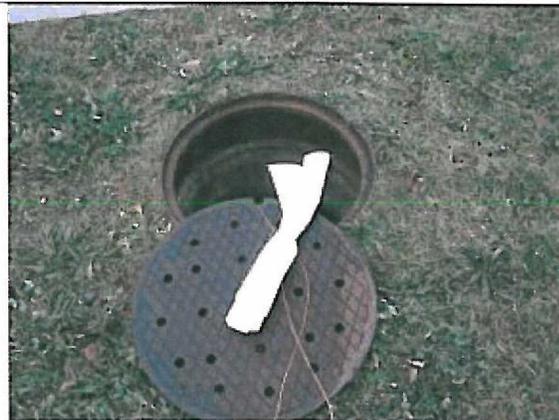
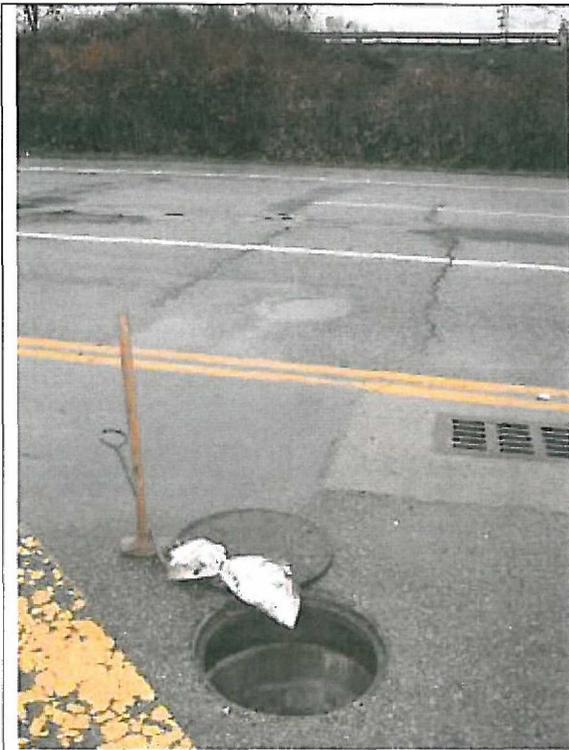
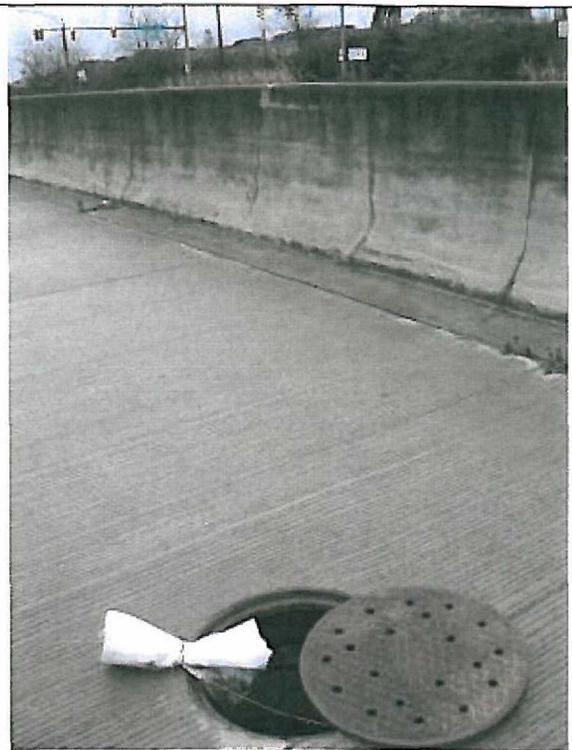
On November 23, 2011, Ohio EPA’s DERR inspected booms installed in locations immediately upstream of the facility. The upstream booms documented that a discharge of oil upstream of the facility had not occurred (Figures 25 to 26).

Figure 25 - Booms upstream of the facility documented that a discharge of oil had not occurred.

Figure 26 - Booms upstream of the facility documented that a discharge of oil had not occurred.

Figure 27 - Booms upstream of the facility documented that a discharge of oil had not occurred.

Figure 28 - Booms upstream of the facility documented that a discharge of oil had not occurred.
