**Environmental  
Protection Agency**

February 8, 2012

RE: MAHONING COUNTY  
EXTRUDEX ALUMINUM, INC.  
NPDES PERMIT NO. OHR000004  
OHIO EPA PERMIT NO. 3GR01011\*DG  
INDUSTRIAL STORM WATER INSPECTION

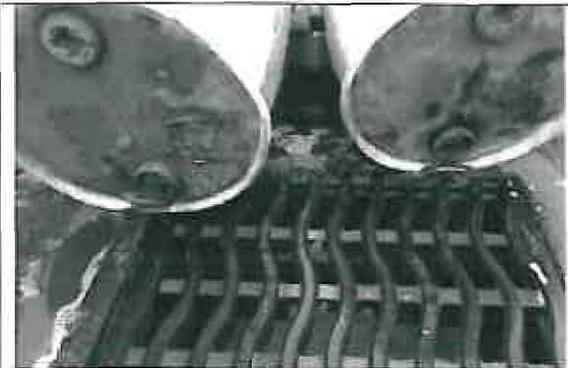
On November 28, 2011, Ohio EPA received an anonymous complaint alleging that wastewater and aluminum chips associated with the operation of a deburring machine utilized at Extrudex Aluminum, Inc., located at 12051 Mahoning Avenue, Jackson Township, Mahoning County (facility), are being into a storm drain serving the facility. On December 7, 2011, Ohio EPA received documentation of the dumping activities that are allegedly occurring at the facility (Figure 1).

**Figure 1** - Picture alleging that dumping of wastewater and aluminum chips is occurring at the facility.

Ohio EPA informed the facility to not dump any materials into the storm sewer system. Generated wastewater must be properly managed and discharged into the sanitary sewer system. In addition, general housekeeping BMPs must be improved at the facility to prevent aluminum scrap from entering the storm sewer system.

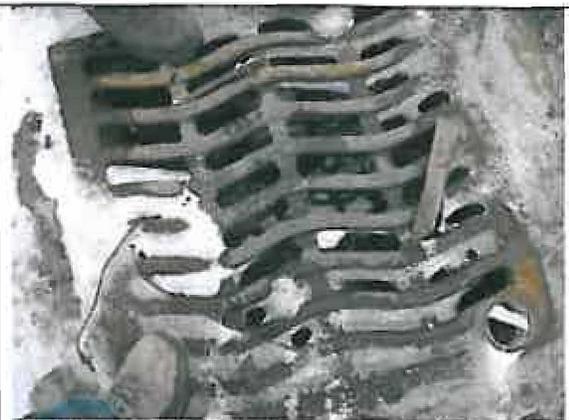
7. An inspection of the storm sewer catch basins serving the facility documented aluminum scrap on the grate and around the northeastern storm sewer catch basin (Figures 2 to 3) and grey colored water pooled around the southeastern storm sewer catch basin (Figure 4), which is the complaint documentation provided in Figure 1. This appears to contradict the information provided in item No. 5 above.

**Figure 2** - Aluminum scrap on the grate and around the northeastern storm sewer catch basin.

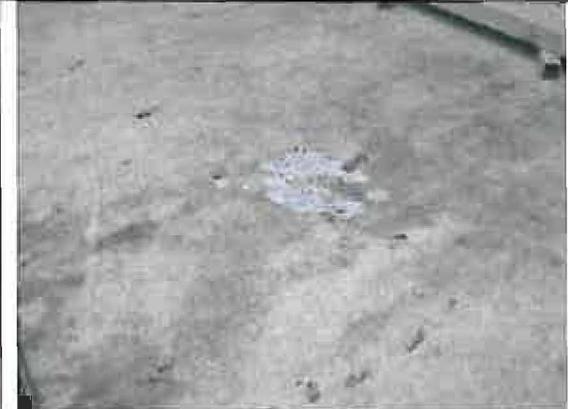
**Figure 3** - Aluminum scrap on the grate and around the northeastern storm sewer catch basin.

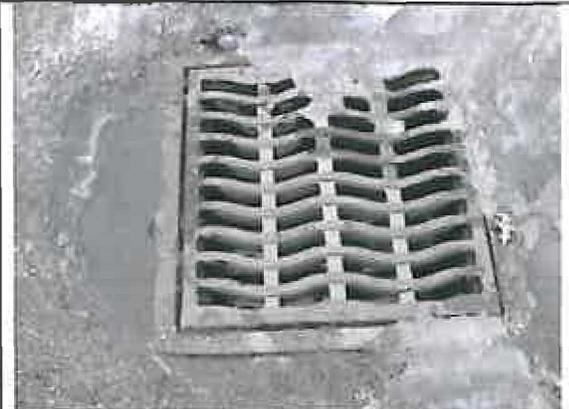
**Figure 4** - Grey colored water was pooled around the southeastern storm sewer catch basin.
