**Environmental  
Protection Agency**

February 9, 2012

RE: CUYAHOGA COUNTY  
CITY OF CLEVELAND  
CHEMICAL SOLVENTS INC.  
INDUSTRIAL STORM WATER

NOTICE OF VIOLATION

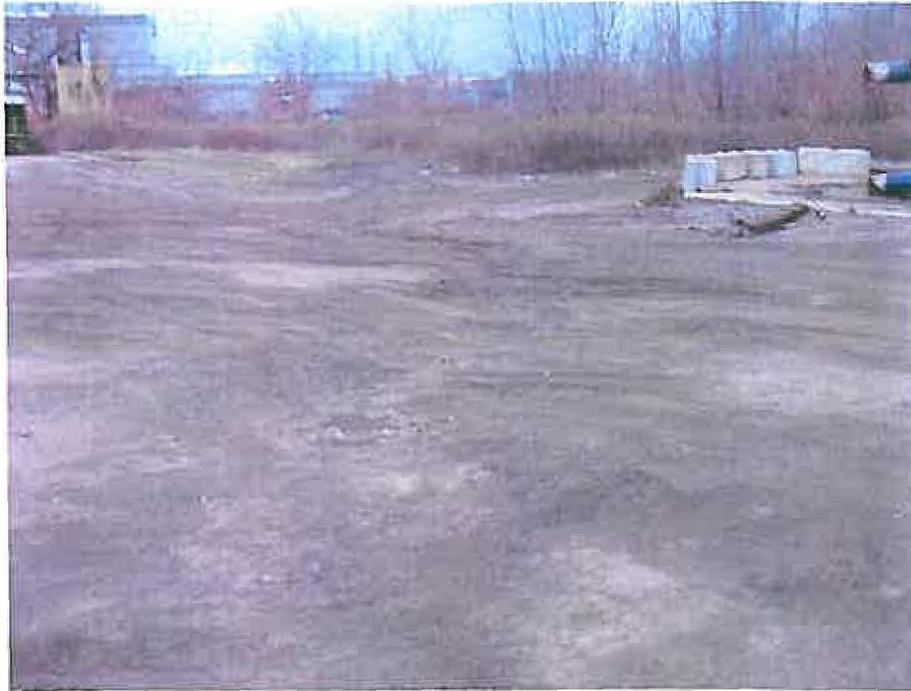
**Fig 1.** A swale drains the area of the site between the New Warehouse and the Maintenance Building to the Cuyahoga River. Soil erosion from the yard is a concern that must be addressed in the SWP3.

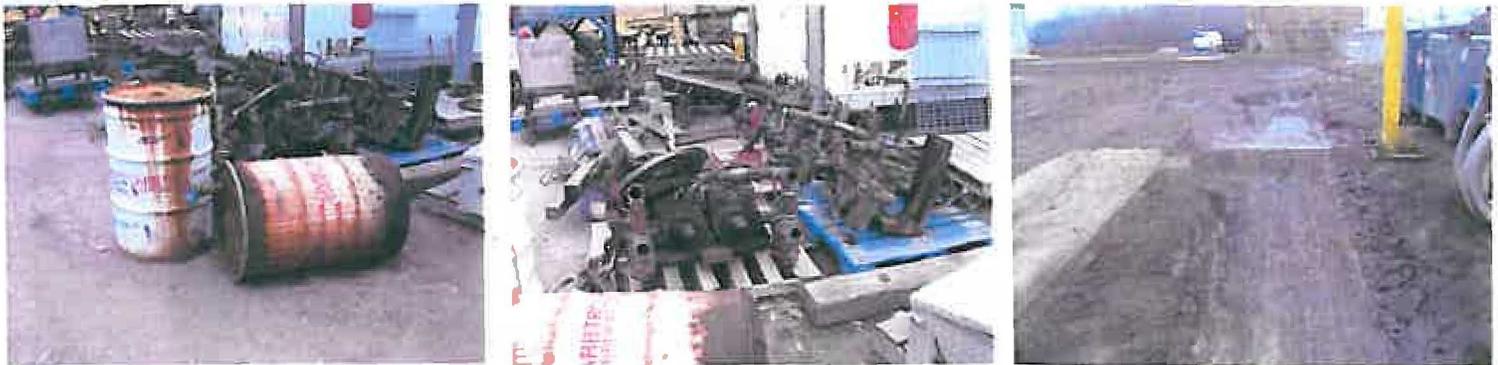
- Deteriorating drums and scrap machine parts are stored out in the yard in an area without cover or being in containment areas (Fig 2 & 3).
- Vehicles track solvents beyond the Bulk Product Loading Dock containment pad onto surrounding ground (Fig 4). Please note that our previous inspection identified this deficiency and recommended that the containment pad here be enlarged. Chemical Solvents took no action.

**Fig 2 – 4.** In addition to soil erosion, there are a number of other storm water pollution sources within the drainage area of the swale pictured in Fig 1. Deteriorating drums containing carbon powder, scrap machine parts with residual lubricating fluids, and tracking of solvents beyond the Bulk Product Loading Dock are some of the sources observed on the date of inspection. There are no BMPs in place to minimize their discharge in storm water runoff.

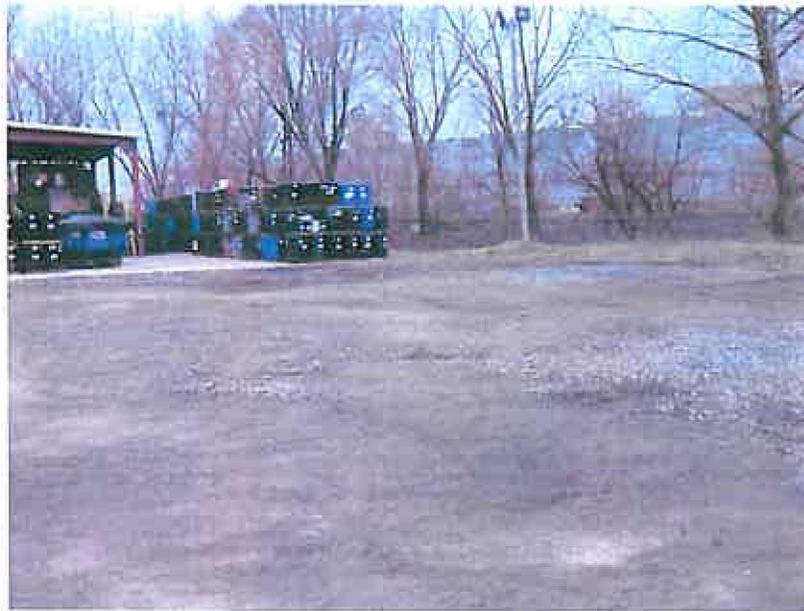
Fig 5. Sheet flow runoff from the area between the New Warehouse and the Auger Pad flows past the Auger Pad to the Cuyahoga River. Soil erosion from the yard is a concern that must be addressed in the SWP3.

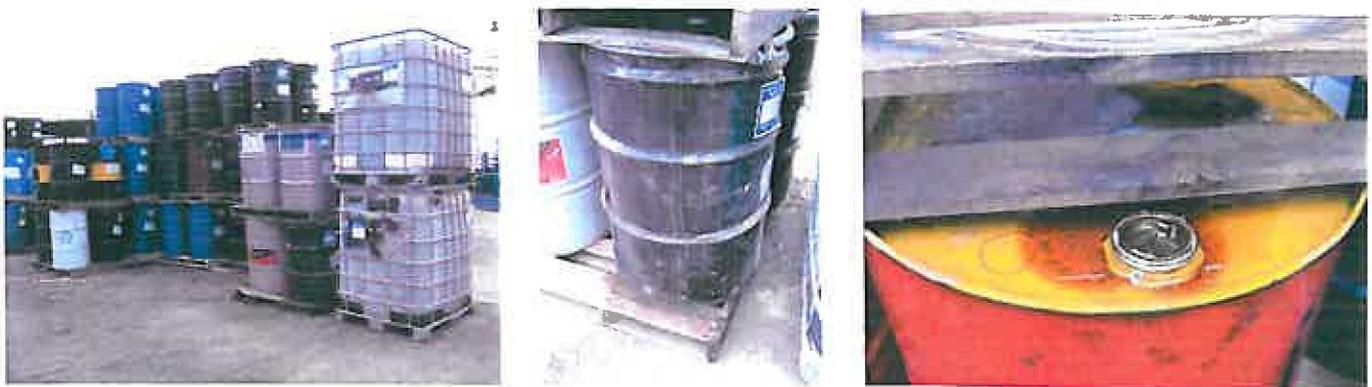
- Totes and drums containing non-hazardous waste are being stored off the containment pad in an area sloped toward the river. These containers and the pallets they are stored upon were observed to have residual or spilled solvents on them where storm water can contact and mobilize them (Fig 6-8).

Fig 6 – 8. In addition to soil erosion, there are a number of sources of storm water pollutants within the drainage area depicted in Fig 5. The placement of non-hazardous waste containers off the containment pad, pallets with residuals from spills, and drums with leaked or spilled solvents on top of them are some of the pollutants observed on the date of inspection. No BMPs are in place to address these sources.

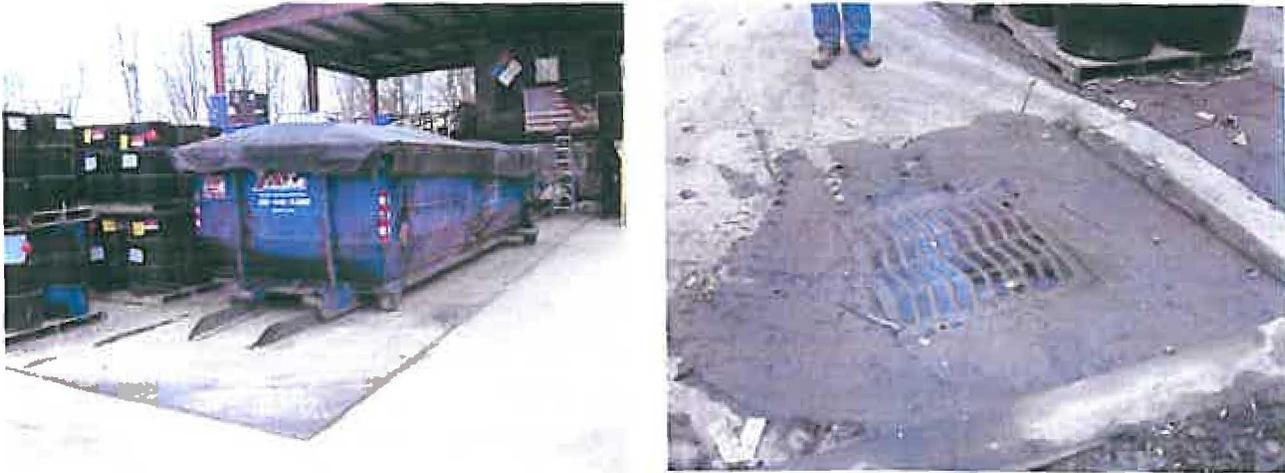
**Fig 9 & 10.** Although waste chemical drums are stored on a containment pad, the drains within the containment pad are blind sumps, the majority of catch basins are filled with sediment and provide little to no storage beyond that provided by the pad itself. When it rains, Chemical Solvents indicated that the water is tested and either (a) discharged to the combined sewer or (b) pumped into totes and placed into the appropriate bulk chemical storage tank on site.

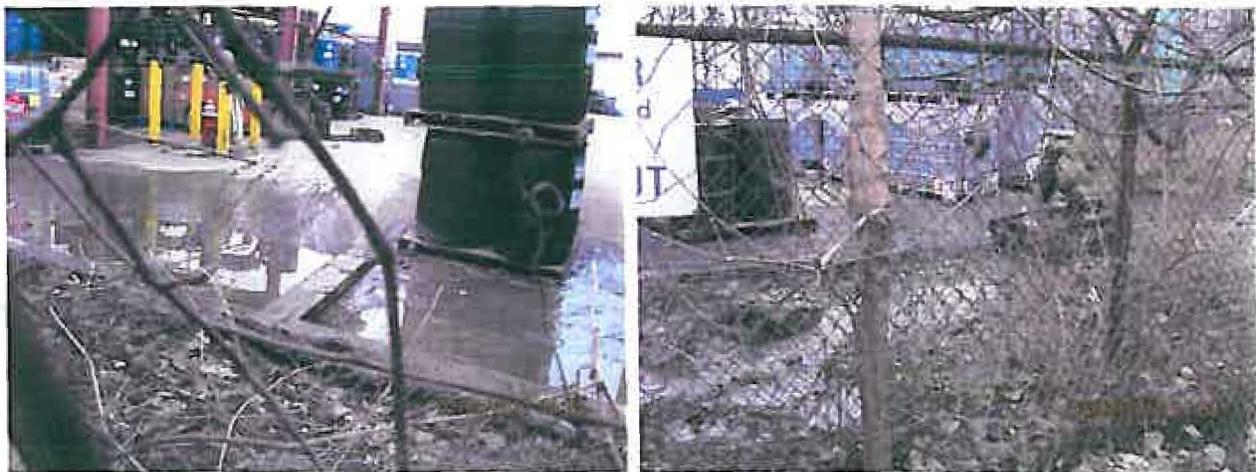
NEORSR on February 2, 2012, found Chemical Solvents pumping water contained within the Auger Pad out to the ground outside the containment pad (Fig 11 & 12).

**Fig 11 & 12.** These photos, taken by NEORSD on February 2, 2012, show runoff that accumulated on the Auger Pad is being pumped out to the grassy area between the pad and the facility fence. This area is sloped to the Cuyahoga River. This discharge of contaminated storm water is a violation of the BMPs established in the SWP3 required by the NPDES permit.

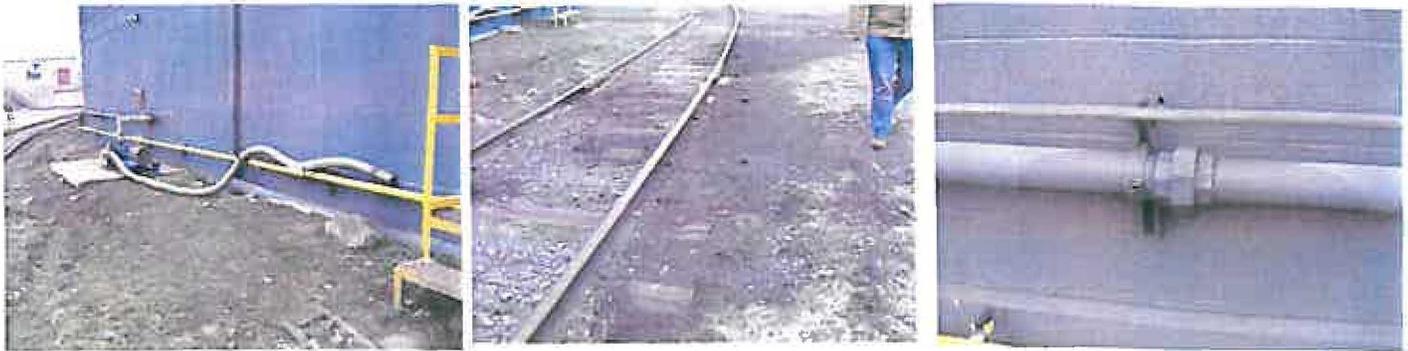
- Chemical Solvents has installed a railcar receiving station for an oil blend product at the LUWA Building. No spill response equipment or containment practices were observed in this location, yet stains from what appears to be past spills were observed along these railroad tracks (Fig 13 & 14).

**Fig 13 (LEFT).** Potential storm water pollutants were noted along the west side of the LUWA Building. A new hose and pump has been installed to receive an oil blend product from railcars. No spill prevention BMPs were evident in this location.

**Fig 14 (MIDDLE).** Stains on the ground along the rail spur leading to the main railcar receiving dock. When spills occur, the material and any contaminated soil must be properly cleaned up and disposed.

**Fig 15 (RIGHT).** There may be a leak at the connection joint between these two sections of pipe allowing the material contained in the piping to become exposed to storm water. Note the darker color, indicative of wetness at the joint, but not on other sections of piping. Regular inspections and routine maintenance practices are BMPs that can be implemented to minimize this concern.

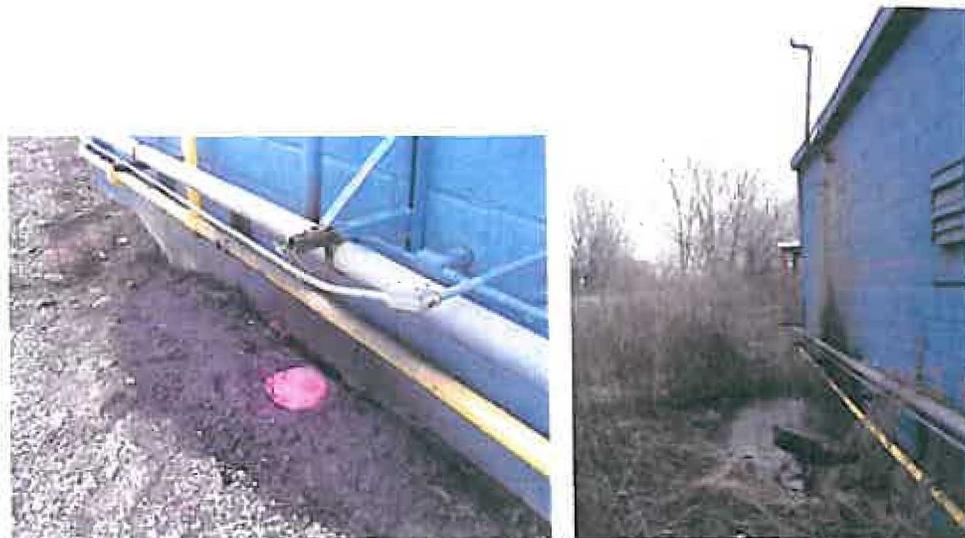
- **Failure to prohibit the discharge of non-storm water.** This is a violation of Part III.A. of the NPDES permit. The distillation process which occurs within the LUWA Building results in two non-storm water discharges. One is coolant from a compressor and the other is heated water discharged from a boiler (boiler blowdown) (Fig 16 & 17). These discharges are not authorized under your existing NPDES permit and must be eliminated.

**Fig 16 & 17.** There are two unauthorized non-storm water discharges from the LUWA Building. Coolant from the air compressor (ABOVE) is discharging onto the ground outside the building. The steam boiler releases heated water through a high pressure relief valve. You must take steps to eliminate these discharges or obtain an additional NPDES permit to authorize such discharges. These areas do not drain to the combined sewer.

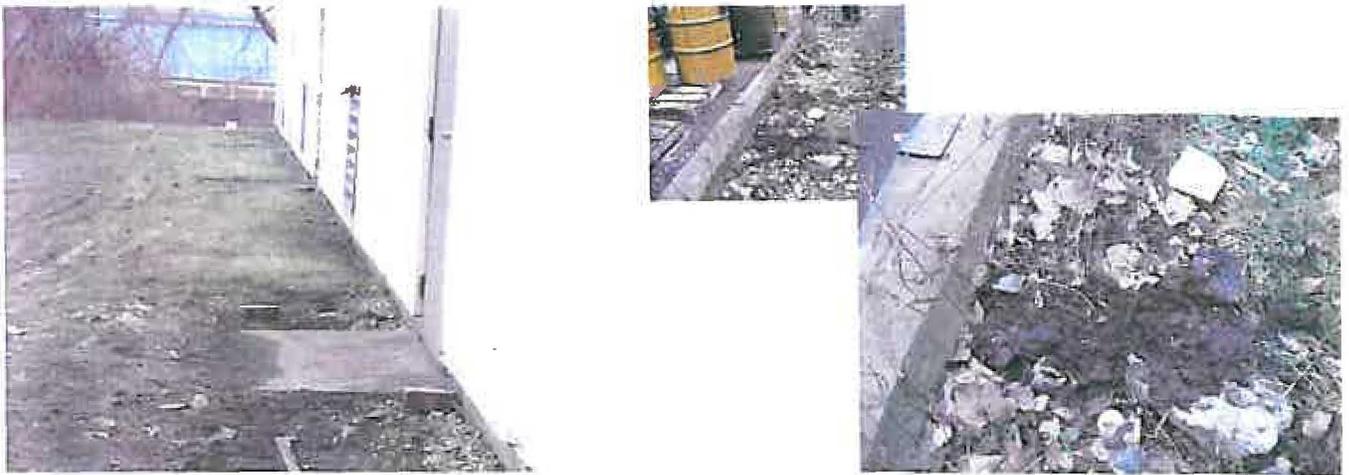
**Fig 18. (LEFT).** A noticeably dark stain was observed next to the back door of the New Warehouse, which may indicate that a spill had occurred, but contaminated soils were not removed and disposed.

**Fig 19 (RIGHT).** Sediment collected within the containment pad was observed at regular intervals outside the Auger Pad indicating that sediments that settle on the pad may not be properly disposed. Sediments that settle on the pad must be characterized and disposed per regulatory requirements.

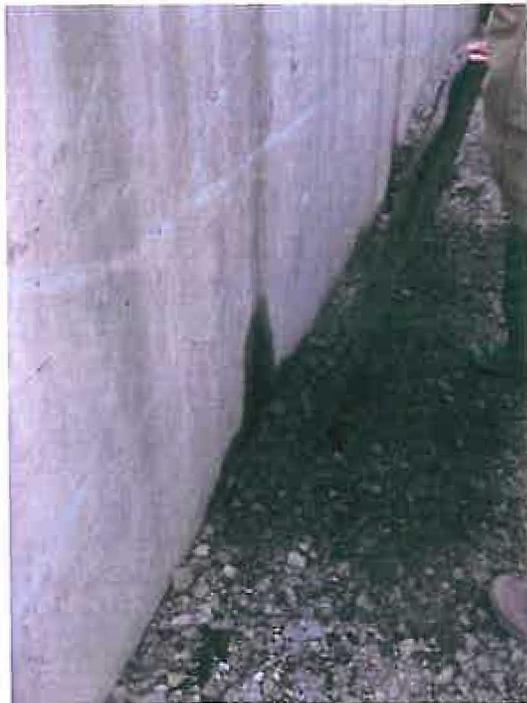
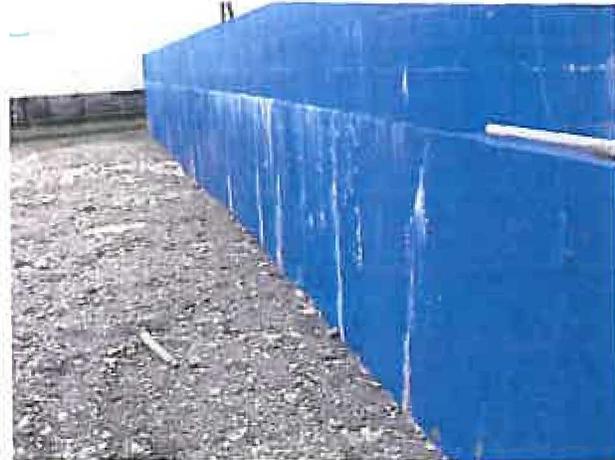
- Seepage of solvents and other chemicals through the walls of containment structures (Fig 20 & 21).

**Fig 20 & 21.** Signs of solvent seeps were observed on the containment walls for the Bulk Product and the Bulk Fuel containment pads. Scheduled inspections and prompt repair are required to comply with the NPDES permit.

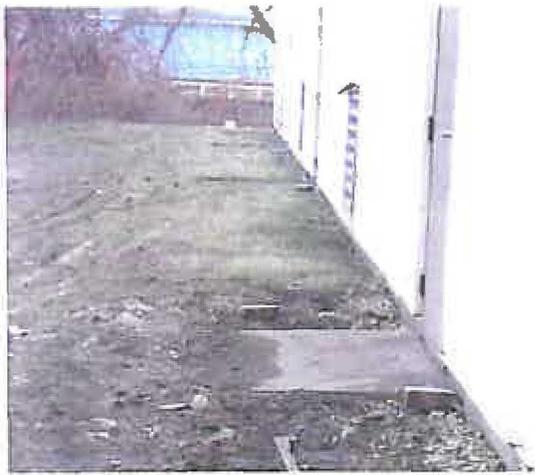
**Fig 18. (LEFT).** A noticeably dark stain was observed next to the back door of the New Warehouse, which may indicate that a spill had occurred, but contaminated soils were not removed and disposed.

**Fig 19 (RIGHT).** Sediment collected within the containment pad was observed at regular intervals outside the Auger Pad indicating that sediments that settle on the pad may not be properly disposed. Sediments that settle on the pad must be characterized and disposed per regulatory requirements.

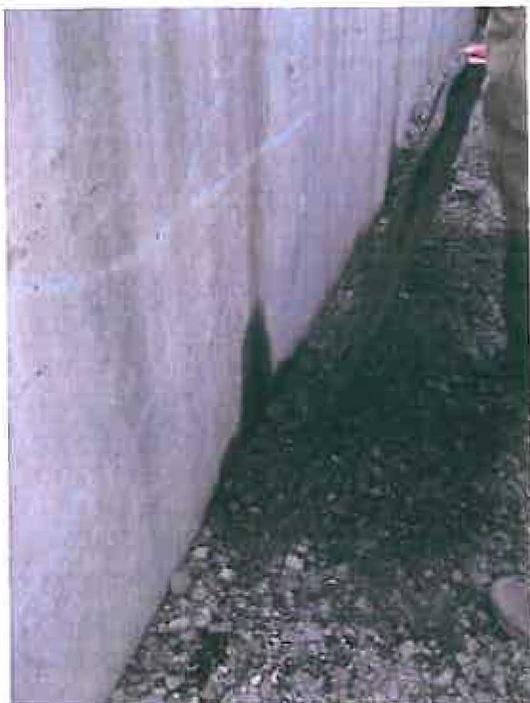
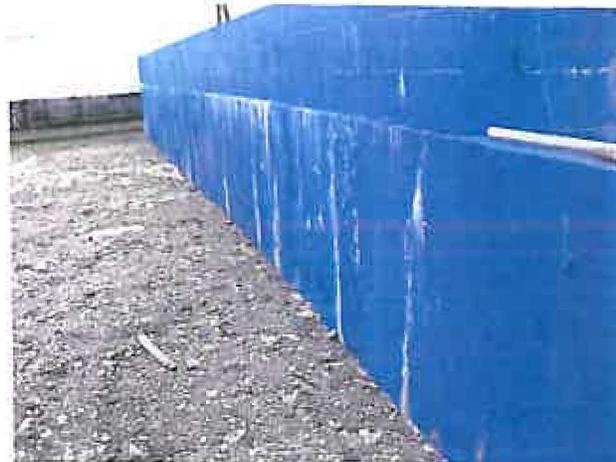
**Fig 20 & 21.** Signs of solvent seeps were observed on the containment walls for the Bulk Product and the Bulk Fuel containment pads. Scheduled inspections and prompt repair are required to comply with the NPDES permit.

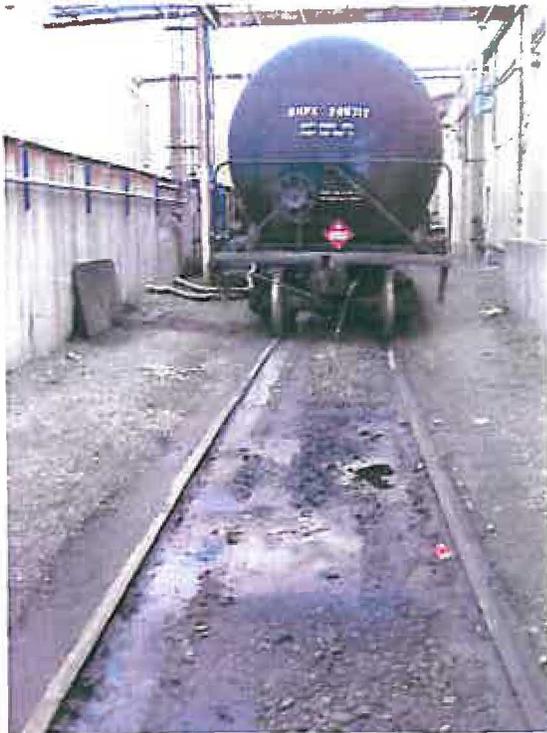
**Fig 22 (LEFT).** Solvents spilled during transfers from rail cars were observed on the ground. It appears that Chemical Solvents is not promptly cleaning up spills and disposing of contaminated soils.

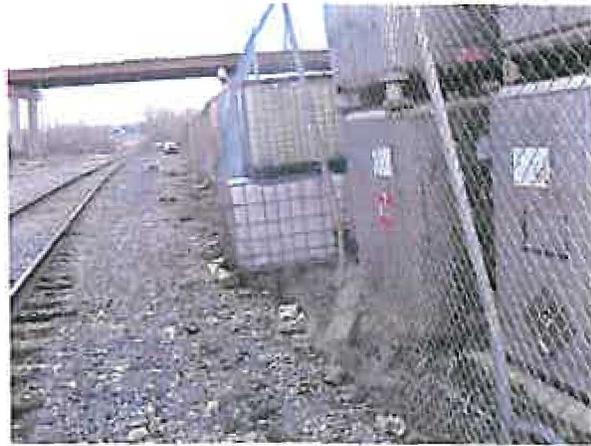
**Fig 23 (ABOVE).** Totes containing chemicals at 3751 Jennings Ave. are pushed past the containment pad.

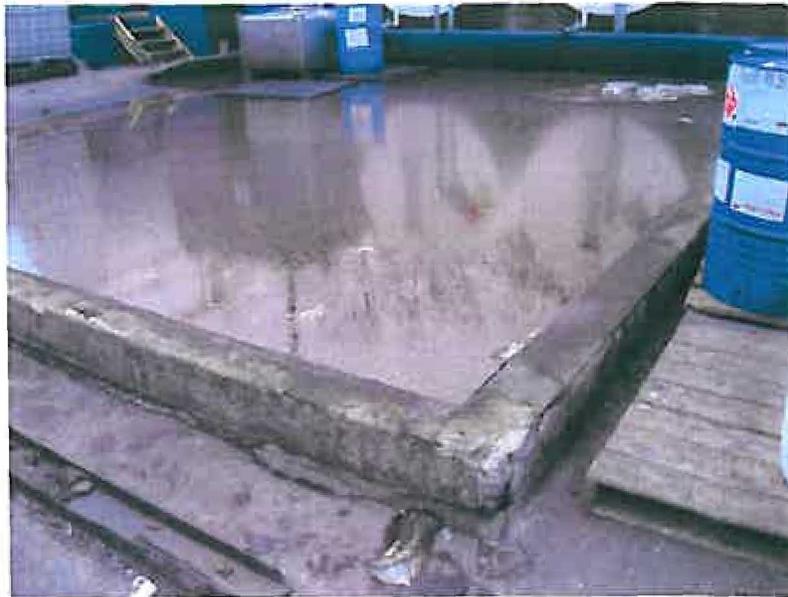
**Fig 24.** Management of runoff that collects within containment pads is critical to the success of the storm water pollution prevention plan. This containment pad at 3751 Jennings Ave. is nearly brimful. It is important that collected runoff is disposed before the next expected storm event.
