**Environmental
Protection Agency**

RE: Holmes County
Miller-Hope Condominium Development
NPDES Permit No. OHC000003
Ohio EPA Permit No. 3GC05169*AG
Construction Storm Water Inspection

Notice of Violation

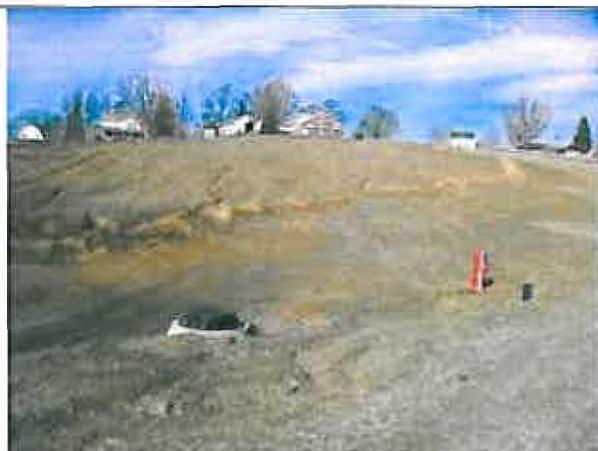
- No erosion and sediment best management practices (BMP) have been installed to prevent the discharge of sediment to the onsite stream (Figures 1 to 2). Diversion channels and erosion gullies discharge untreated sediment-laden storm water runoff to "waters of the State." Sediment deposition was observed within the onsite stream. Properly designed sediment settling ponds must be installed on the western portion of the site.

The failure to install appropriate erosion and sediment controls constitute violations of Ohio Revised Code Chapter (ORC) 6111.07 and and Part.III.B and Part III.G.2.c of the General Storm Water Permit.

- No stabilization of idle areas of the site has occurred prior to the onset of winter and portions of the site that have remained idle for longer than twenty-one days (Figures 1 to 2). Seeding and mulching must be implemented on all idle areas of the site.

The failure to temporarily stabilize idle areas of the site constitute violations of ORC 6111.07 and Part III.G.2.b.i of the General Storm Water Permit.

Figure 1 - Diversion channels and erosion gullies discharge untreated sediment-laden storm water runoff to "waters of the State."

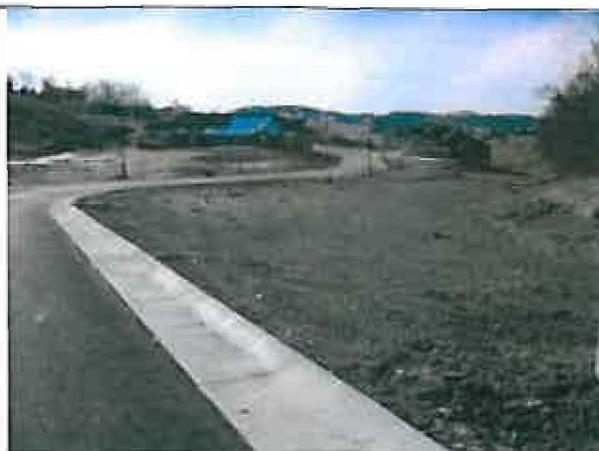
Figure 2 - Diversion channels and erosion gullies discharge untreated sediment-laden storm water runoff to "waters of the State."

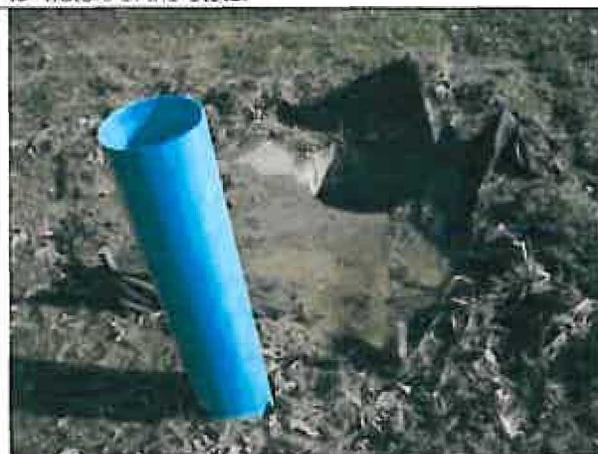
- A sediment detention basin has been constructed in the southeastern portion of the site that has not been modified for sediment removal (Figure 3). A properly designed dewatering skimmer must be installed on the outlet structure. In addition, a catch basin has been installed within the basin, which appears to drain the sediment detention basin directly into the culverted onsite stream.

The failure to provide structural practices to control erosion and trap sediment from a site remaining disturbed for more than fourteen (14) days constitute violations of ORC 6111.07 and Part.III.B and Part III.G.2.c of the General Storm Water Permit.

Figure 3 - The sediment detention basin outlet has not been modified for sediment removal

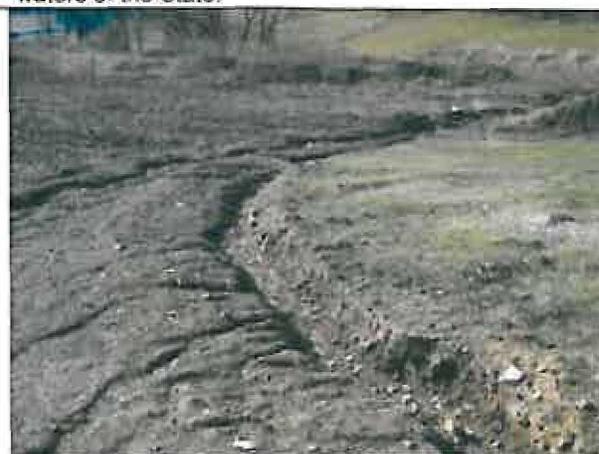
- Untreated sediment-laden storm water runoff is discharging directly into the undisturbed stream channel that has been bypassed via the stream culvert on the south eastern portion of the site (Figure 4). A properly designed sediment-settling basin must be installed to treat sediment prior to a discharge to "waters of the State."

The failure to provide proper dewatering BMPs constitute violations of ORC 6111.07 and Part III.G.2.g.iv of the General Storm Water Permit.

Figure 4 - Untreated sediment-laden storm water runoff is discharging directly into the undisturbed stream channel.

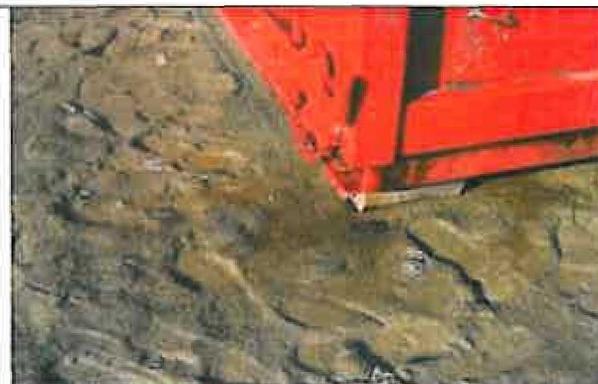
- Leachate is being generated from precipitation events contacting solid waste within an uncovered dumpster (Figure 5). The General Storm Water Permit does not authorize the discharge of leachate, which must be eliminated.

The failure to prevent the discharge of leachate with storm water runoff constitutes violations of ORC 6111.07 and Part III.G.2.g.i of the General Storm Water Permit.

Figure 5 - Leachate is being generated from precipitation events contacting solid waste within an uncovered dumpster.
