RE: CUYAHOGA COUNTY
CITY OF BROOKLYN HEIGHTS
ROSBY RESOURCE RECOVERY
CONSTRUCTION STORM WATER

NOTICE OF VIOLATION

ROSBY RESOURCE RECOVERY

Photos Taken: January 9, 2012

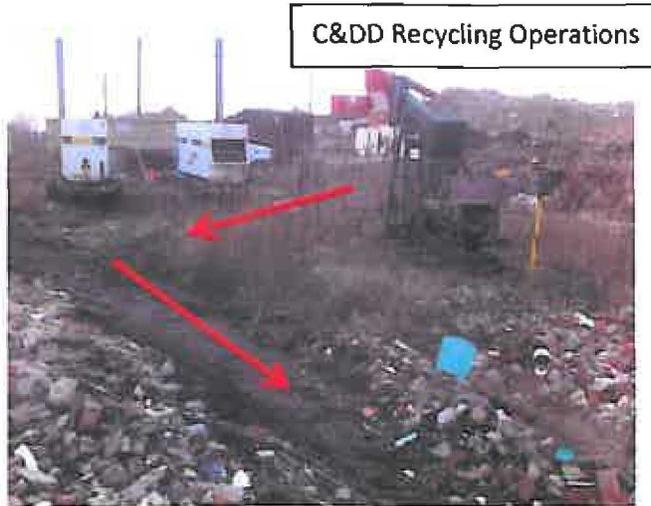
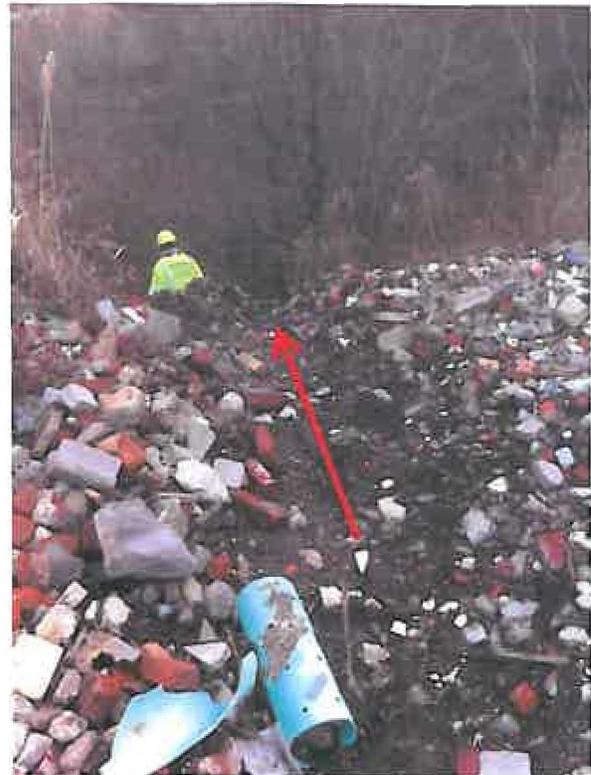
Fig 1 (ABOVE) & 2 (RIGHT). Runoff from significant stockpiles of construction & demolition debris (visible in the background of the photo above) is directed down the eastern slope via the various drainage systems. This swale is located near the office trailers.

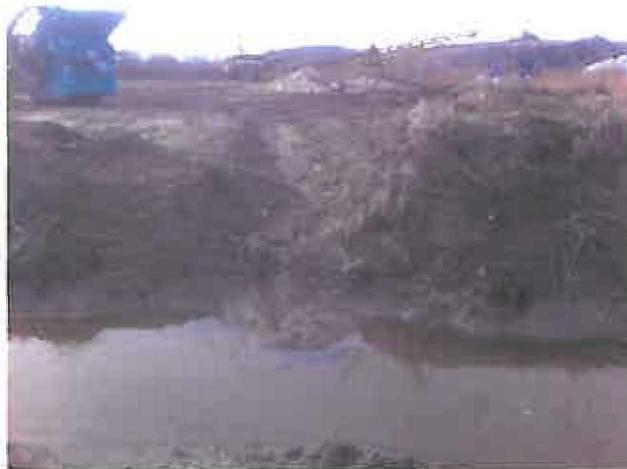
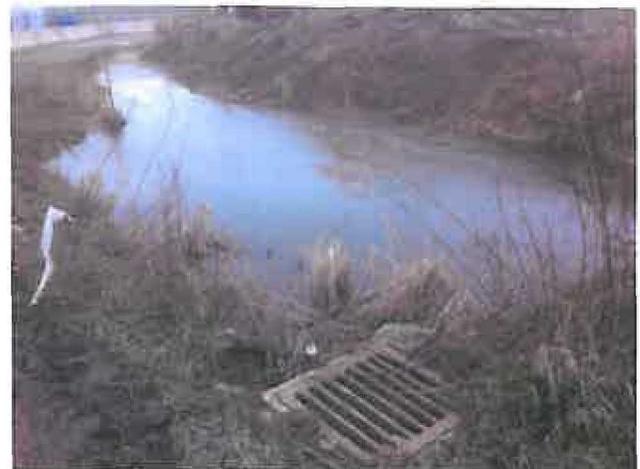
Fig 3 & 4. The staging area area drains via swale to the storm water management pond shown on the LEFT. However, this pond does not meet current standards for sediment ponds. The pond discharges via storm sewer to the eastern slope at the location shown in Fig 2.

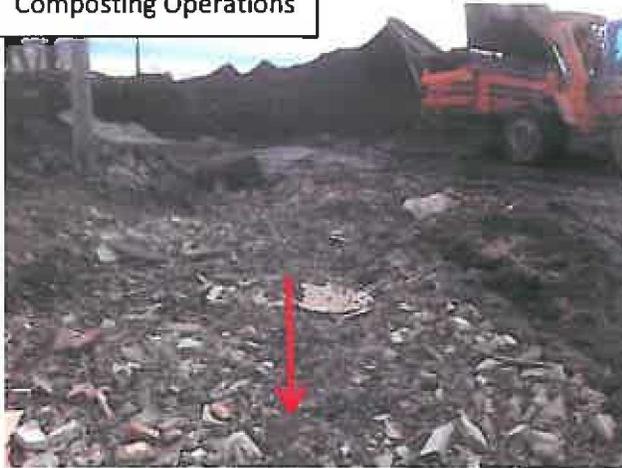
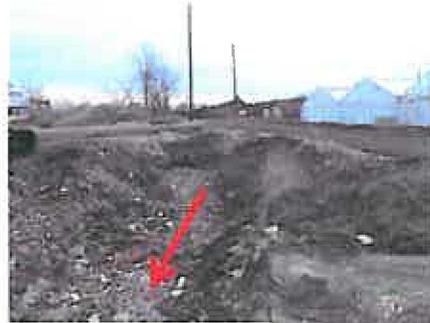
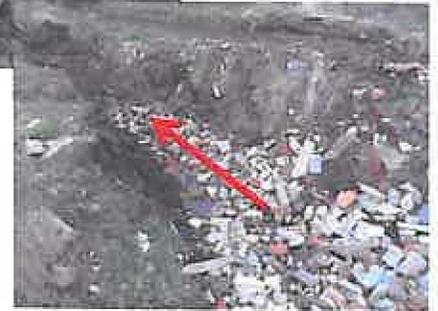
- Leachate associated with composting operations appears to have been pumped outside the containment berm or otherwise breached the berm around the compost windrows. In addition, a drainage channel has been established on the east end of the composting area to allow leachate to flow down the hill into a storm sewer system that discharges to the Cuyahoga River.

Fig 5-7. There is no containment berm for the eastern end of the composting operations area. Rather, a brick-lined drainage swale has been installed to direct leachate down the eastern slope.

These conditions were documented in the attached photographs. BMPs must be implemented to prevent the discharge of leachate from this facility. Practices may include berming, curbing and diking; collection of leachate for disposal at a wastewater treatment facility (with permission of the wastewater treatment plant operator); or storage of materials indoors or under cover so as to prevent the generation of leachate.

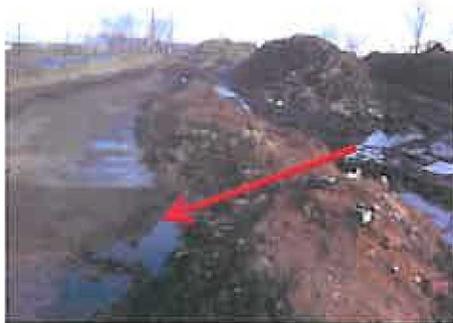
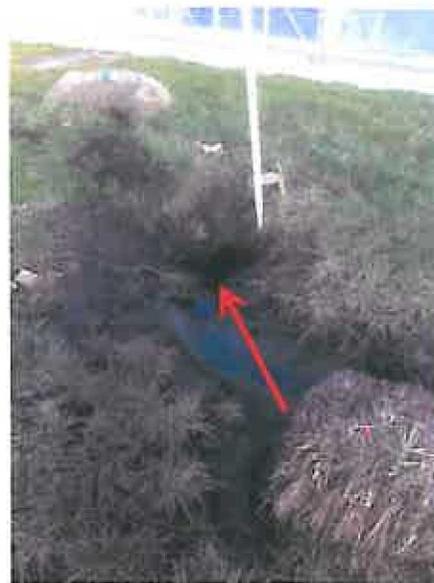
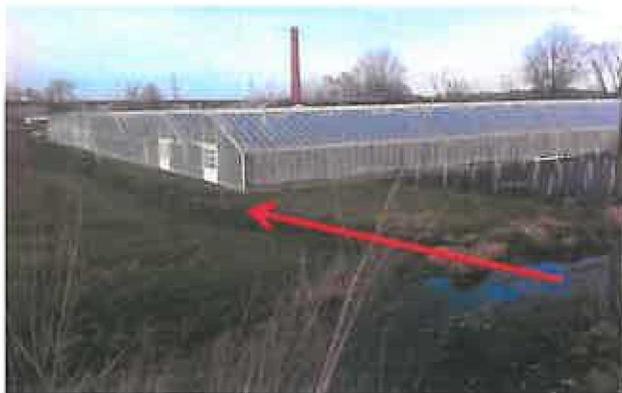
Fig 8-10. A breach in the containment berm along the north side of the composting area has allowed leachate to enter a storm drainage system near the greenhouses resulting in an unauthorized discharge of wastewater.

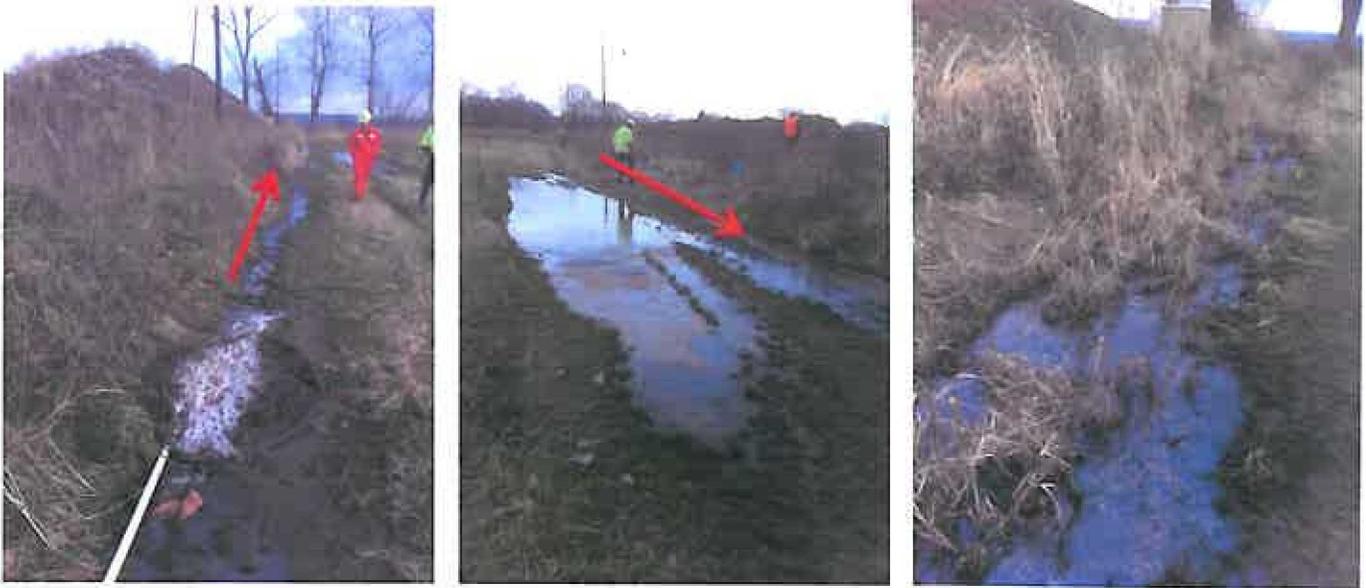
Fig 11-13. It appears that leachate is being pumped outside the containment berm around the south side of the composting area. Leachate-impacted flow was observed going down the eastern slope.

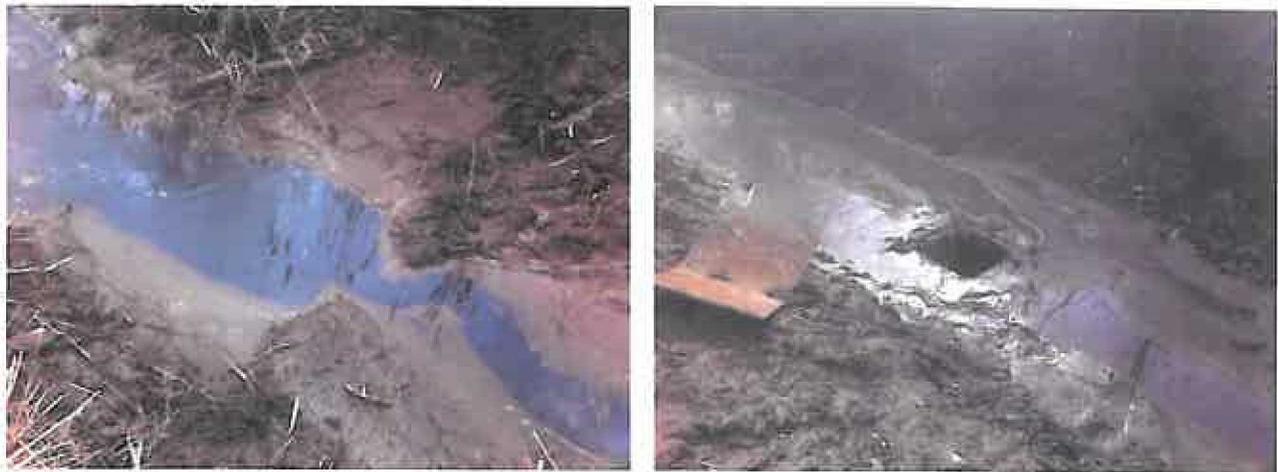
Fig 14 & 15. The discharges of leachate depicted in Fig 5-13 were observed in the drainage channel at the base of the eastern slope along the railroad tracks. The drainage channel feeds a storm sewer system that discharges to the Cuyahoga River. Note the sediment-laden and leachate-impacted runoff entering the storm manhole in Fig 15 (RIGHT).

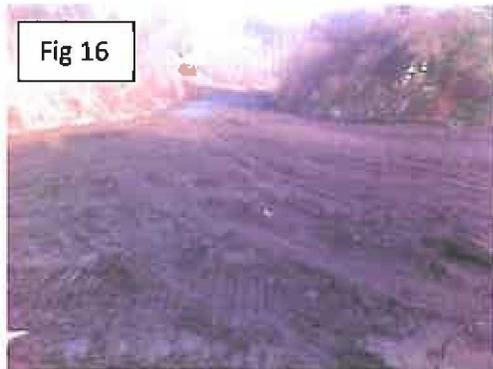
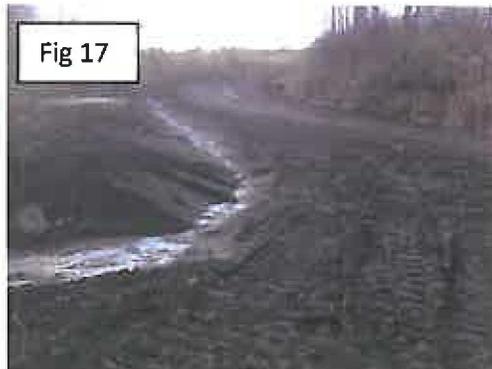
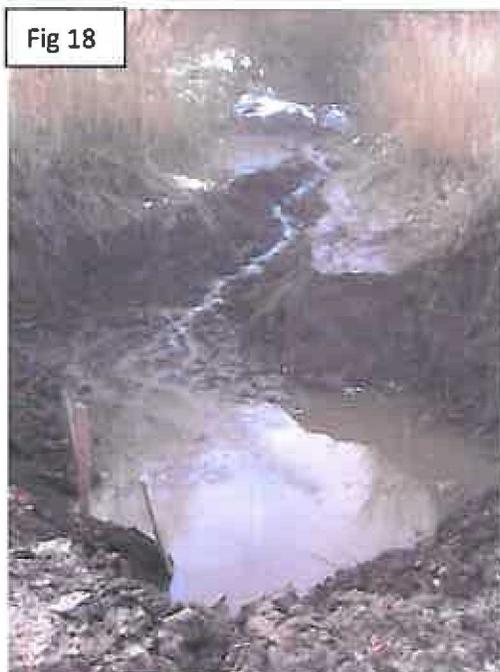
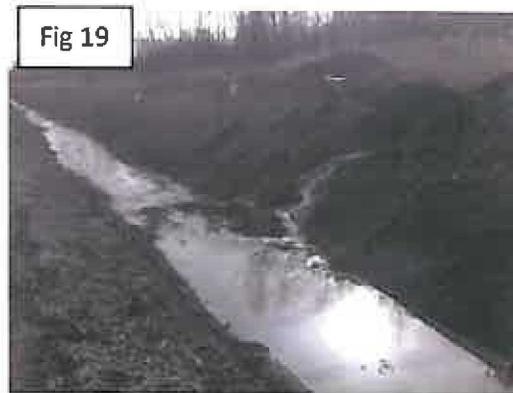
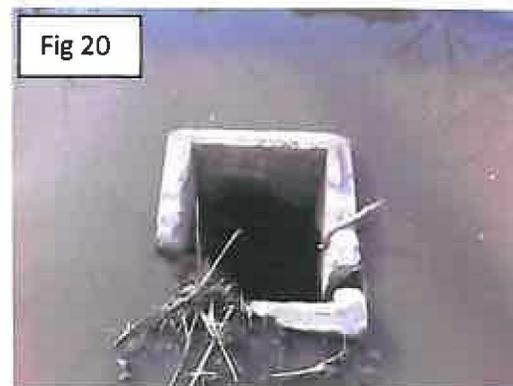
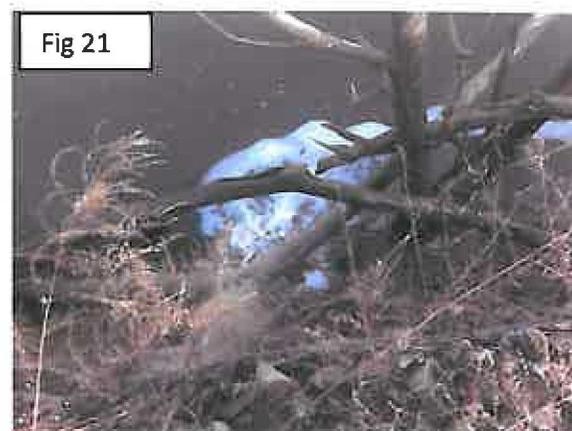
Fig 16-21. Runoff from C&DD recycling operations and stockpiles also flows down the haul road depicted in Fig 16 & 17 and then through what is intended to be a sediment pond (Fig 18). This pond is not designed to sediment basin standards. The pond then discharges to the drainage channel along the railroad tracks (Fig 19) and into a storm sewer system (Fig 20). The resulting discharge to the Cuyahoga River is shown in Fig 21.

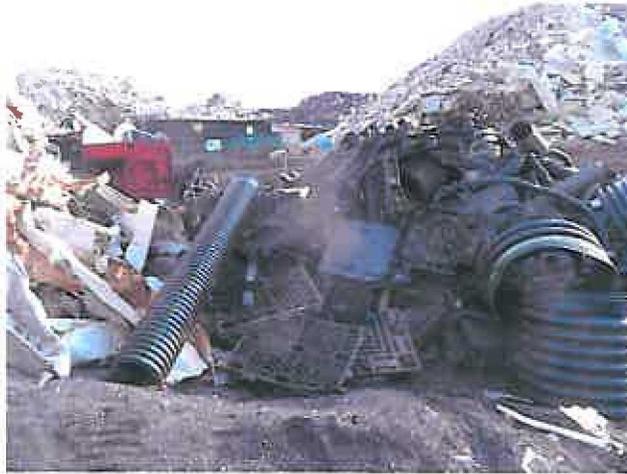
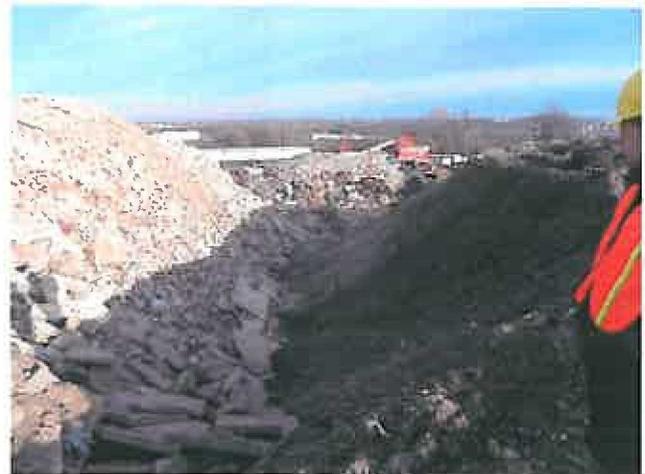
Fig 22 & 23. Overview of area where C&DD is stockpiled along with concrete slabs and other wastes. Recycling operations area is visible in the rear of Fig 23 (RIGHT).

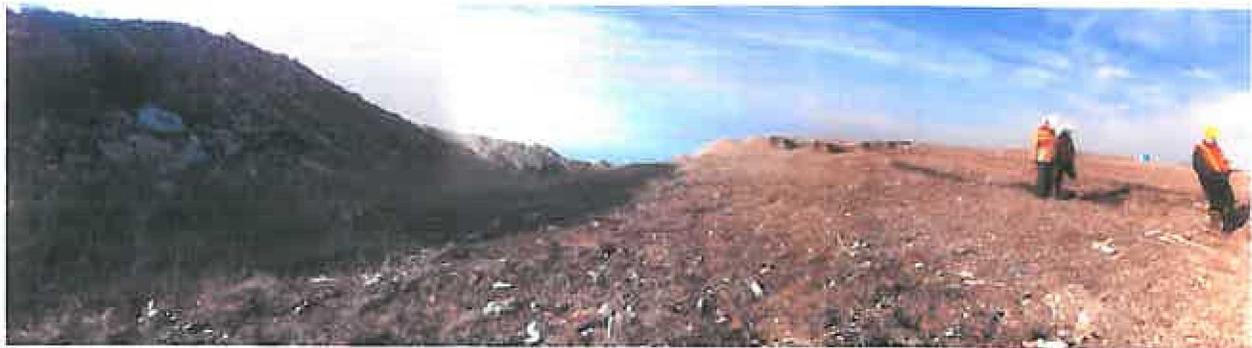
Fig 24 (ABOVE). The capped C&DD waste cell is visible on the left side of this photo. "Daily cover" is placed on top of the active waste placement area on the right side of this photo.

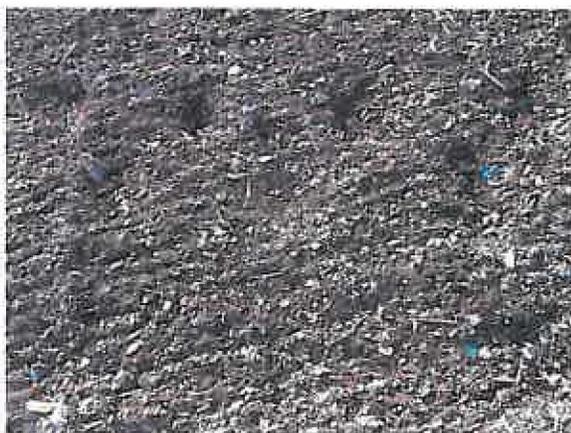
Fig 25 (LEFT). Close up view of the "daily cover" shows that it consists of shredded C&DD. Storm water that contacts this material is leachate.

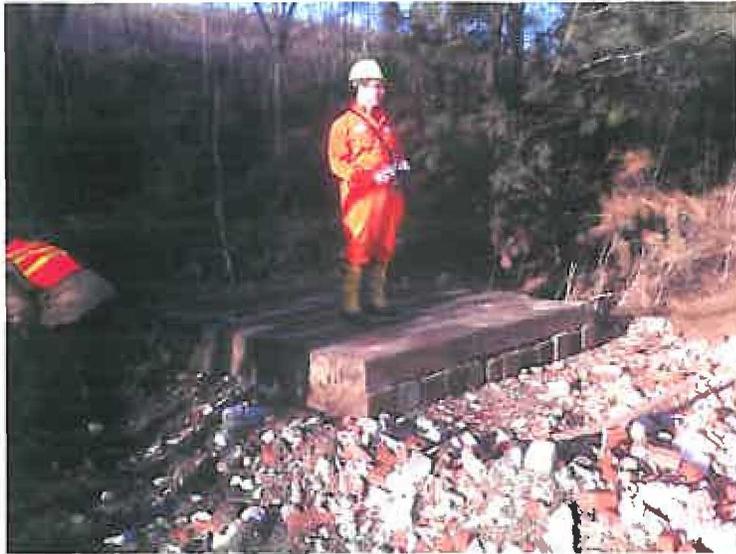
Fig 26. Runoff from the capped C&DD waste cell and the active C&DD waste placement area shown in Fig 24 drains to a storm sewer system along the south side of the facility. This system discharges to the eastern slope. This photo shows a manhole that provides access to the system.

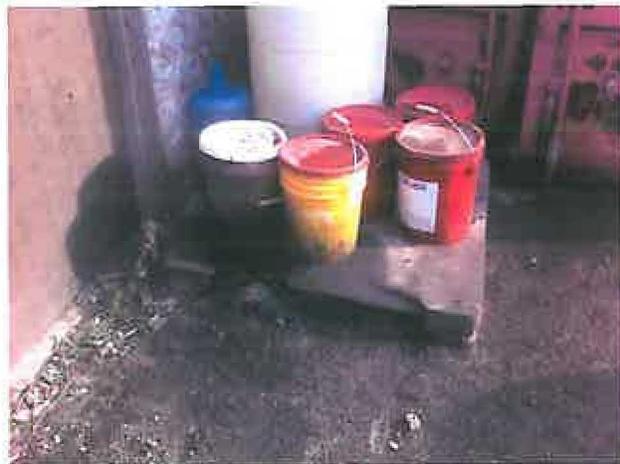
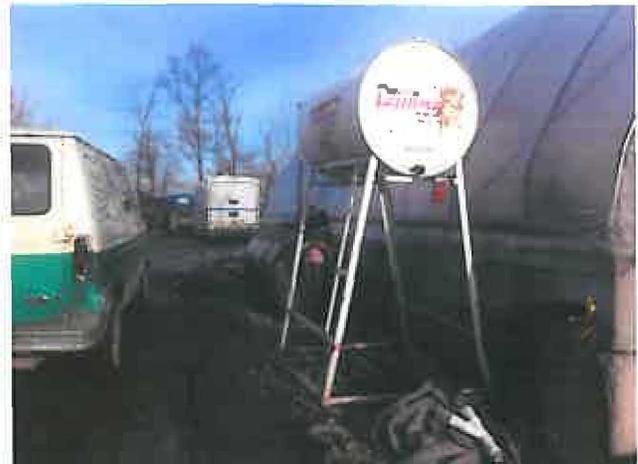
Fig 27 & 28. Secondary containment has not been provided for 5-gallon buckets and fuel tanks that contain automotive fluids. Spill clean-up procedures have not been implemented to address spills of oil and petroleum-based products.
