**Environmental
Protection Agency**

May 2, 2012

RE: DIANO CONCRETE
STORMWATER
STARK COUNTY
PERMIT NO. 3GR001253*DG

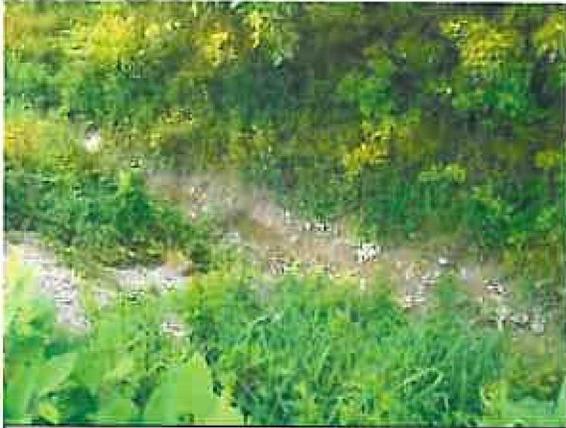
Figure 1: Sediment building up in drainage ditch near where it empties into creek.

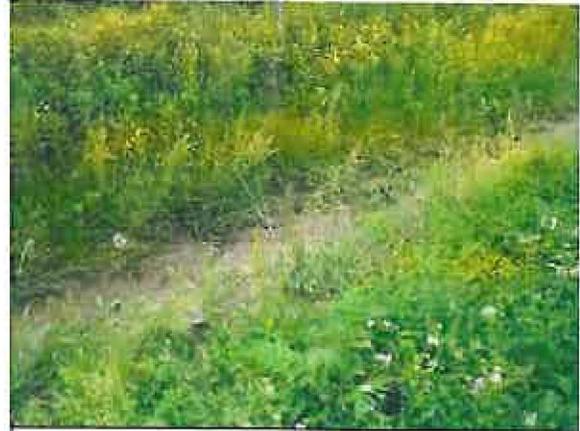
Figure 2: Sediment building up in drainage ditch

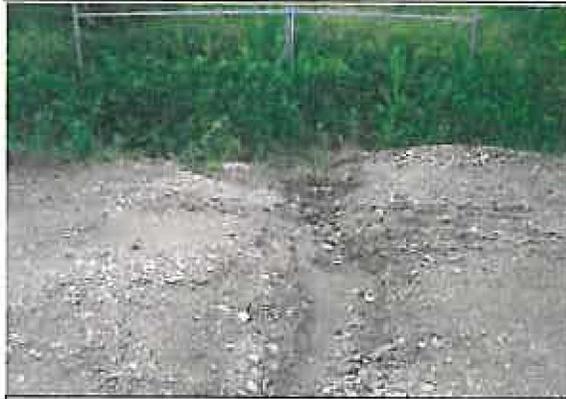
Figure 3: Erosion of the storage yard where most of the water drains into ditch along south side of property.

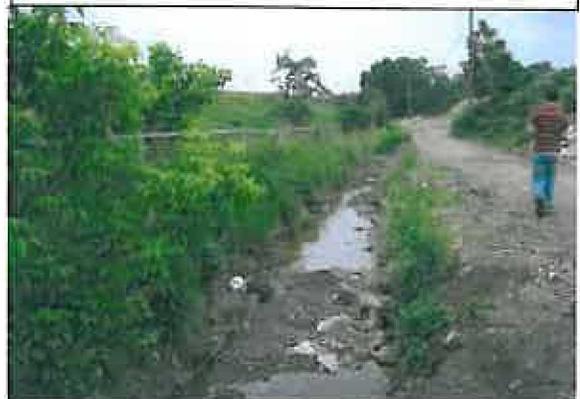
Figure 4: Sediment building up in drainage ditch.

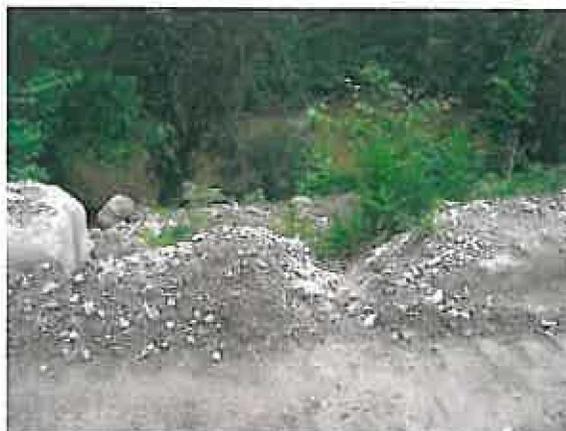
Figure 5: Erosion of the earthen berm surrounding the backside of the yard.

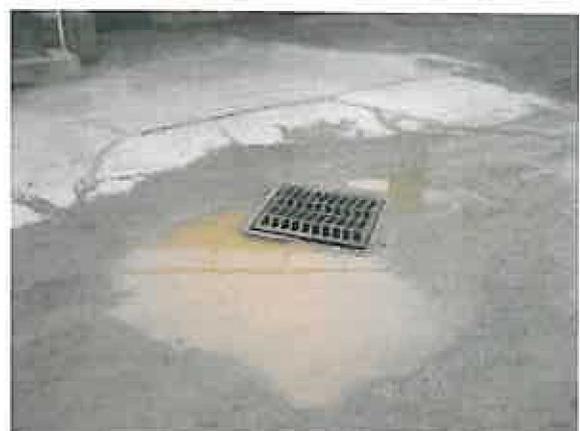
Figure 6: Sediment building up around a catch basin.
