**Environmental
Protection Agency**

May 8, 2012

RE: WAYNE COUNTY
CITY OF ORRVILLE
INDUSTRIAL STORM WATER
THE SCOTTS CO, LLC

Mike Henkle
The Scotts Co., LLC
563 South Crown Hill Rd.
Orrville, OH 44667

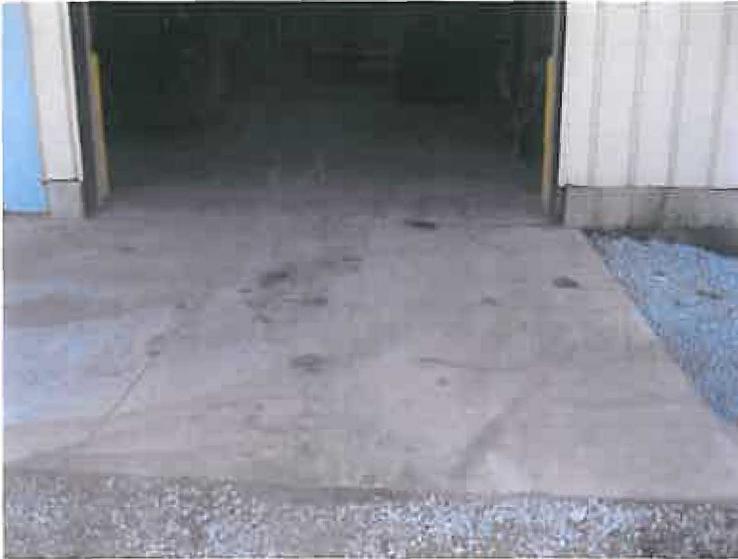
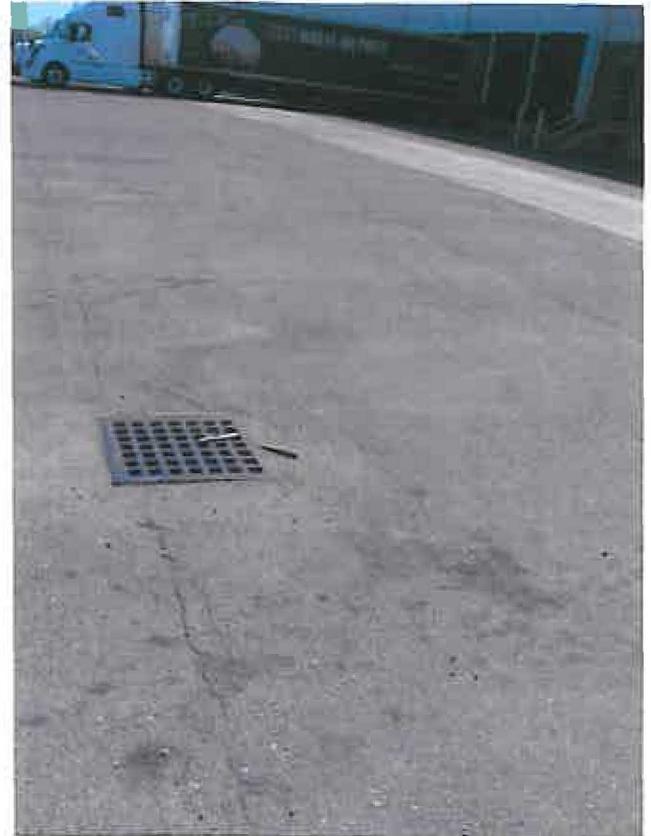
- **Staining on the pavement was observed outside the Maintenance Shop and along the loading docks of the Distribution Center.** If vehicles must be parked outside the Maintenance Shop to await repair, drip pans or absorbent pads should be placed under leaks to prevent pollutants from reaching the pavement. If leaks do fall onto the pavement, Oil Dri or other such absorbent should be used to clean up the material promptly. You may also want to consider installation of an oil and water separator to pretreat runoff from the loading dock area of the Distribution Center before it enters the detention basin. Vehicles should be inspected regularly to identify those that are leaking and need repair. Repair should occur promptly.

Fig 1 & 2. Stains indicative of leaking fluids from trucks and other motor vehicles were observed on the pavement outside the Vehicle Maintenance Shop (ABOVE) and all along the Distribution Center loading docks (RIGHT).

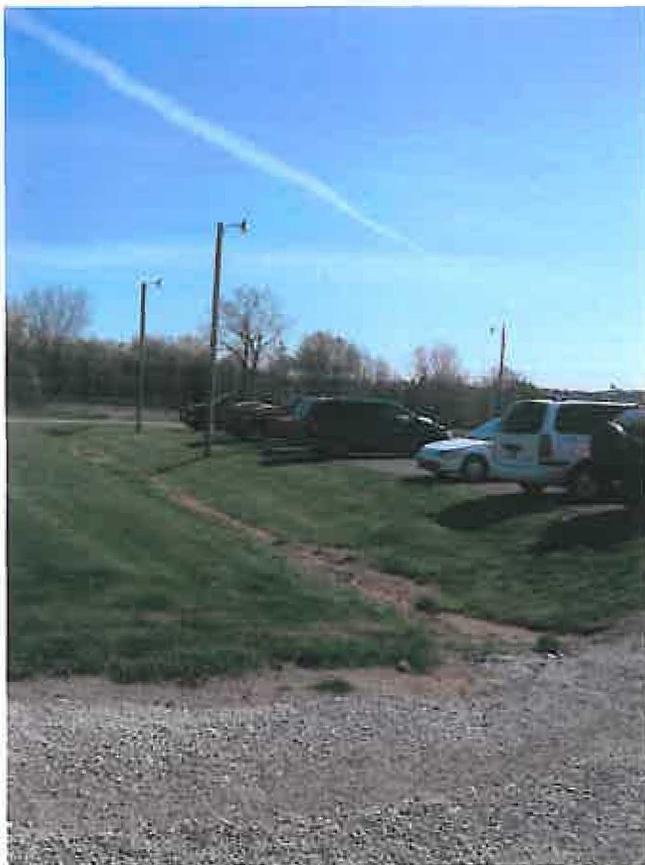
Fig 3 (LEFT). Erosion was evident in the drainage swale that leads to Outfall 001 (Drainage Area 1). Erosion control matting or rip-rap may be necessary to stabilize this drainage channel.

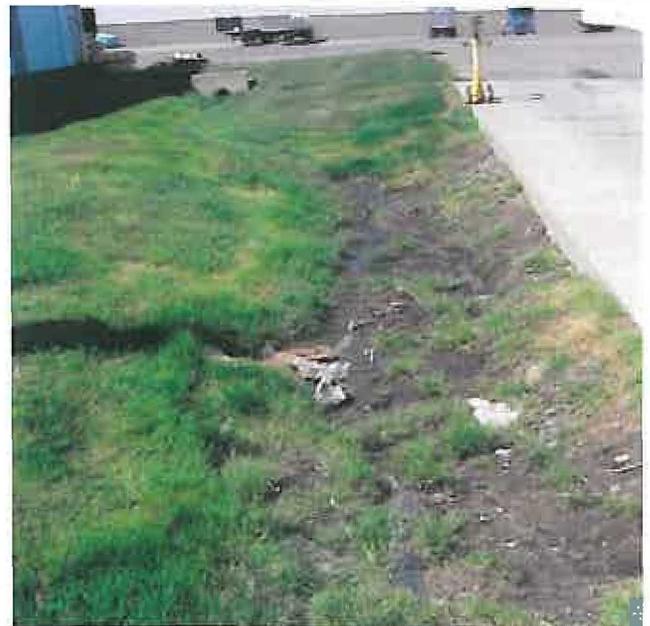
Fig 4 (ABOVE). Dark soils were observed in and around the West Fertilizer Building.

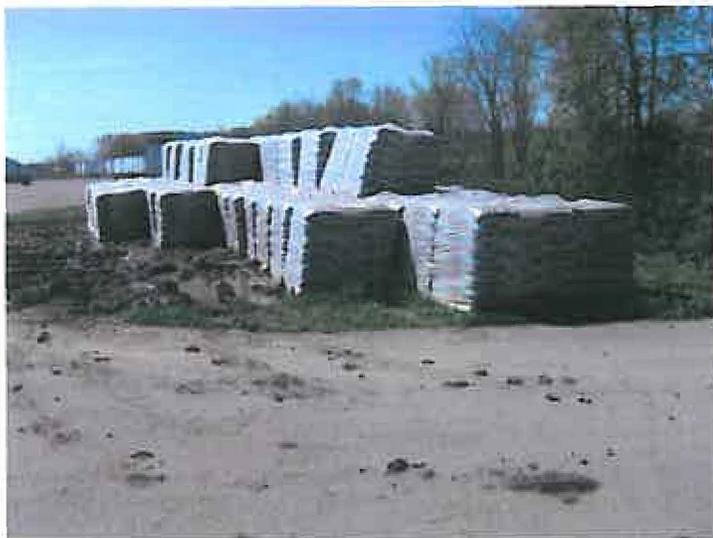
Fig 5 (ABOVE LEFT). A grassy area near the creek has been torn up by equipment. This area must be restabilized.

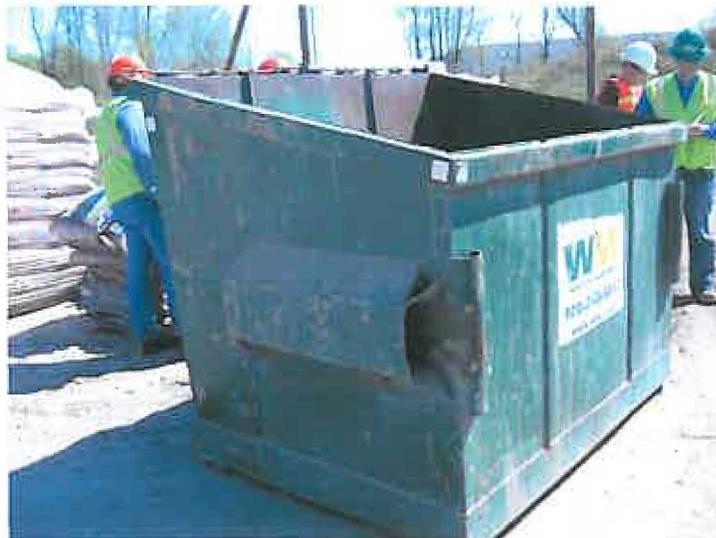
Fig 6 (ABOVE RIGHT). The lid on the trash dumpster in the Finished Product Storage Area was open at the time of inspection even though it was not in use.

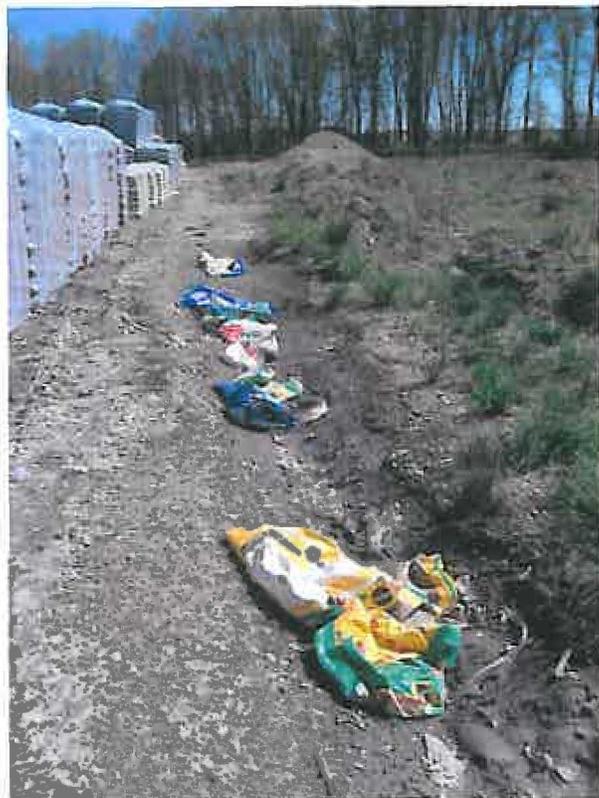
Fig 7 (LEFT). Trash and debris was observed along the south end of the Finished Product Storage Area and in the Wooded Area.

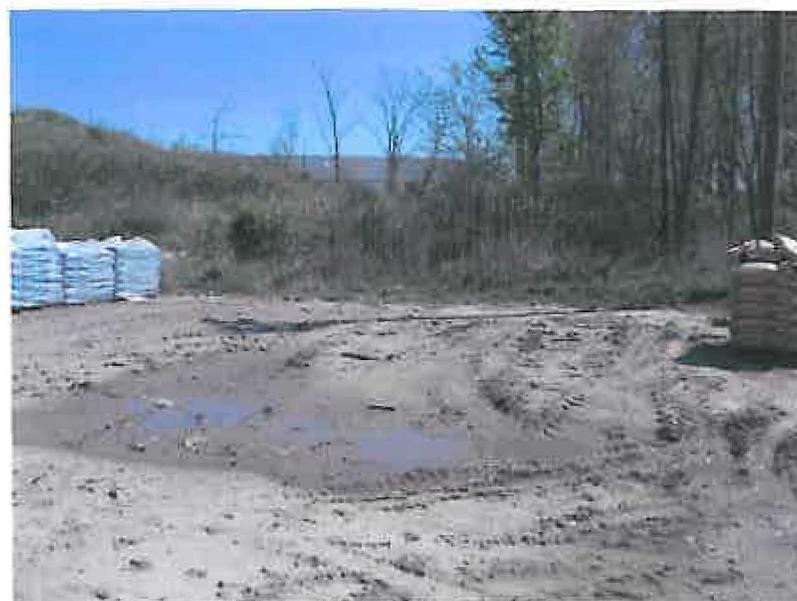
Fig 8 (RIGHT). Some portions of the Finished Product Storage Area do not drain to the storm water retention pond.

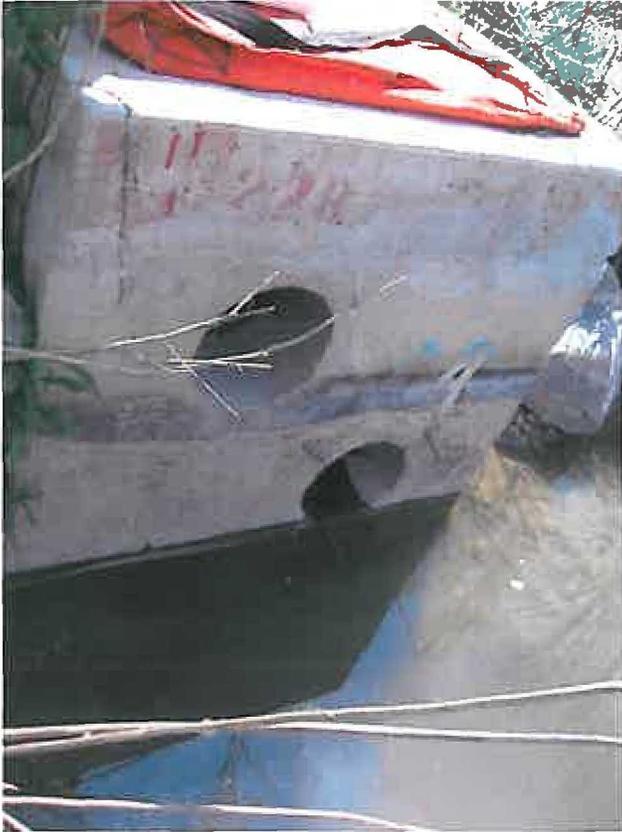
Fig 9 (LEFT). The 6-inch diameter lower orifice of the retention pond serving Drainage Area 6 appears too large to provide extended detention of the WQv.

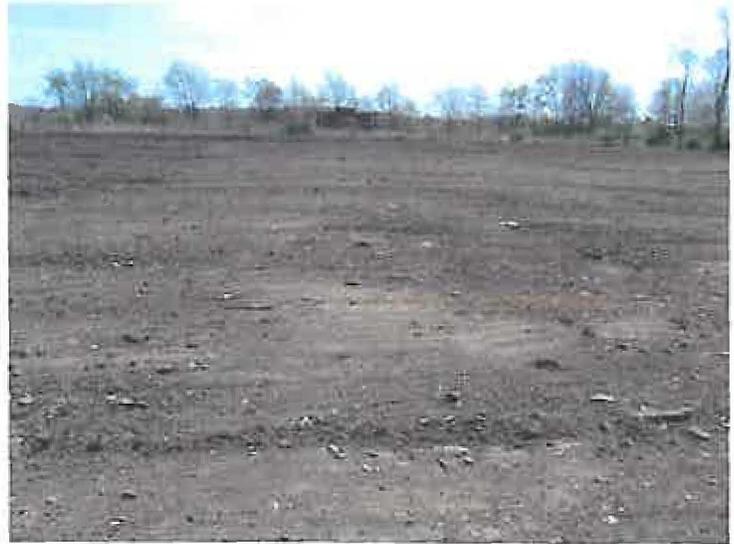
Fig 10 (ABOVE). The former Composting Area has been graded and now must be stabilized with seed and mulch.

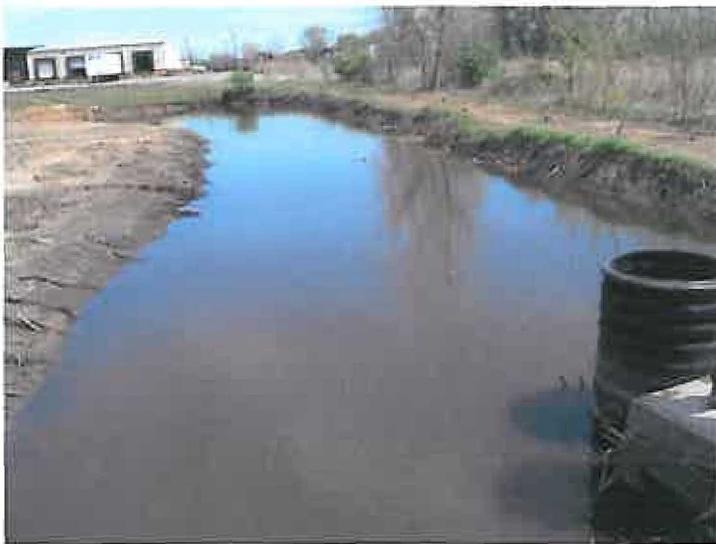
Fig 11 (LEFT). The sediment pond that serves Drainage Area 4 provides very little dewatering volume. The outlet structure does not draw water from the surface of the pond.

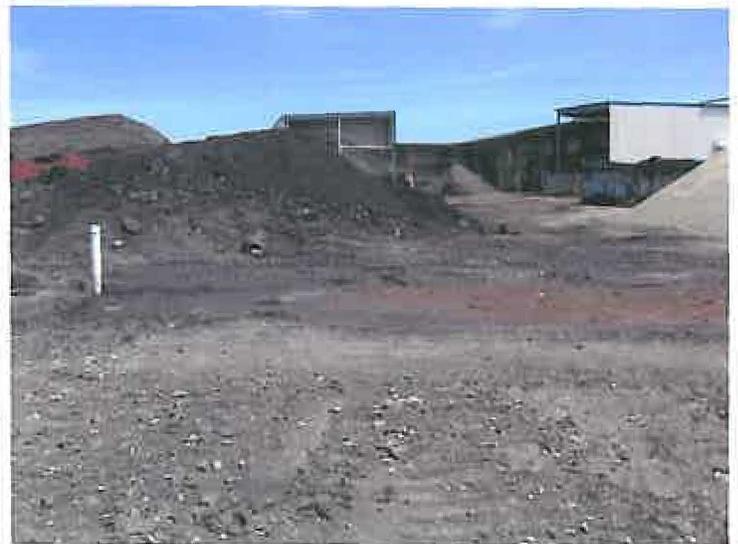
Fig 12 (RIGHT). Finished compost and peat humus are stored outdoors at the Growing Media Facility where they are prone to wind erosion. Runoff is directed to the sediment pond pictured in Fig 11 via surface flow and a subsurface drainage system (white pipe).

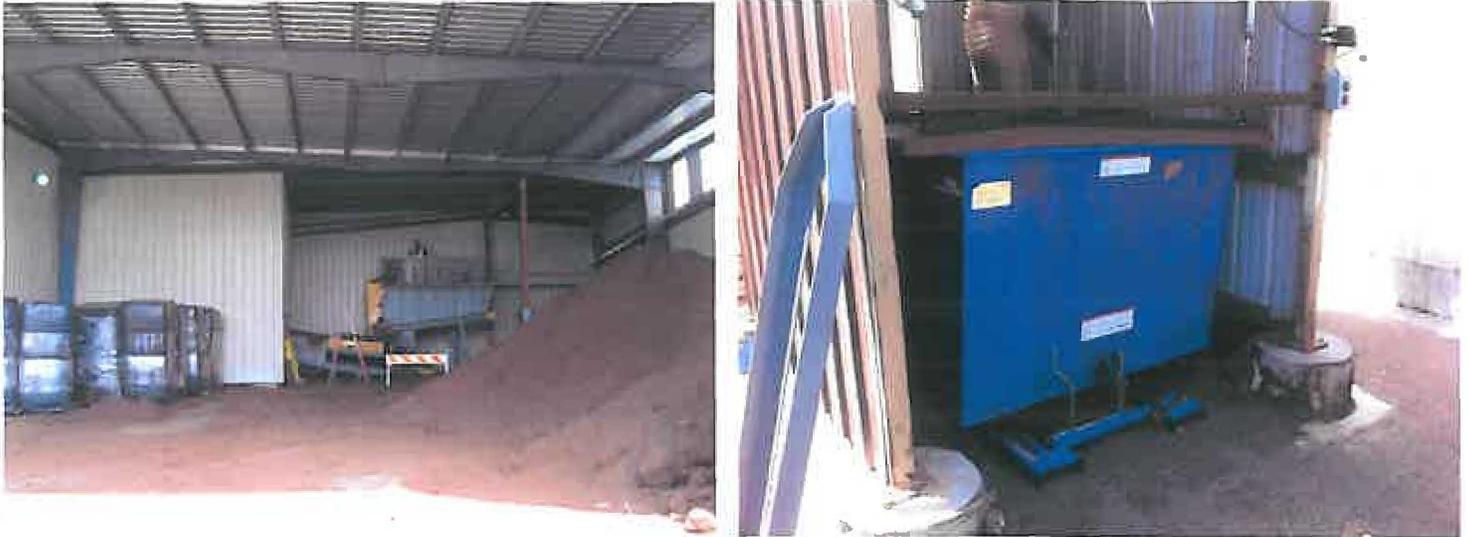
Fig 13 (LEFT). A roof has been built over the Fluffer to reduce windblown erosion of potting soils.

Fig 14 (RIGHT). Dust collectors (bag houses) have well-fitting solid lids, but it appears that there is still some spillage when collection bins are emptied. Employ good housekeeping practices to clean up spills promptly.

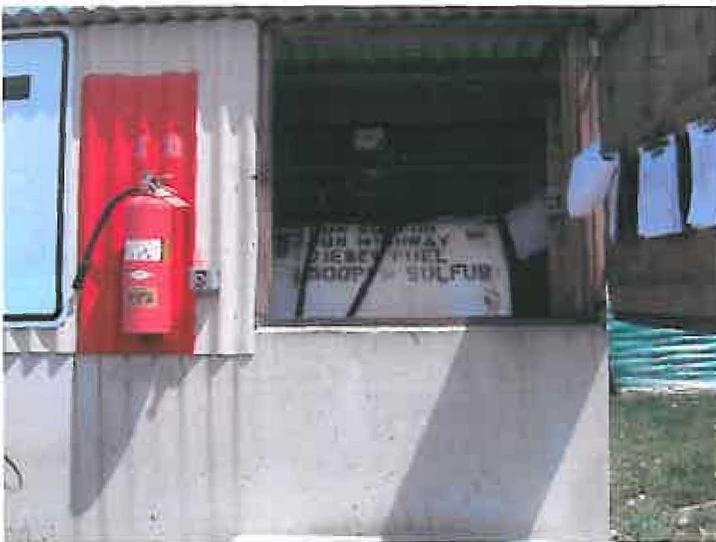
Fig 15. The fuel tank is kept within secondary containment and is covered with a roof.
