**Environmental
Protection Agency**

RE: SUMMIT COUNTY
CITY OF TWINSBURG
PFG
CONSTRUCTION STORM WATER

NOTICE OF VIOLATION

PFG
INSPECTION PHOTOS

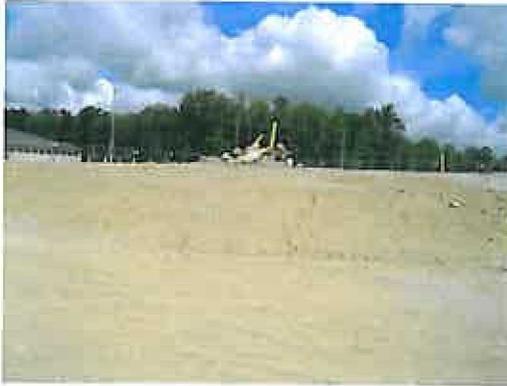
- There are rills forming in the dirt berms and piles. This shows that it has been untouched for a few weeks. The east diversion is draining to the road because it has not been seeded and mulched. This needs to be stabilized immediately.

Figure 1: Rills forming on the East side of the property.

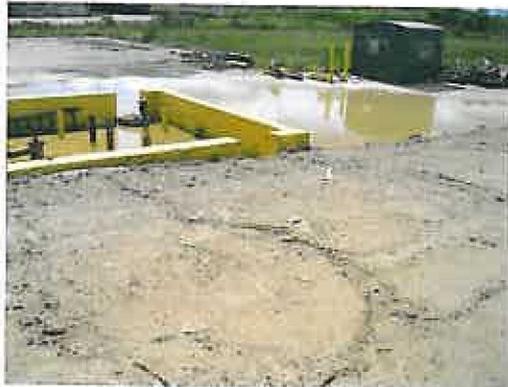
- There is no silt fence or silt sock on the east side of the property, as shown on the SWP3. Water is running off to the adjacent site.
- There is inlet protection missing on a catch basin to the west as well as the catch basin in the southeast corner of the site. These must have inlet protection on them while work is being done.

Figure 2: Rills forming on the East side and water flowing off of the site.

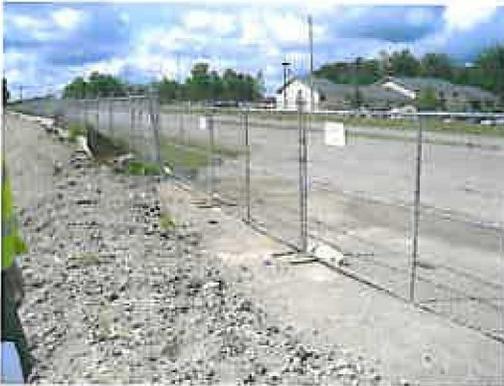
Figure 3: North side of site. Nothing preventing runoff to the street.

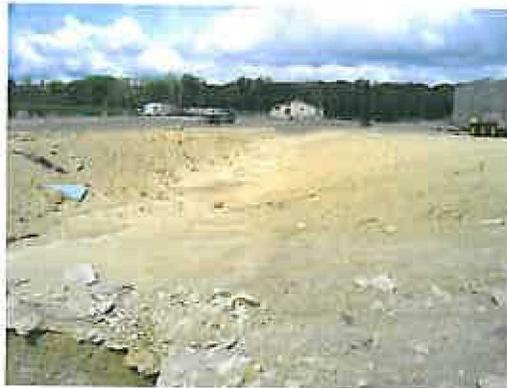
Figure 4: Sediment basin. Rills have formed on the sides. Full of trash and debris.

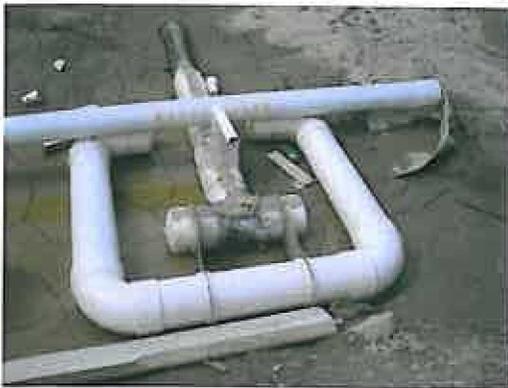
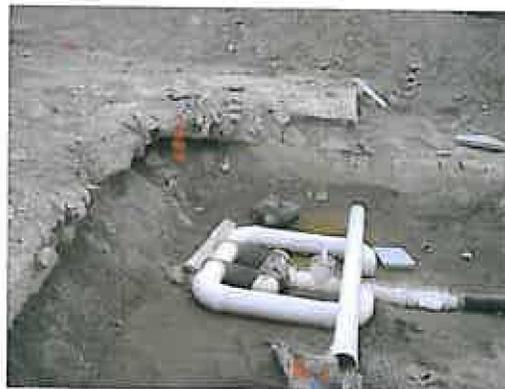
- The other catch basins that have inlet protection need to be cleaned and maintained. They are either filled with dirt or have holes poked into them.
- The sediment basin is full of trash and debris. The skimmer is clogged with trash and may be stuck in the mud. Clean this out and check to see if it works during the next rainfall. The skimmer should be set on a bed of gravel or rock to keep it out of the mud.

Figures 5&6: Skimmer clogged with trash and stuck in the mud. Sediment Basin full of trash.

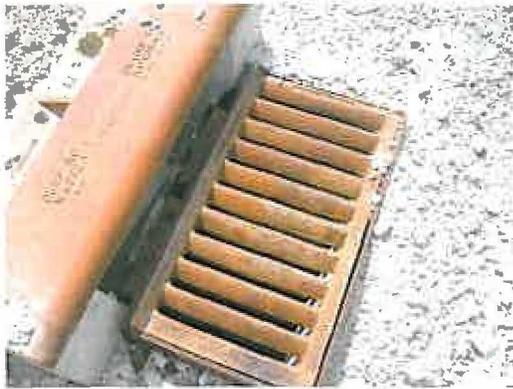
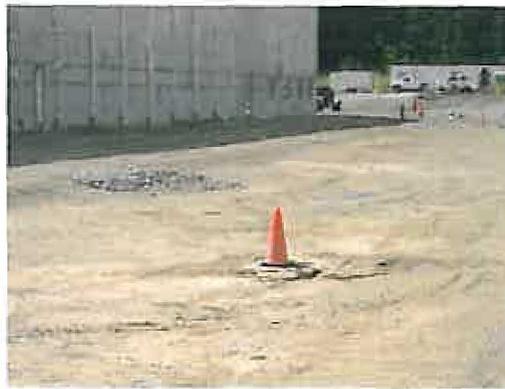
Figures 7&8: Inlet protection missing on several catch basins.

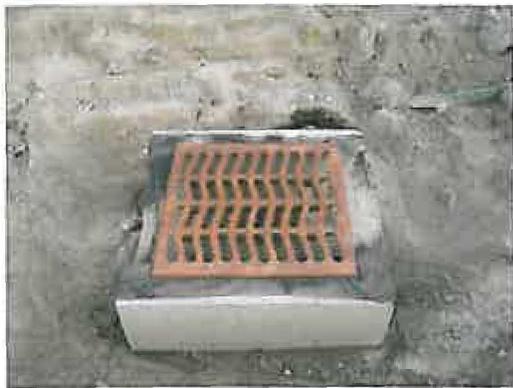
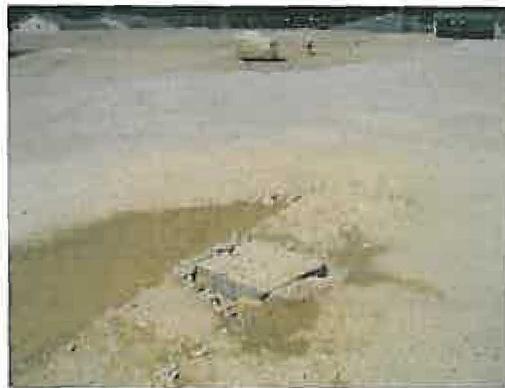
Figures 9&10: Inlet protection has worked but needs to be cleaned and checked for holes.

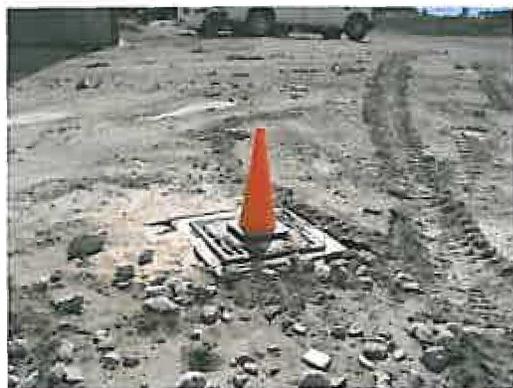
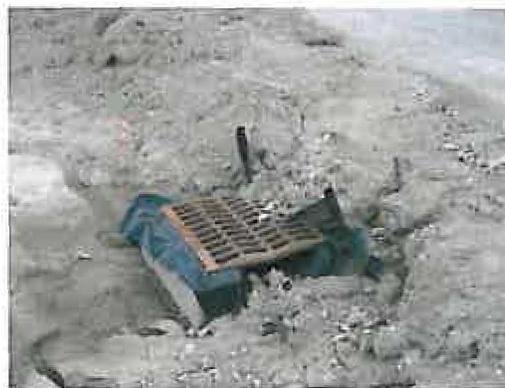
Figures 11&12: Inlet protection has failed and needs to be repaired or replaced.

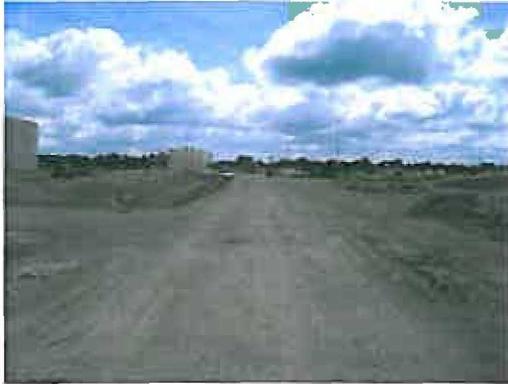
- On the road south of the sediment basin, there is nothing directing the water into the basin rather than the other side of the road. A water bar should be installed across the road.

Figure 13: Haul road. Nothing keeping the water from running off to the right. Water needs to flow to the left to the sediment basin.

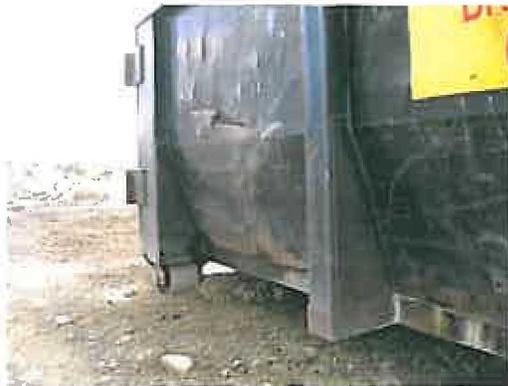
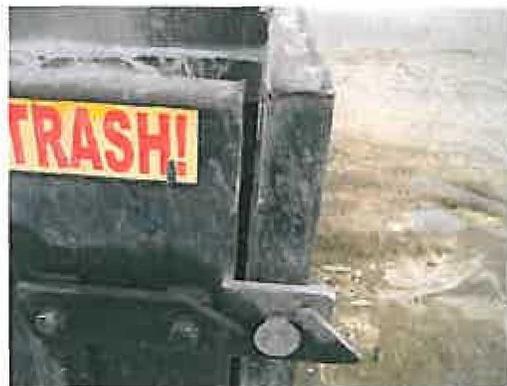
- The liner of the concrete washout bin has fallen down and the bin has several holes in it. Please fix the liner and replace the bin.
- The waste dumpster's door does not seal shut, allowing leachate to escape. Ask for a new dumpster from your dealer. As a good housekeeping practice, dumpsters should be kept covered.

Figure 14&15: Dumpster is in disrepair. Holes are visible. The door does not have a watertight seal.
