**Environmental
Protection Agency**

June 14, 2012

RE: LAKE COUNTY
CITY OF MENTOR
INDUSTRIAL STORM WATER
AEXCEL CORPORATION

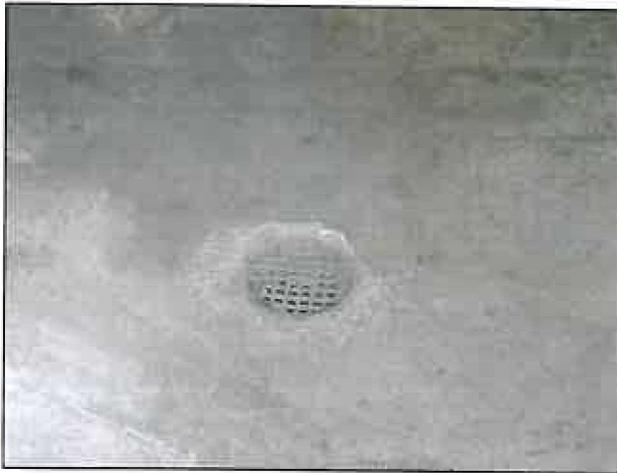
1. An inside floor drain next to the southwest receiving docks is not permanently capped (Figure 1). There is hazardous waste being stored near, but not immediately near the drain. The drain must be capped.

Figure 1 Floor drain next to southwest door to facility.

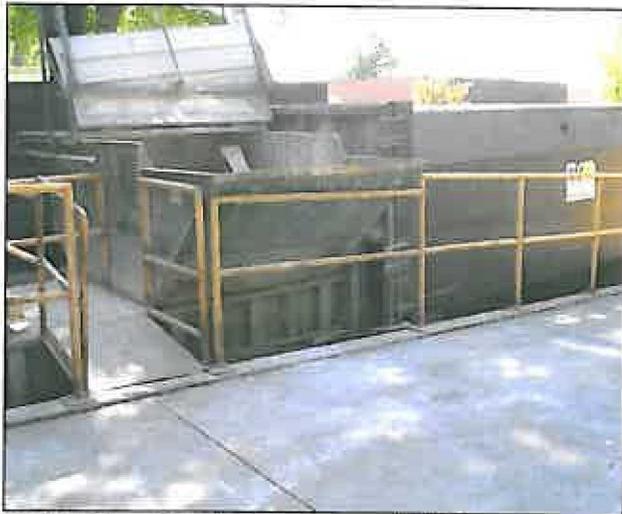
2. A spill kit is not available at the northeast loading docks. It is recommended that a spill kit be available in case any spill should occur.
3. There is staining under the trash compactor and the lid was left open (Figure 2). Be more careful when adding trash to the compactor making sure there is minimal spillage. The lid must be kept closed at all times, except when adding or removing trash occurs. Implement good housekeeping practices to clean up trash that spills outside the compactor.

Figure 2 Trash Compactor, Lid Open

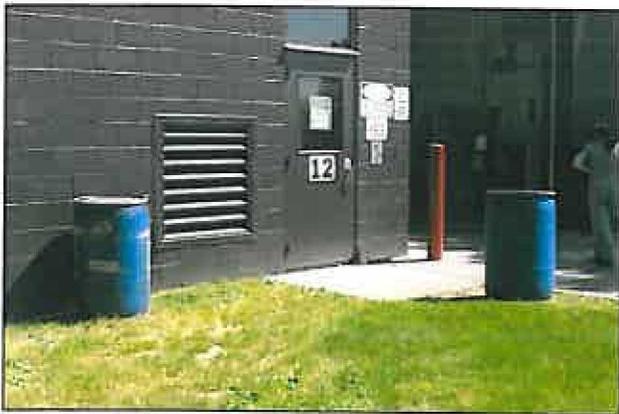
4. Rag drums are being stored outside the northeast door of the facility and were lidded (Figure 3). These drums should be added to the facility's list of pollutants in your Storm Water Pollution Prevention Plan (SWPPP).

Figure 3 Rag Drums

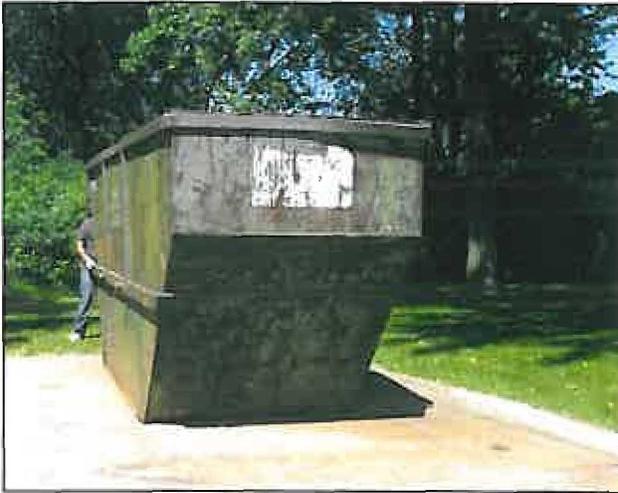
5. The scrap metal dumpster is uncovered (Figure 4). The dumpster must have a lid or tarp over it at all times except when adding or removing scrap occurs.

Figure 4 Scrap Metal Dumpster, Uncovered

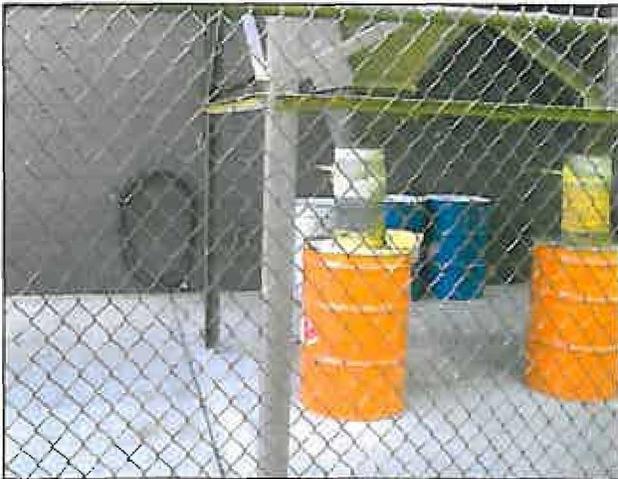
7. There is a water hose at the baghouse (Figure 5). Your SWPPP states that the dust from the baghouse is swept up. Do not use the hose to spray off the dust. That dust is a pollutant and should be swept up and put into the waste dumpster. You indicated that this is indeed your procedure.

Figure 5 Baghouse, Hose in Area

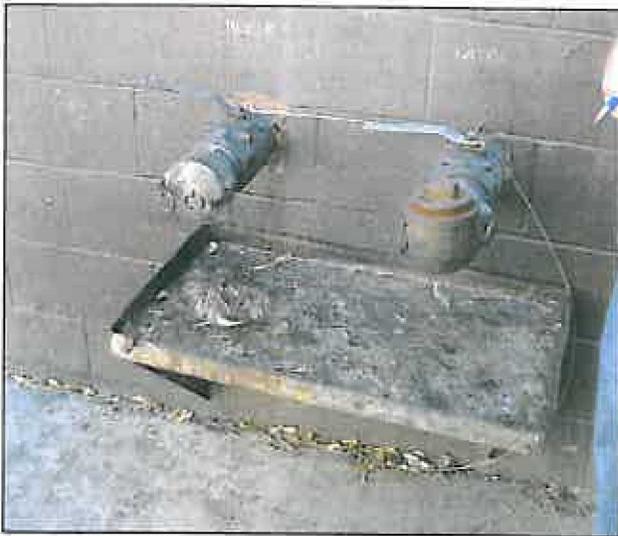
8. The resin and latex receiving dock, on the southeast corner of the building, has a drip pan under it (Figure 6). This is good, but the drip pan has not been cleaned out in a while. If it rains, the pollutants can splash or overflow onto the ground. There is staining on the ground around the dock, which indicates that there was leaking or overflow from the drip pan or during the chemical receiving process. The drip pan must be cleaned out immediately after any resin or latex has been loaded into the dock. It should be routinely checked for any leakage and cleaned up immediately. Spill prevention and response measures must be implemented to prevent resins and latex from spilling onto the ground during unloading.

Figure 6 Resin & Latex Dock, Drip Pan Needs Cleaned

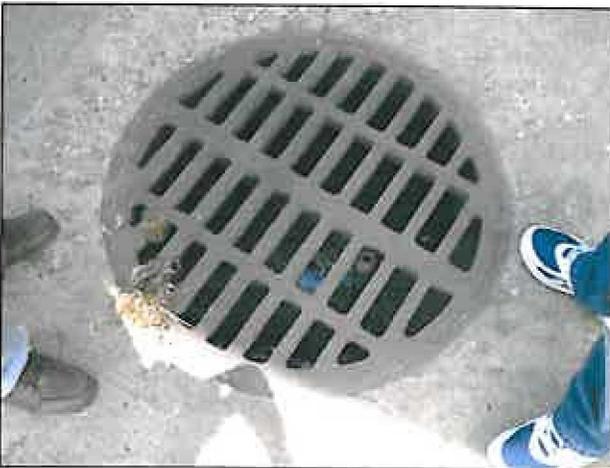
10. The facility indicates that valves in the storm water drainage system are all kept closed even during normal operations (Figure 7). But, in a heavy rain event, the entire area around the receiving docks, on the south side of the facility, floods and becomes like a swimming pool. When this occurs, the accumulated runoff is discharged, either by opening the valves or being pumped out. Ohio EPA cautions Aexcel Corporation that any pollutants that have spilled onto the pavement have been accumulating since the last time the runoff was discharged. The raw material storage area, the resin and latex docks, and the evaporating pool are contributing pollutants to the storm water that accumulates and is subsequently discharged. Processes and procedures to evaluate this storm water before it is discharged must be added to your SWPPP. This dewatering activity must be identified in the SWPPP as a potential pollutant source.

Figure 7 Valve Closed in Catch Basin
