June 21, 2012

RE: WAYNE COUNTY
CITY OF WOOSTER
INDUSTRIAL STORM WATER
FRITO-LAY INCORPORATED
3GR00288*EG

INSPECTION PHOTOS:
June 6, 2012
Wayne County

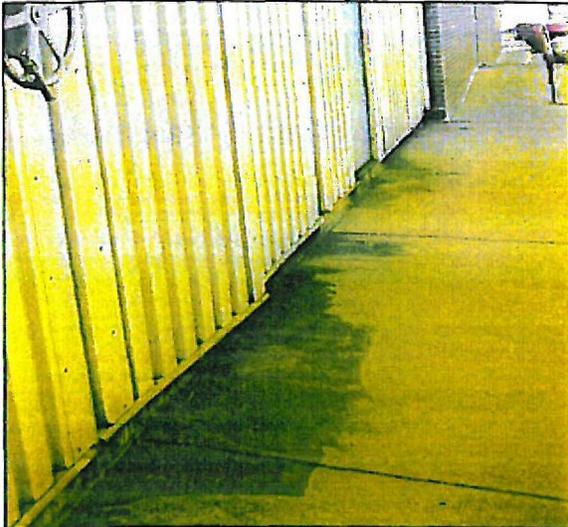
1. Oil from the heat exchanger, on the east side of the building, is leaking out of the doors (Figure 1). The facility has installed a berm inside of the doors to stop the oil from leaking out and to make sure the oil enters the adjacent trench drain that connects to sanitary sewers (Figure 2). A larger berm would be better. There is evidence that shows oil has spilled over the existing berm in the past. Air filters above the doors may be also be a source of storm water pollution here (Figure 3). They appear dirty and may need to be changed.

Figure 1
Vegetable oils spill stains from heat exchanger.

- Make aforementioned improvements to the heat exchanger problems.
- Provide containment at the potato conveyor system.
- Place an air filter in the air vent of the wastewater sludge room.
- Carry small loads of starch waste to the compost dumpster so to minimize spillage.
- Clean up spilled materials around compost dumpster.
- Cover the scrap dumpster with lid or tarp.
- Place an air filter in the corn dust room air vent.
- Take measures to prevent outflow of pollutants from the maintenance building garage door.
- Make aforementioned changes to the waste dumpster catch basin, CW19.
- Seed and mulch disturbed soil.
- Implement good housekeeping practices for oil leaks, spills, trash and debris throughout the facility.
- Add the auxiliary parking lot to your list of outfalls, and implement quarterly visual assessments to this outfall as well.
- Make aforementioned improvements to SWPPP.

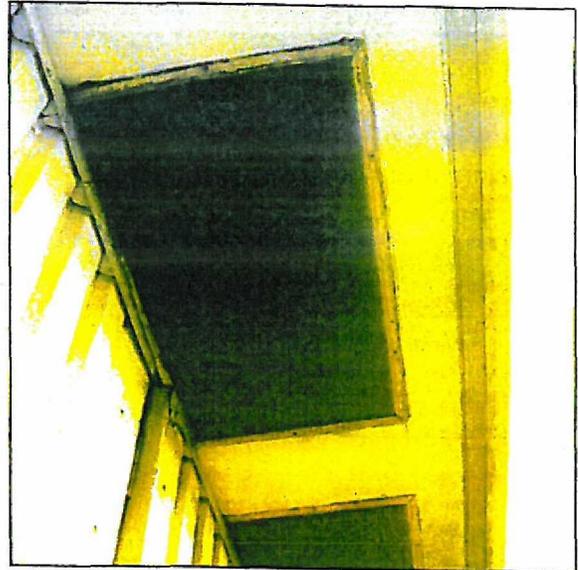
Figure 3
Heat exchanger air filters – dirty, need to be changed.

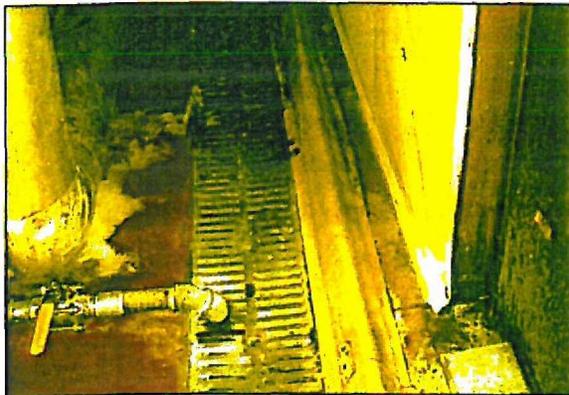
Figure 2
Berm and adjacent trench drain inside heat exchanger room.

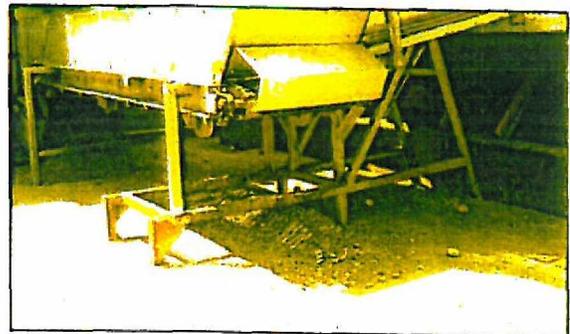
2. Piles of potato particulate are visible under the conveyor system of the potato unloading dock on the northeast side of the facility (Figure 4). This particulate, like sediment, is a pollutant to storm water. Placing a hopper under the conveyor system to catch the potato particulate should prevent the discharge of this pollutant to the storm water system.

Figure 4
Piles of potato particulate under conveyor system.

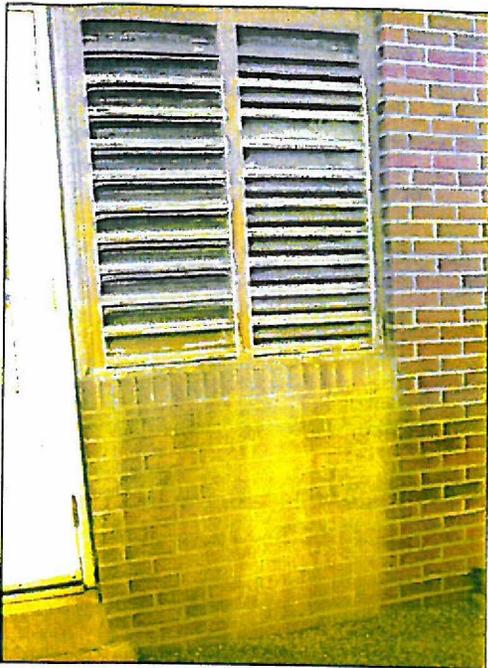
4. The air vent from the wastewater sludge room has evidence of staining on the wall and dust and debris on the vent (Figure 5). A finer screen may be required to catch the dust particles and prevent the dust from escaping. Implement good housekeeping practices to make sure the vent is cleaned regularly.

Figure 5
Wall stains from air vent.

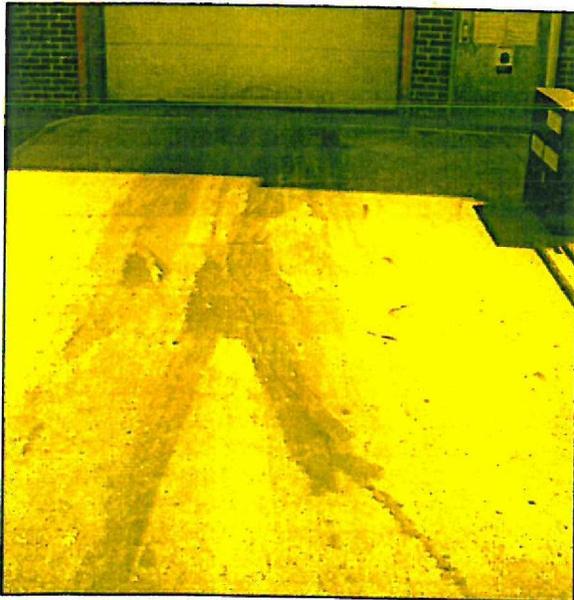
5. At the starch waste removal door, on the north end of the facility, there are black oil stains on the pavement exiting the garage door and towards the compost dumpster (Figure 6). Good housekeeping practices must be implemented to avoid dripping oil on the pavement or tracking oil outside. Do not carry a large load to the dumpster so to minimize spilling.

Figure 6
Stains from starch waste removal process.

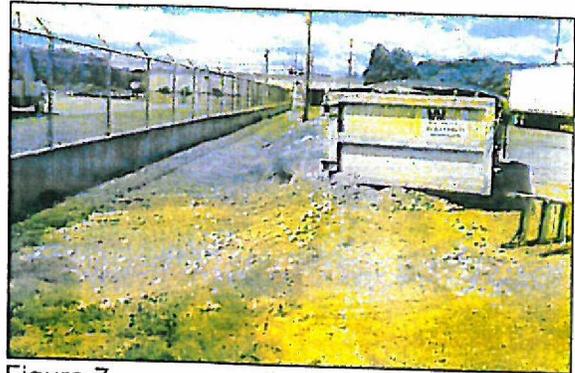
6. The compost dumpster is covered by a tarp, but there is compost on the ground all around the dumpster (Figure 7). Implement good housekeeping practices to keep the area around the dumpster clean. If materials are spilled in the transfer process, clean it up immediately. An additional compost dumpster or more frequent pick-up of the existing dumpster is also suggested.

Figure 7
Compost dumpster needs good housekeeping.

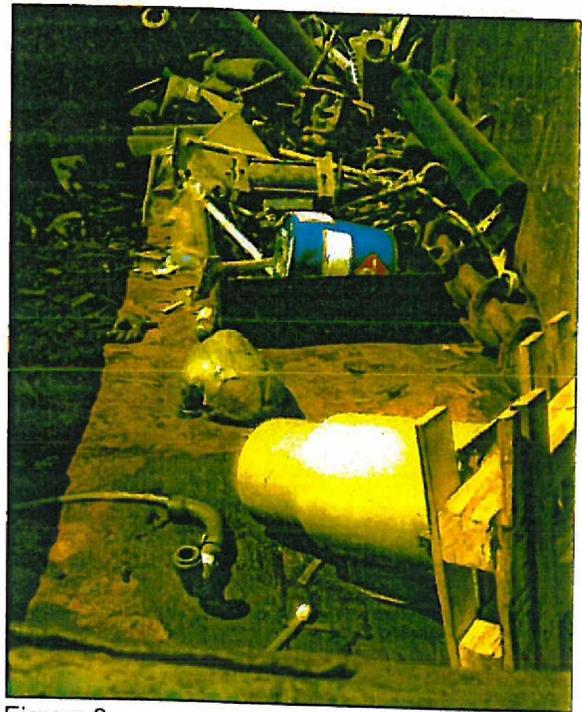
7. The scrap dumpster, by the compost dumpster, is uncovered (Figure 8). The dumpster should be covered to prevent the collection of storm water and the formation of leachates.

Figure 8
Scrap dumpster uncovered – oily parts inside.

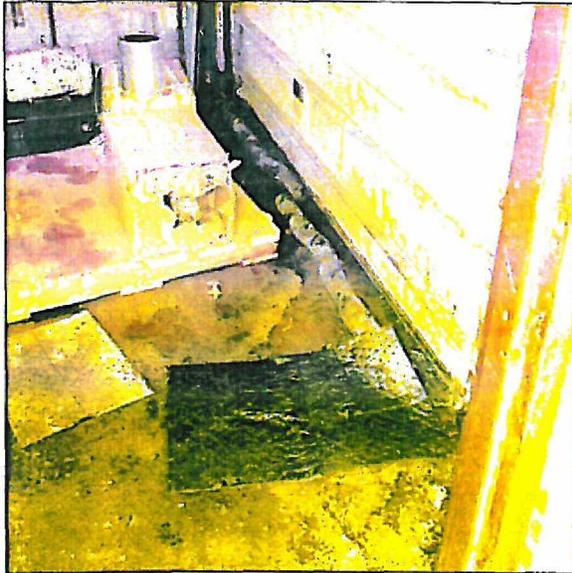
9. The maintenance building, next to the pump house, on the west side of the facility, has an excess amount of oils seeping out of the garage door (Figure 9). The facility indicated that drainage in this area is connected to sanitary sewers. Still, a berm or other measures should be installed inside the maintenance building so to prevent the flow from exiting outside.

Figure 9
Maintenance building - oils seeping out garage door. Must be bermed like heat exchanger room.

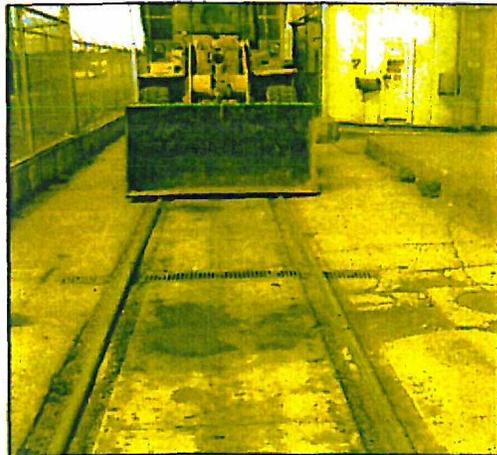
10. There is evidence of rail car leaks on the tracks (Figure 10). Good housekeeping practices must be implemented to quickly clean up the leaks immediately detected.

Figure 10
Oil stains from rail cars - Good Housekeeping!

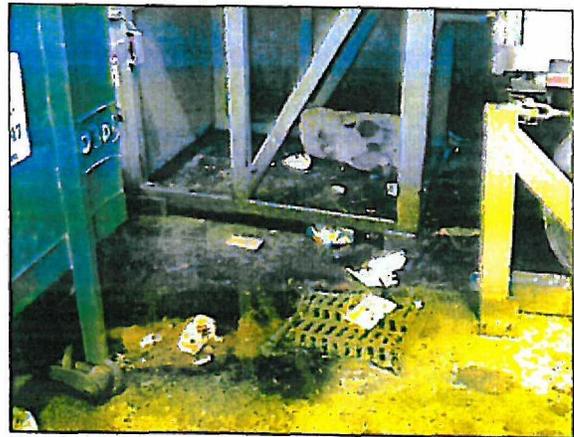
11. The waste dumpster and truck, on the west side of the facility, are leaking significant amounts of oils into storm water catch basin, CW19, right next to them (Figure 11). In manhole MHW2, there is evidence of oil getting in the system from the waste dumpster catch basin CW19 (Figure 12). The facility has installed a catch basin insert and other filters within the storm sewer system tributary to Outfall D to address this issue. Examining Outfall D, Ohio EPA did not see staining or other physical evidence that the pollutants are discharging into the unnamed tributary of Killbuck Creek, but we did detect the odor of cooking oil. The facility is advised to conduct more frequent visual observation of the discharge from Outfall D to determine if the measures taken are truly adequate. It should be noted that Ohio EPA observed this outfall during a period of dry weather. Observations during storm events may lead to other results. Discharges of cooking oil and other pollutants from the waste dumpster area are unacceptable. Additional measures that can be taken to address this situation include, but are not limited to, installation of an oil/water separator or other such treatment device, and re-routing CW19 to the sanitary sewer system. Looking at the site drainage map, Figure 3A in your Storm Water Pollution Prevention Plan (SWPPP), a sanitary line runs very close to the catch basin. Permission to reroute CW19 to sanitary sewers must be obtained from the City of Wooster and may require additional pre-treatment. The facility

Figure 11
Waste dumpster oil leaking into storm drain. Install oil/water separator.

should also determine the source of the oils in this area and see if additional source controls can be implemented.
