**Environmental
Protection Agency**

RE: CUYAHOGA COUNTY
CITY OF SOLON
ANCHOR INDUSTRIES INC
CONSTRUCTION STORM WATER

On June 6, 2012, I performed a compliance inspection for storm water best management practices (BMPs) at the above referenced site. While on site, I met with Carl Vasil, Superintendent of the site. Our records indicate that the Geis Companies have obtained coverage under the Ohio EPA General Storm Water National Pollutant Discharge Elimination System (NPDES) Permit for Construction Activities #3GC05880*AG.

INSPECTION PHOTOS

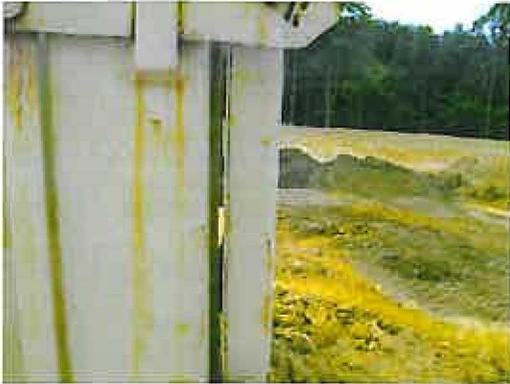
1. The dumpster's door does not seal shut. This may result in the discharge of pollutants due to leaks. Further, dumpsters should be covered and checked for holes when received. Replace dumpsters if they are not in good condition.

Figure 1: Garbage bin not covered and door not sealed

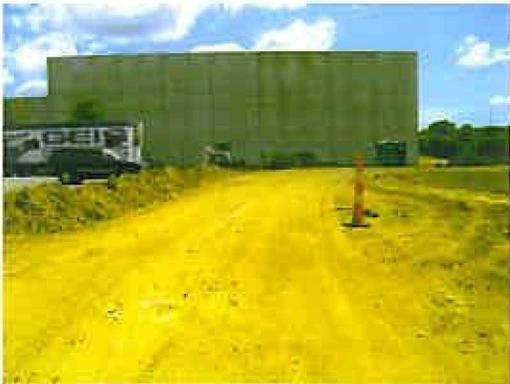
2. The construction entrance was not clearly defined. The asphalt roads were covered in sediment that had been tracked from the site. The entrance needs to be a rock construction entrance (RCE) as shown in the *Rainwater and Land Development* manual (see enclosed specification for RCEs). Good housekeeping is required to address off-site tracking.

Figure 2: A rock construction entrance has not been provided as indicated in the SWP3

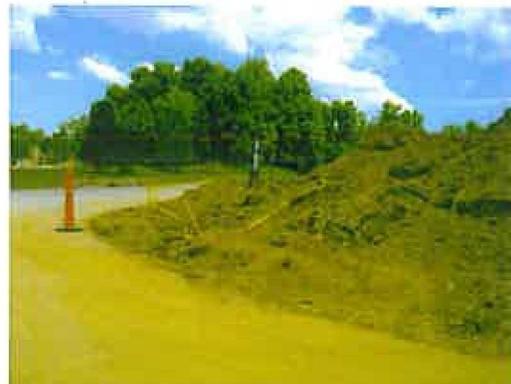
9. There are piles of soil on the northwest part of the site. These are not being protected by silt fences and sediment is going into the road. There are two catch basins on this road

Figure 3: Pile of dirt on the northwest side of the side. Sediment covering paved road

that all the sediment is running to. These do not have any inlet protection. A silt fence should be installed to stop this from happening.

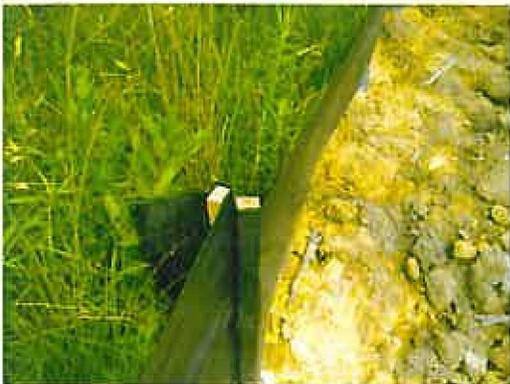
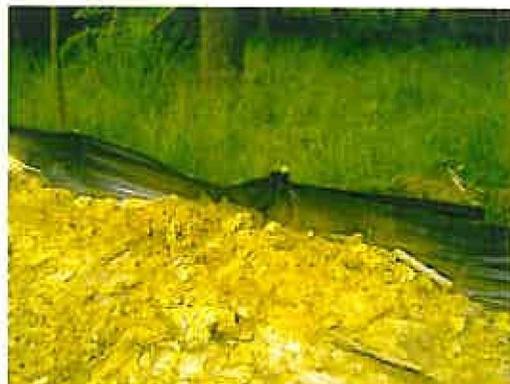
3. The silt fence along the site was not backfilled, which caused bulging of the fence and holes to form underneath. The joints of the fence need to be connected by twisting the stakes together before staking them into the ground, not overlapping them.

Figures 4&5: Silt fence joints not properly twisted together. Dirt piled up next to it leaving little ability for runoff to pond up against the fence and seep through the fabric

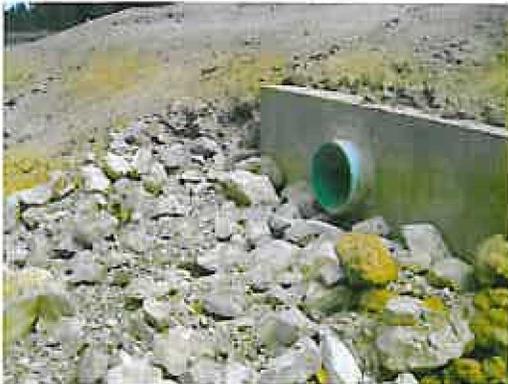
4. The outfall from the basin does not appear to have geotextile fabric underneath the rock rip rap. See the enclosed specification for rock outlet protection.

Figure 6: Outlet from the sediment basin onto the large mound on the west side.
Figure 7: Tree has fallen on the silt fence. This is where most of the water ponds.

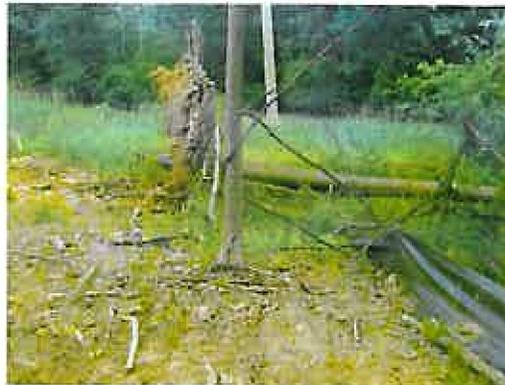
5. A tree has fallen on the southeast corner of the silt fence. This area is crucial since most of the water collects there. Please remove the tree and repair the silt fence.

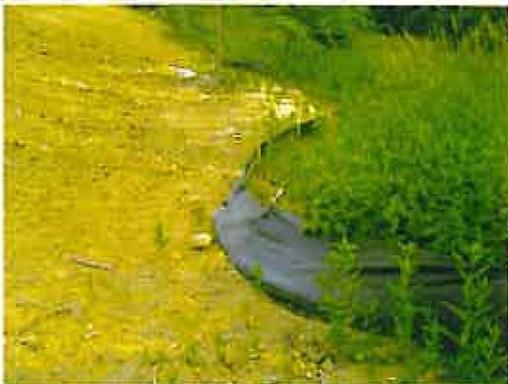
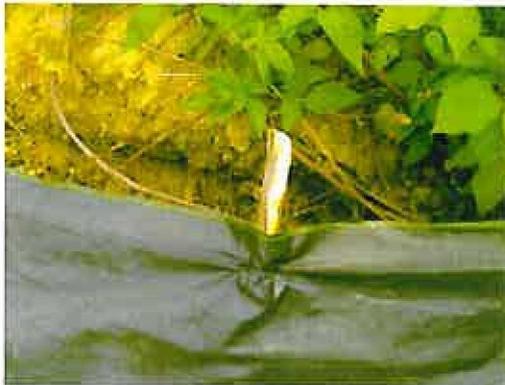
6. A little farther down the fence are sticks being used as stakes. These are not holding up the fence correctly. Please use appropriate staking for silt fence.

Figures 8&9: Silt fence falling over. Not backfilled. Sticks being used as stakes.

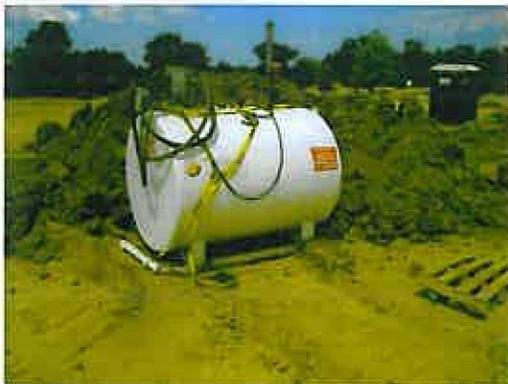
8. There is a petroleum tank on the site with no spill kit present. A spill kit should be on site at all times when there is fuel or other chemicals on site.

Figure 10: Large Oil Tank with no spill kit. Middle of the north side.

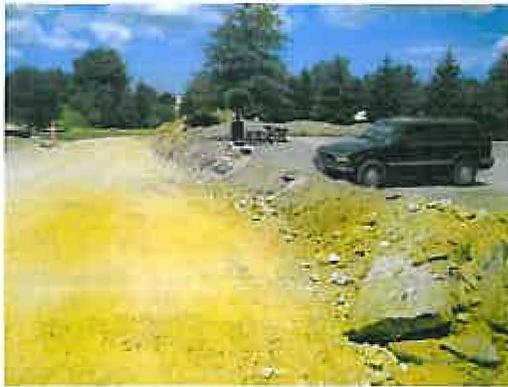
Figure 11: Construction entrance with berm on the north side next to the parking lot.
Figure 12: Parking lot catch basin with sediment flowing in.

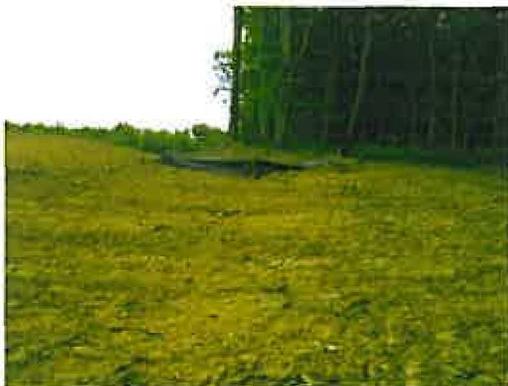
10. Concentrated runoff is occurring in the NW corner of the property. Mr. Vasil indicated that the contributing slope will be re-stabilized during the week of June 11-15. If this has not yet occurred, a sediment trap may need to replace the existing silt fence. Silt fence is not appropriate to control concentrated storm water runoff. These areas are show in the pictures below.
11. If areas disturbed by construction activity will not be reworked within 21 days of the last date they were disturbed, the NPDES permit requires temporary stabilization to be initiated within seven days of last disturbance. There appear to be areas of the site where temporary stabilization is appropriate.

Figure 15: Area one on the south side of the property. A small silt fence is trying to block a ditch's concentrated flow.
Figure 16: Area two on the east side of the property. Flow is being concentrated before reaching the silt fence below.
