**Environmental  
Protection Agency**

June 27, 2012

RE: CUYAHOGA COUNTY  
CITY OF SOLON  
SOLON VILLAGE  
CONSTRUCTION STORM WATER

**INSPECTION PHOTOS**

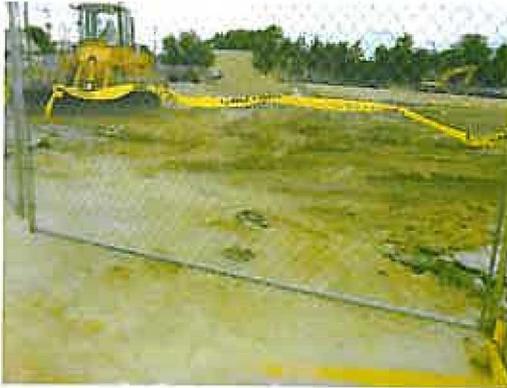
3. There is a second construction entrance. It has been improperly constructed. The inlet protection on the nearby catch basin to account for this is also improperly constructed (see enclosed specification from *Rainwater and Land Development, Ohio's Standards for Stormwater Management, Land Development and Urban Stream Protection* (Ohio Department of Natural Resources, 2006, for proper construction of inlet protection within paved areas). The second entrance must be closed off or made into a proper construction entrance. Adding a construction entrance would require an amendment to the SWP3 to show its location.

**Figure 1:** The second construction entrance that was not called for.  
**Figure 2:** Nearby catch basin without proper inlet protection

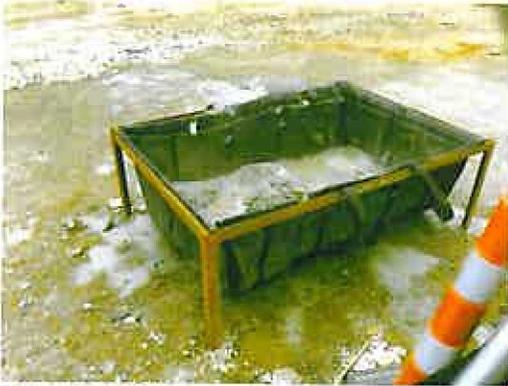
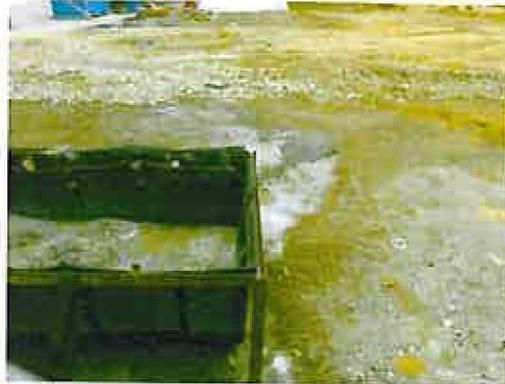
4. The concrete washout area was not where it was supposed to be on the plan. It is also not the design that the SWP3 called for. Concrete washout pits must ensure that washwater is contained and kept on site. Washwater cannot be discharged into storm drainage systems.

**Figures 3&4:** Concrete washout pit. Note that it does not provide containment for washwater.

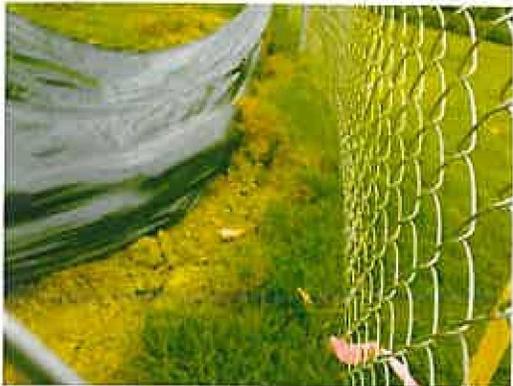
5. The silt fence was not properly trenched and backfilled; shown by the bulging of the fence (see Fig 5). Please repair the silt fence per specifications contained in the SWP3.

**Figure 5:** Silt fence not trenched and backfilled.

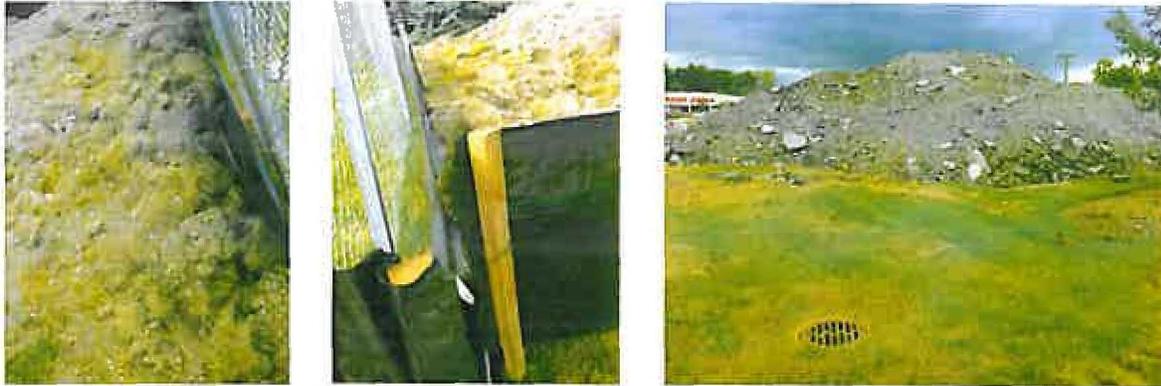
6. The southwest silt fence next to the stock pile was also not trenched and backfilled. The stock pile is also pushing against the fence. A buffer needs to be kept between the pile and the fence to ensure proper ponding.
7. There is an asphalt pile on the site that was not called for in the SWP3. This must be taken off the site and disposed of properly.

**Figures 6&7:** Soil stock pile too close to silt fence. Silt fence joints not twisted together.  
**Figure 8:** Asphalt pile

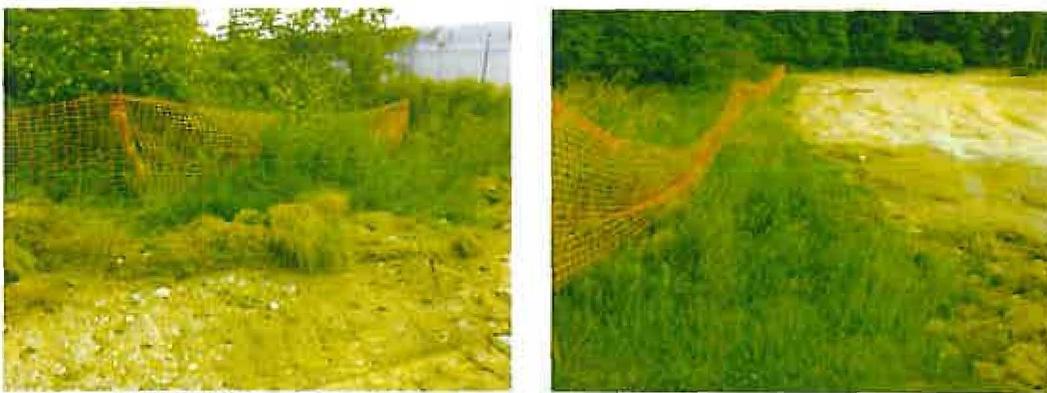
8. There is no silt fence around the wetlands even though that is what was called for in the SWP3. Please install the silt fence per SWP3.
9. There is an area of disturbance along the southern edge of the existing shopping center where soil has been pushed onto the pavement. This has resulted in sediment being discharged to existing catch basins. Due to the limited nature of disturbance and potential concerns with ponding around the catch basin, we recommend that the disturbed area be re-graded to drain back onto the construction area, or the disturbed area be temporarily stabilized (Fig 11 & 12).

**Figures 9&10:** Orange fence along wetlands without silt fence.

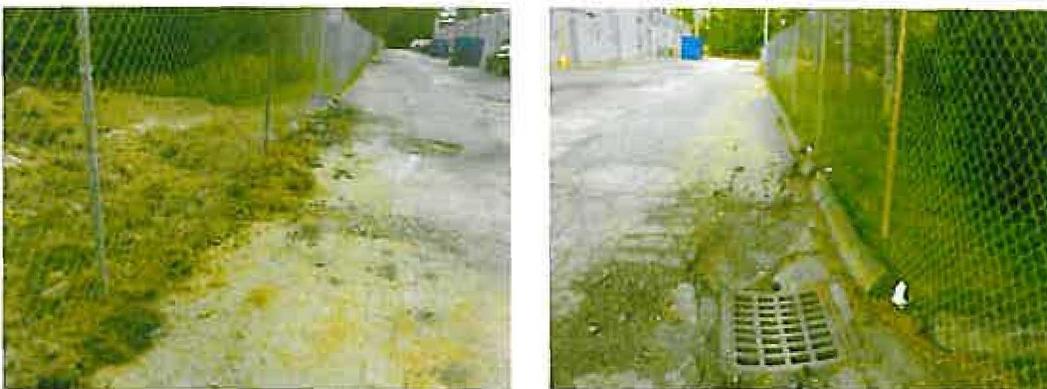
**Figures 11&12:** Dirt being pushed onto pavement. Sediment running to nearby catch basin.

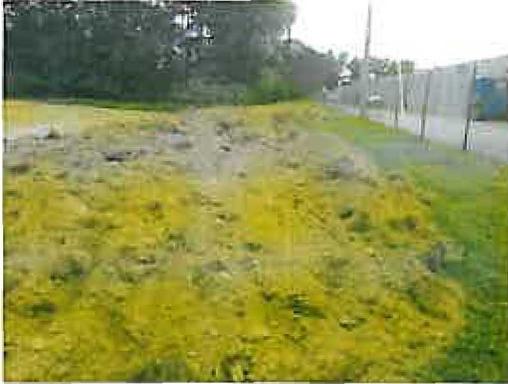
**Figure 13:** Northern dirt wall

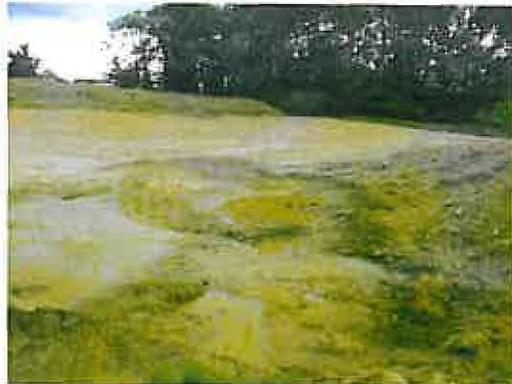
12. The SWP3 calls for silt fence along the eastern perimeter. This has not been installed. However, as graded, runoff appears to concentrate in the NE corner of this work area. The drainage area appears to be larger than is allowable for silt fence. A sediment trap may be more appropriate, at least during this initial phase of construction. Please consult with your project engineer to determine a proper course of corrective action. A BMP is needed here to protect wetlands and downstream drainage systems.

**Figure 14:** Northeast corner of the property. All water flows here.

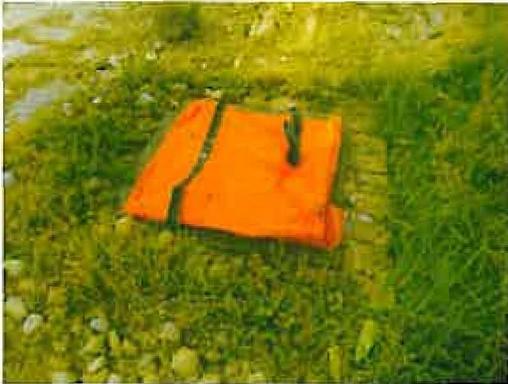
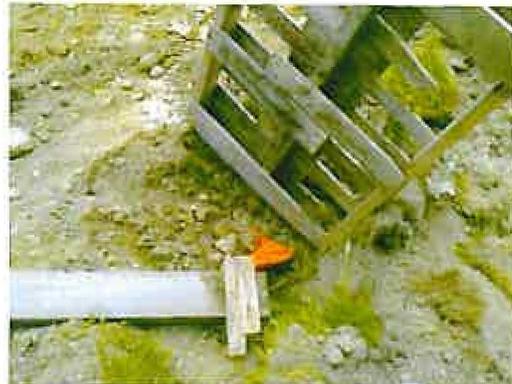
11. Storm drain inlet protection has been installed on existing catch basins within this area, but some require maintenance. Please repair or replace so no sediment can get into the storm sewer.

**Figures 15&16:** Existing catch basins with failing inlet protection.

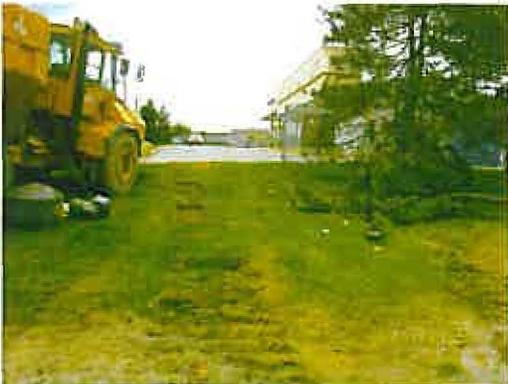
the SWP3. In addition, we noted that there is a second gate in the SW corner of the existing shopping center that is being used for site access. An RCE has not been installed here either. If you intend to keep using this as a construction entrance, the SWP3 must be amended to show an RCE in this location and it must be built per specifications contained in the SWP3.

**Figure 17:** Unplanned entrance on the northwest side

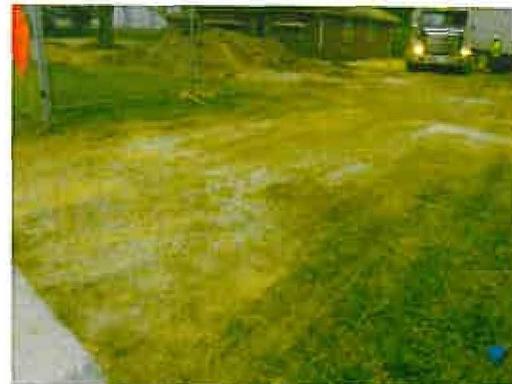
**Figure 18:** Construction entrance not built correctly

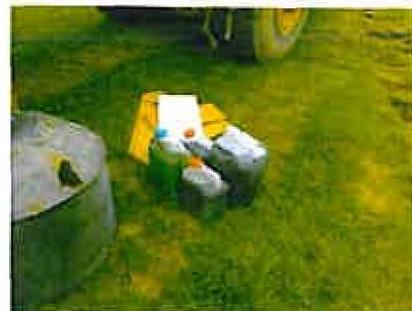
15. There were containers of antifreeze and other petroleum products on the ground. These must be stored inside or within secondary containment. Spill kits should be kept on site to clean up spills if they occur.

**Figure 19:** Unmarked liquids. Petroleum products.
