**Environmental
Protection Agency**

RE: LAKE COUNTY
CITY OF MENTOR
FRESENIUS MEDICAL CARE
CONSTRUCTION STORM WATER
PERMIT NO: 3GC05801

NOTICE OF VIOLATION

INSPECTION PHOTOS

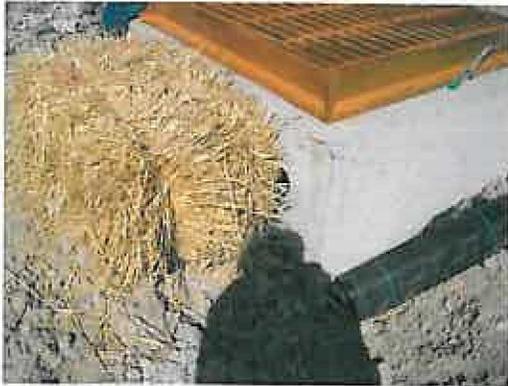
2. A straw bale has been placed across an opening on the side of the middle catch basin along Tyler Boulevard. Straw bales are not an approved form of storm drain inlet protection. Please refer to the SWP3 for your options on how to properly construct storm drain inlet protection around this catch basin.

Figure 1: Catch basin along Tyler Boulevard with only hay blocking the hole.
Figure 2: Incorrectly built inlet protection

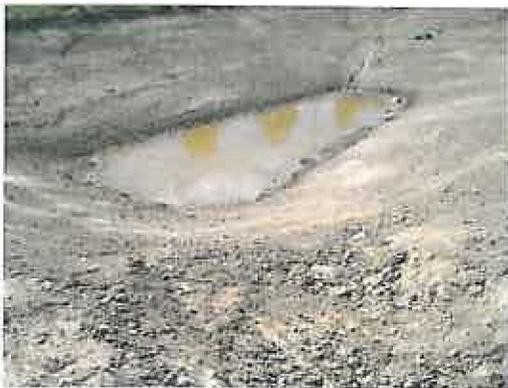
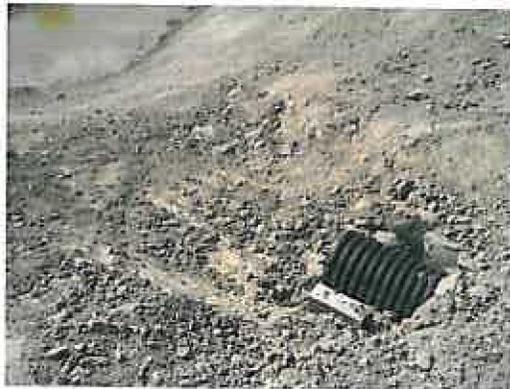
1. Although the pond has been constructed in the location shown on the SWP3, the contractor has installed the permanent outlet structure and not the temporary structure needed for sediment control during construction. The pond does not provide a sediment control function without the temporary outlet. Further, it was noted that the riser pipe outlet detail shown on the SWP3 as the sediment control outlet is out of date. Please refer to the *Rainwater and Land Development* manual (Ohio Department of Natural Resources, 2006) for the current specifications and Part III.G.2.d.ii of the NPDES permit for current design requirements for sediment basins. Amend the outlet design as necessary to comply with the NPDES permit. Sediment basins are required to be installed within seven days of first grubbing and prior to grading the area they will control. Thus, the outlet structure should have been installed quite some time ago.

Figures 3 & 4: Sediment basin with improper outlet structure

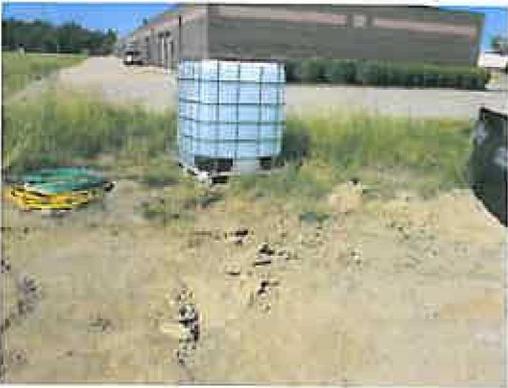
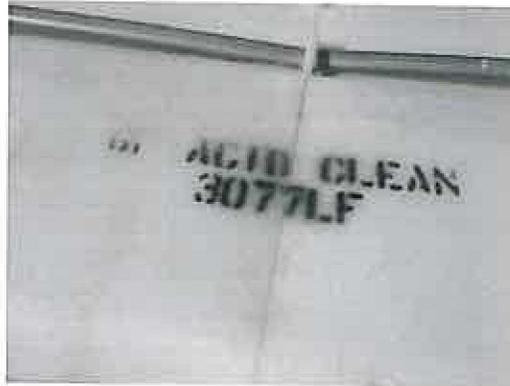
3. There is a container marked "acid clean". This is a hazardous material and must be stored within secondary containment. A spill kit should be available on site and spill response procedures should be noted in the SWP3.

Figures 5 & 6: Container marked "acid clean"

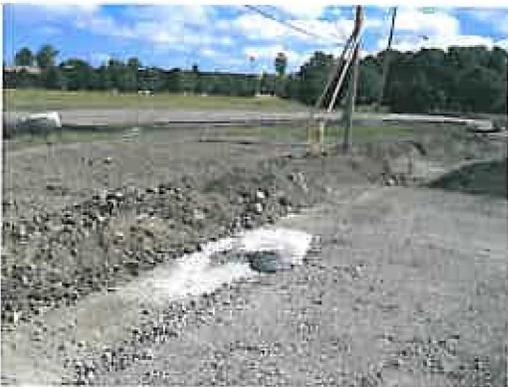
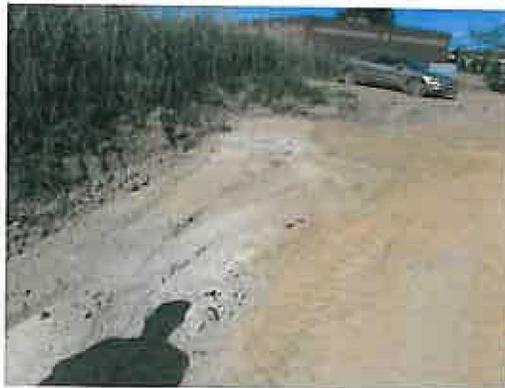
4. Mortar and concrete have been dumped on the ground. A washout pit should be provided on site to ensure these materials do not enter the storm water drainage system. Practice good housekeeping and clean up materials immediately after spilling. Solid waste should go into a dumpster or be otherwise properly disposed.
5. Disturbed areas expected to remain idle for 21 days or longer must be temporarily stabilized between construction operations. Temporary stabilization must be initiated within seven days of last disturbance. Please review your site on a weekly basis and determine which areas will require temporary stabilization and ensure that they are seeded and mulched by week's end. Part III.G.1.m of the NPDES permit requires you to keep a log documenting grading and stabilization activities to document compliance with this provision of the NPDES permit.

Figures 7 & 8: Dumped or spilled mortar and concrete
