**Environmental
Protection Agency**

RE: LAKE COUNTY
MADISON TOWNSHIP
MADISON MIDDLE SCHOOL
CONSTRUCTION STORM WATER
PERMIT NO: 3GC05366

NOTICE OF VIOLATION

Madison Middle School

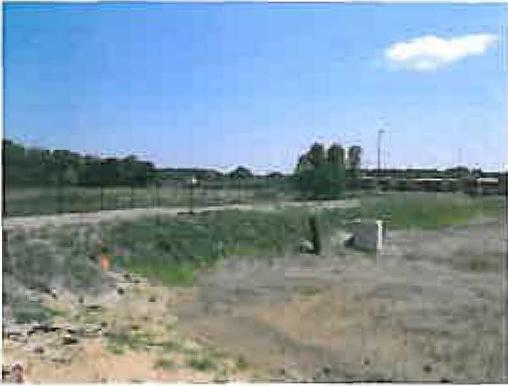
Figure 1: Outlet structure and well pipe for sediment basin

1. The sediment basin currently has a well pipe installed. Please remove this pipe.
2. Batteries and other harmful materials are being kept outside. These items should be kept inside to avoid contact and possible contamination of water.

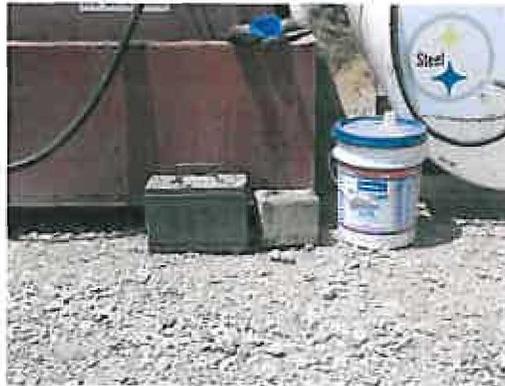
Figure 2: Batteries left outside

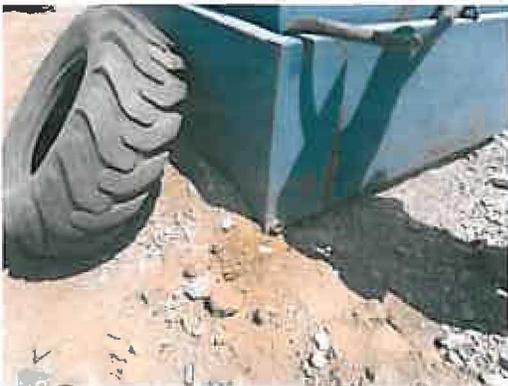
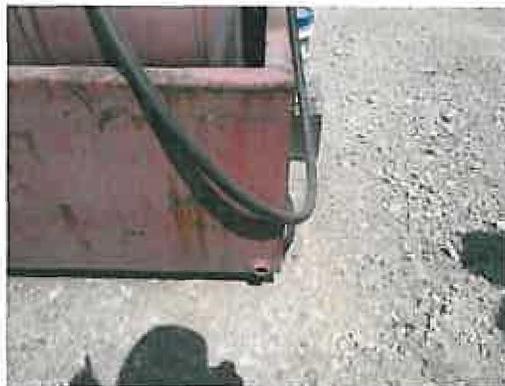
Figure 3&4: Fuel containment dykes missing the plug

3. The fuel containment dyke is missing the plug. Please replace the missing plug to ensure a sealed container.
4. There are several oil spills on site. All contaminated soils must be disposed of in a solid waste dumpster. To prevent spills from occurring, regular checks of equipment should be done to ensure proper functioning. If a leak is inevitable, a drip pan should be placed underneath the equipment to contain the oil.

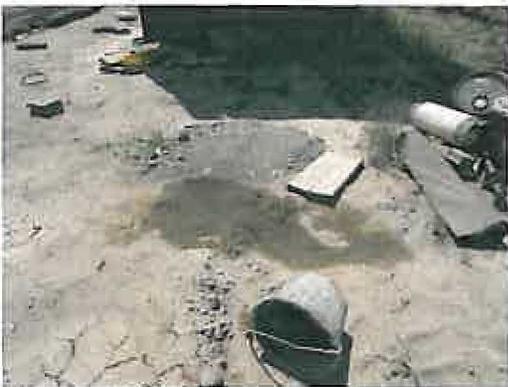
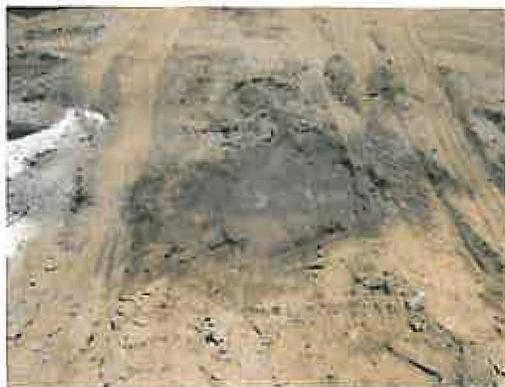
Figures 5&6: Oil spills on ground

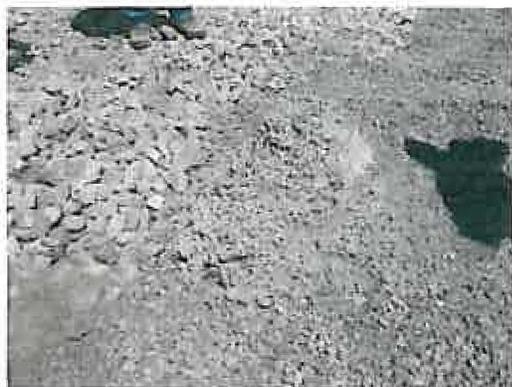
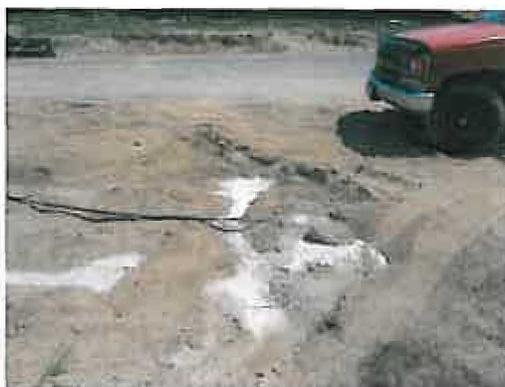
Figures 7&8: Concrete washed out onto the ground

5. Concrete washings have been dumped onto the ground. This material is not permitted to be discharged into offsite bodies of water or the storm sewer. Please clean this up and direct all concrete washings to the provided concrete washout pit. The concrete washout pit is full and the liner has ripped in several places. The pit needs to be cleaned out and a new liner needs to be placed.

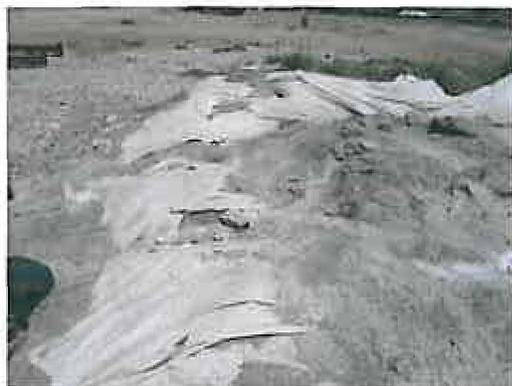
Figure 9: Concrete washout pit is overflowing and the liner is ripped
Figure 10: Mortar mixing area; should be contained

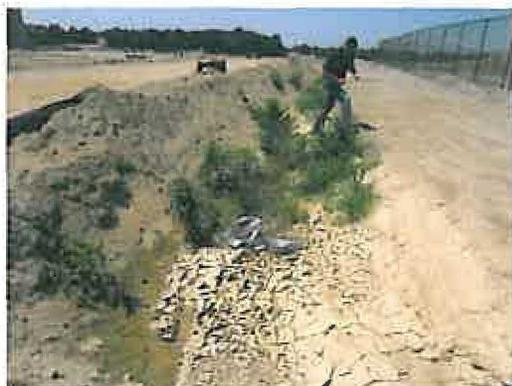
Figure 11: Trash and debris on the site

7. Trash and debris have been disposed of on the ground. Please clean up any waste and dispose of it properly.

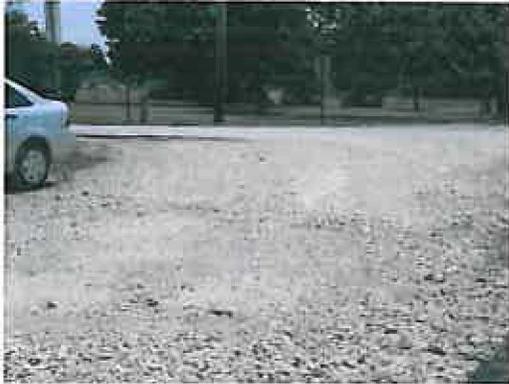
Figure 12: Redress construction entrance

8. The construction entrance needs to be redressed to reduce offsite tracking.
9. The access roads along the back of the site near the bus parking lot are very dusty. The dry weather and soil conditions have made the site extremely dusty. Installing rock construction entrances before the pavement and laying rock along access roads would reduce the amount of dirt that gets kicked up and tracked offsite.
10. Seeding has taken place on all soil left undisturbed for more than 21 days. However, due to the hot, dry weather, the seed has not taken fully. Watering of the seed may be required to achieve germination and subsequent grass growth. If 70% growth density is still not achieved, seeding and mulching may need to occur again. I was informed that seeding would be taking place again in the next week.

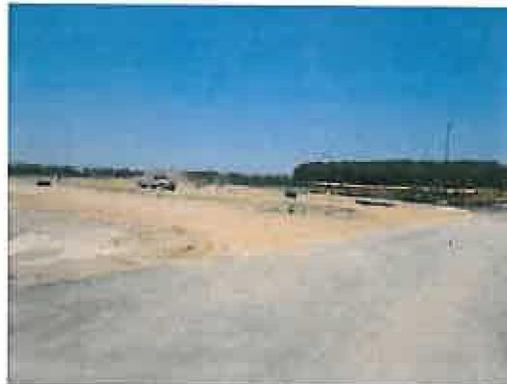
Figure 13: Areas where a rock construction entrance/access road would be beneficial

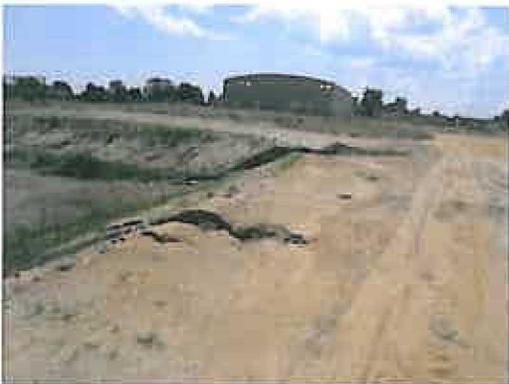
Figures 14: Erosion channels forming on the sides of the sediment basin. Sediment from the sides is washing into the basin

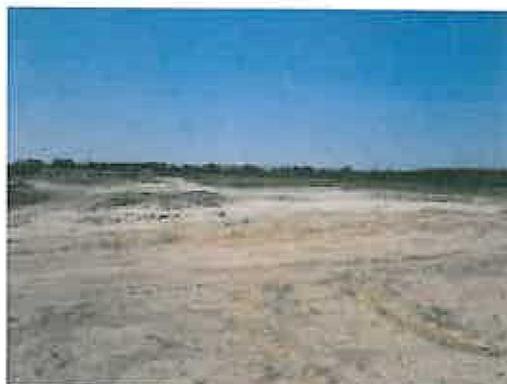
Figure 15: Area where sediment trap 3 was; might need to be reinstalled here
