**Environmental
Protection Agency**

July 19, 2012

RE: LAKE COUNTY
VILLAGE OF MADISON
MADISON ELEMMENTARY SCHOOL
CONSTRUCTION STORM WATER
PERMIT NO: 3GC05571

INSPECTION PHOTOS

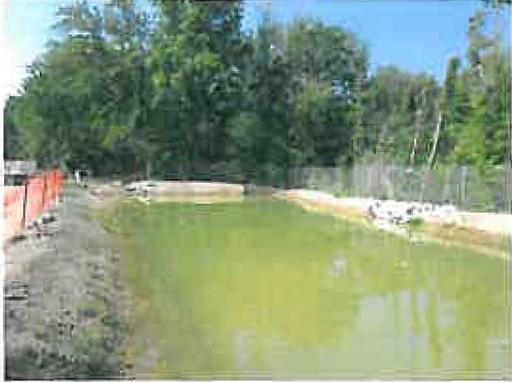
Figure 1: ST-1's outlet not built per plan

1. The ST-1's outlet was not built per plan. Two types of stone should be used to create a saddle-shaped outlet. Please build this outlet per plan.
2. Concrete washings have been dumped onto the ground. This material is not permitted to be discharged into offsite bodies of water or the storm sewer. Please clean this up and direct all concrete washings to the provided concrete washout pit.

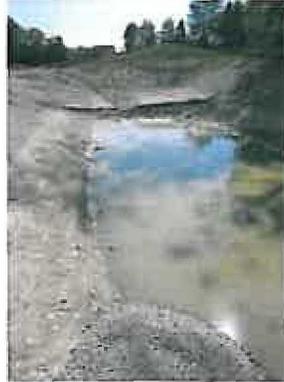
Figure 2: Pond-1 has no skimmer in place

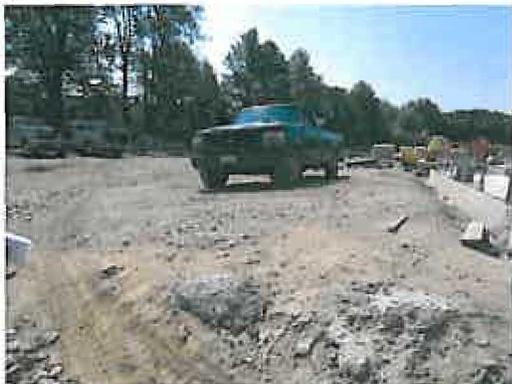
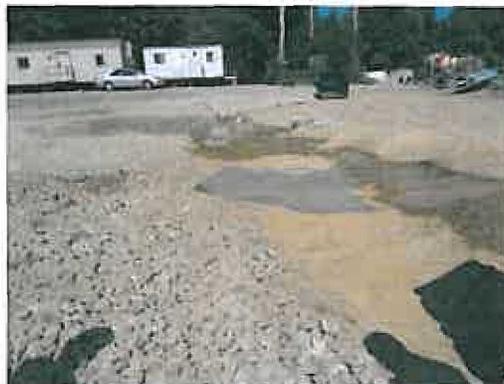
Figures 3&4: Concrete washings being dumped on the ground

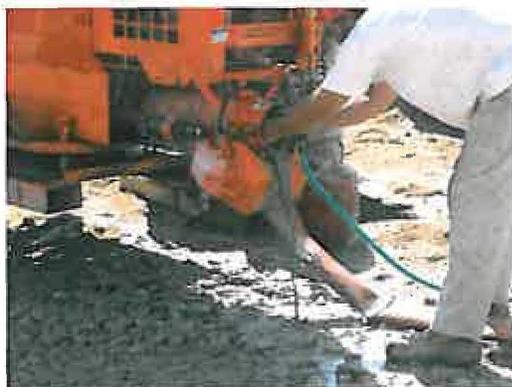
Figure 5: Mortar mixings being washed out onto the ground

3. Mortar is being washed out onto the ground. This liquid is flowing to the large puddles on site. This material is also not permitted to be discharged into offsite bodies of water or the storm sewer. Please clean up this area and dispose of the waste properly. A berm or trench should be built around this area to contain the wash water and mortar.

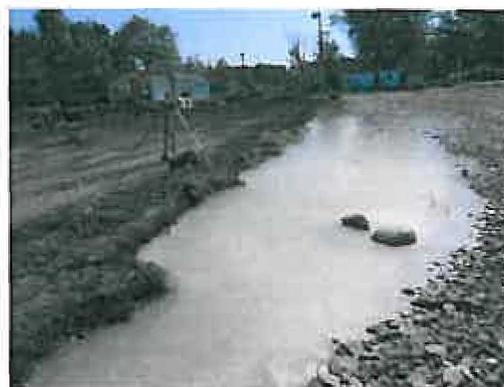
Figure 6: Cloudy water next to the mortar mixing area

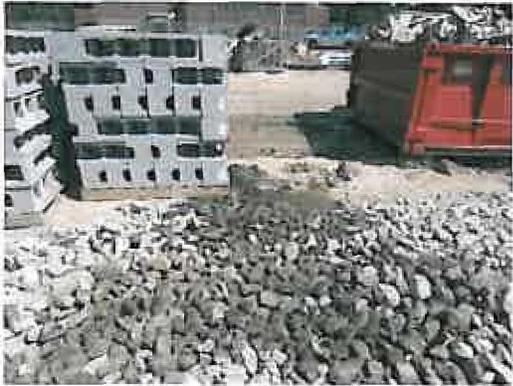
Figure 7: Oil spilled onto the ground

4. There is a large oil spill on site. All contaminated soils must be disposed of in a solid waste dumpster. To prevent spills from occurring, regular checks of equipment should be done to ensure proper functioning. If a leak is inevitable, a drip pan should be placed underneath the equipment to contain the oil.

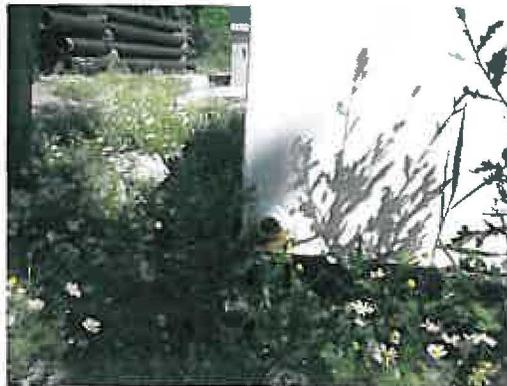
Figure 8: Fuel containment dyke missing the plug

5. The fuel containment dyke is missing the plug. Please replace the missing plug to ensure a sealed container.
6. The silt fence on the west side of the west side of the site is not trenched and backfilled. Since this area is next to a stream, it is important that this fence functions properly.

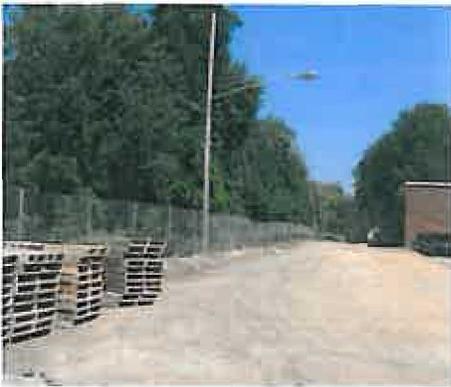
Figure 9: Silt fence not trenched and backfilled

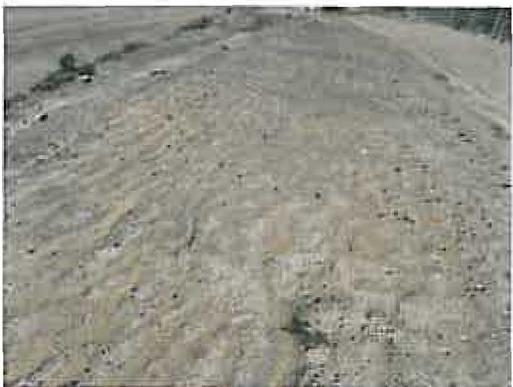
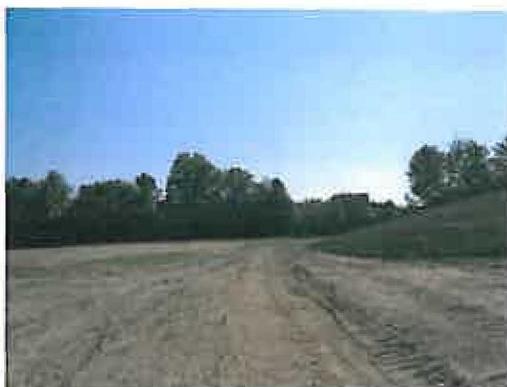
Figures 10&11: Areas where watering or reseeding need to occur

7. Seeding has taken place on all soil left undisturbed for more than 21 days. However, due to the hot, dry weather, the seed has not taken fully. Watering of the seed may be required to achieve germination and subsequent grass growth. If 70% growth density is still not achieved, seeding and mulching may need to occur again.
