RE: LAKE COUNTY  
CITY OF MENTOR  
DIAMOND BUSINESS PARK  
CONSTRUCTION STORM WATER  
PERMIT NO: 3GC05323

**NOTICE OF VIOLATION**

**Diamond Business Park**

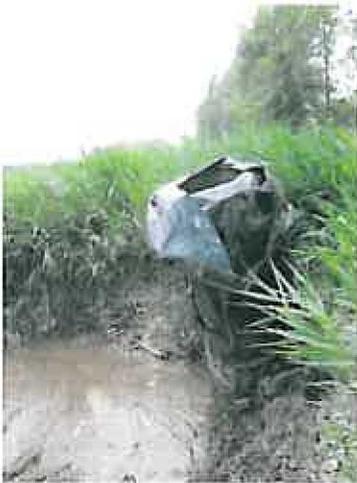
1. **Failure to construct the sediment basin outlet structure in compliance with required design standards.** This is a violation of Part III.G.2.d.ii of the NPDES permit and Ohio Revised Code (ORC) 6111.04 and 6111.07. The outlet is out-of-date and was built incorrectly. Please note that the NPDES permit requires the outlet structure of sediment basins to provide a minimum 48-hour drain time for the dewatering volume. The rule-of-thumb design used on this site, i.e., a perforated riser pipe wrapped in geotextile, does not ensure the minimum drain time is met. The revised plans show a skimmer device was to be installed, but this was not on site. In addition, the SWP3 does not give any cross-section detail plan for the basin. The detailed drawings for the outlet structure, skimmer, and sediment basin need to show the elevations of the sediment storage volume, invert of pipe, dewatering volume, and the top of the basin and outlet structure. Please revise your SWP3 to show these details.

**Figure 1:** Sediment basin outlet structure

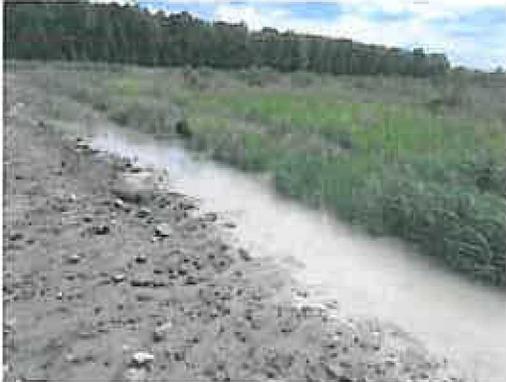
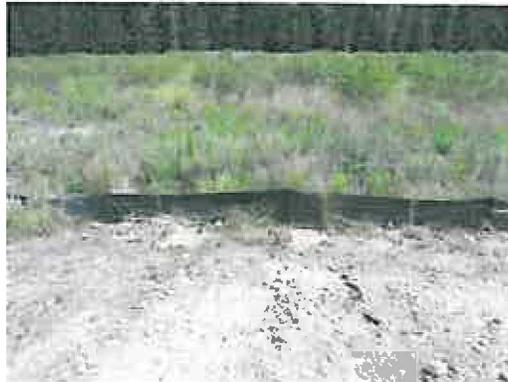
2. **Failure to maintain silt fence in a functional condition until the areas it controls have reached final stabilization.** This is a violation of Part III.G.2.h of the NPDES permit nad ORC 6111.04 and 6111.07. The silt fence along the entire property has not been maintained. It sags and, in some places, it has fallen down. The silt fence along the soil stockpile has been knocked down by the soil. Please maintain a buffer zone between the fence and the soil stockpile.

**Figures 2&3:** Silt fence along wetlands has fallen down or has holes

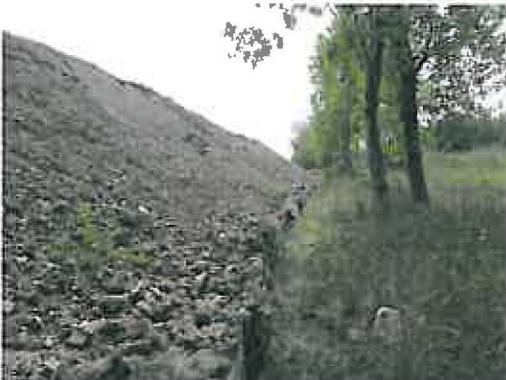
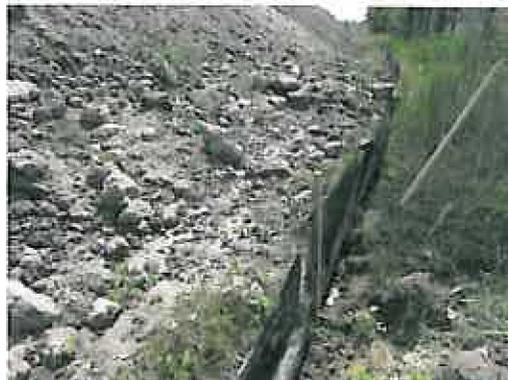
**Figures 4&5:** Silt fence has fallen down, been buried, or has holes along the soil stockpile

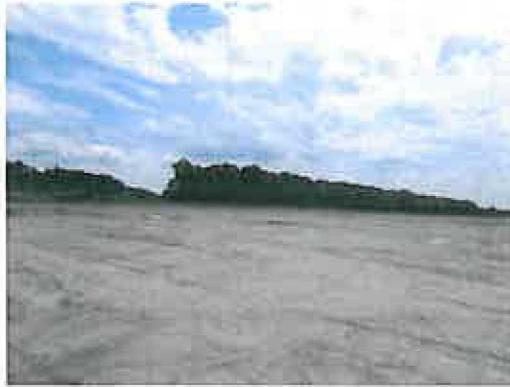
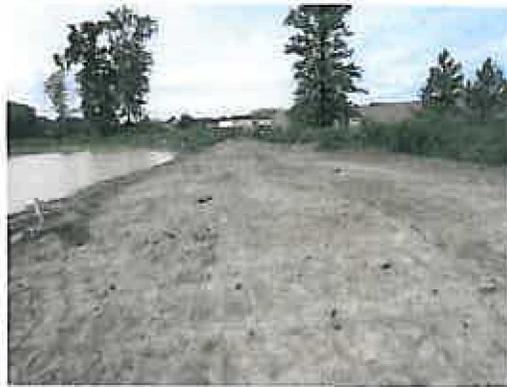
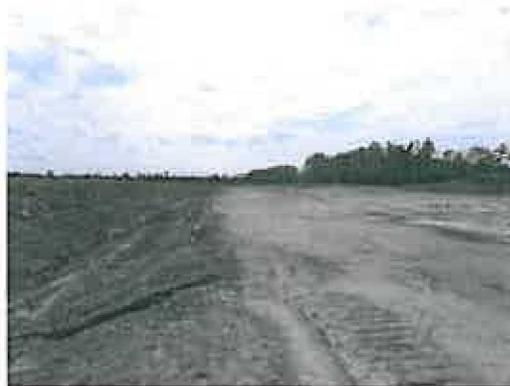
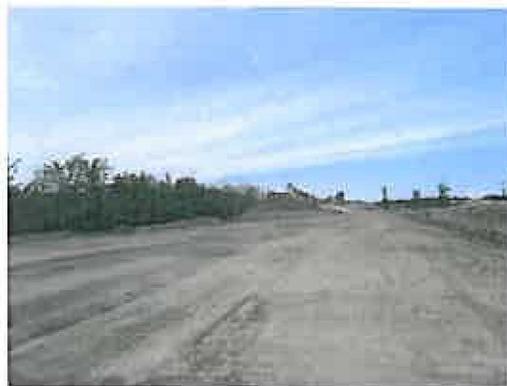
3. **Failure to initiate temporary stabilization of disturbed areas within 7 days of last disturbance if they are to remain idle for 21 days or longer.** This is a violation of Part III.G.2.b.i.Table 2 of the NPDES permit and ORC 6111.04 and 6111.07. The site should be reviewed on a weekly basis to determine which areas require temporary stabilization between construction operations. Areas requiring temporary stabilization must be seeded and mulched (or just mulched) to initiate stabilization. A log documenting grading and stabilization activities is required by Part III.G.1.m of the NPDES permit.

Figure 6-9: Areas where temporary stabilization should occur
