August 17, 2012

RE: TRUMBULL COUNTY
CITY OF GIRARD
TOTAL WASTE LOGISTICS LAS, LLC
NPDES PERMIT NO: OHC000003
OHIO EPA PERMIT NO: 3GC01762*BG
CONSTRUCTION STORM WATER INSPECTION

NOTICE OF VIOLATION

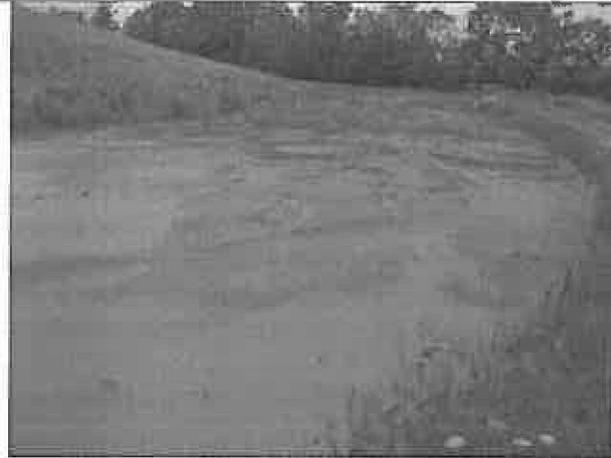
- Sediment basin No. 4 is nonfunctional due to a lack of maintenance to restore the treatment capacity by removing the accumulated sediment that has exceeded the volume of sediment storage zone (Figures 1 to 3). Erosion gullies have formed on the embankment of sediment basin No. 4 (Figure 4). Untreated sediment-laden runoff is discharging into "waters of the State." Accumulated sediment was observed within the channel that discharges to the Mahoning River (Figure 5). **The failure to maintain sediment basin No. 4 in a functional manner constitutes violations of Ohio Revised Code (ORC), Chapter 6111.07 and Part III.G.2.d, of the General Storm Water Permit.**

Figure 1 - Accumulated sediment that has exceeded the volume of sediment storage zone of sediment basin No. 4

A report detailing the corrective actions that been implemented to address the above violations must be submitted to Ohio EPA by August 31, 2012. The report must include the dates when each corrective action item was or will be implemented and completed.

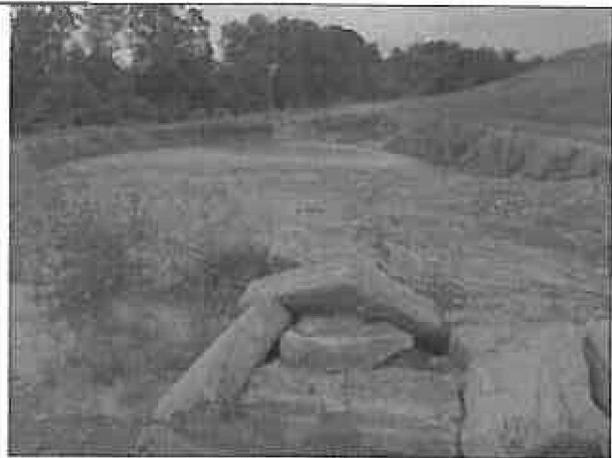
Figure 2 - Accumulated sediment that has exceeded the volume of sediment storage zone of sediment basin No. 4

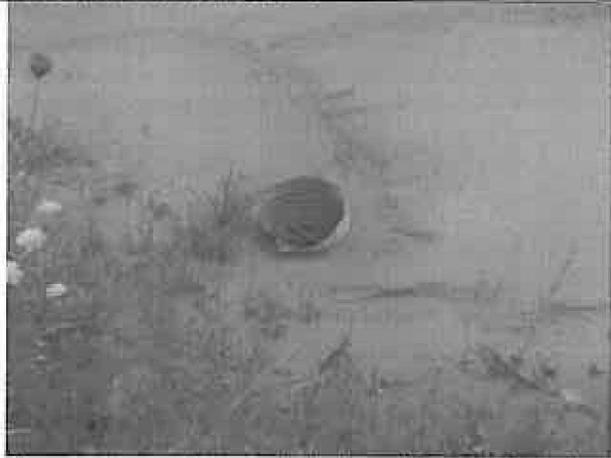
Figure 3 - Accumulated sediment that has exceeded the volume of sediment storage zone of sediment basin No. 4

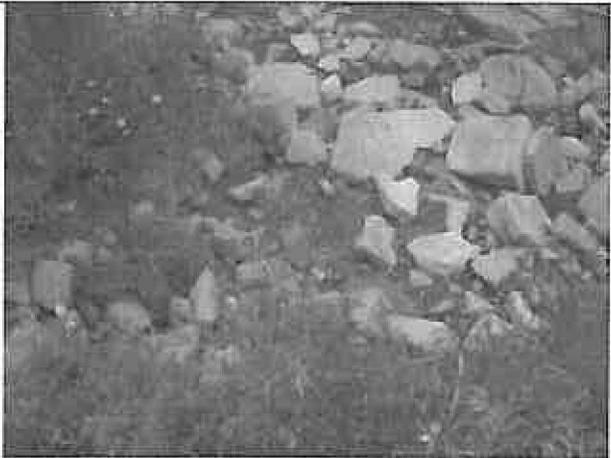
Figure 5 - Accumulated sediment was observed within the channel that discharges to

the Mahoning River.

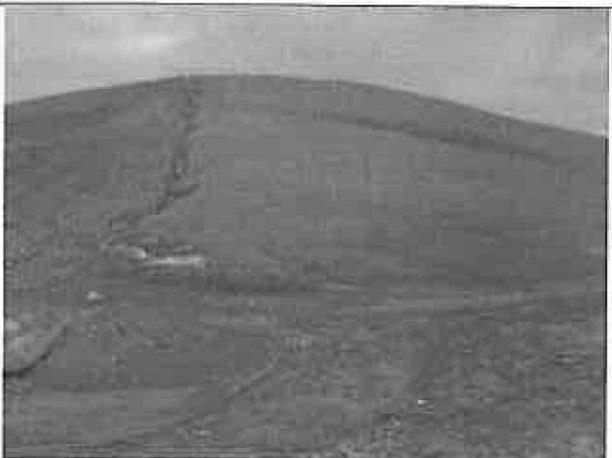
- The site appears to have remained idle for an extended period of time due to the extensive erosion gullies that are present (Figures 6 to 9). Temporarily stabilization has not been performed throughout site to prevent erosion and the discharge of sediment to "waters of the State." **The failure to temporarily stabilize idle areas constitutes violations of ORC 6111.07 and Part III.G.2.b of the General Storm Water Permit.**

Figure 6 - Extensive erosion gullies are present throughout the un-stabilized portions of the site.

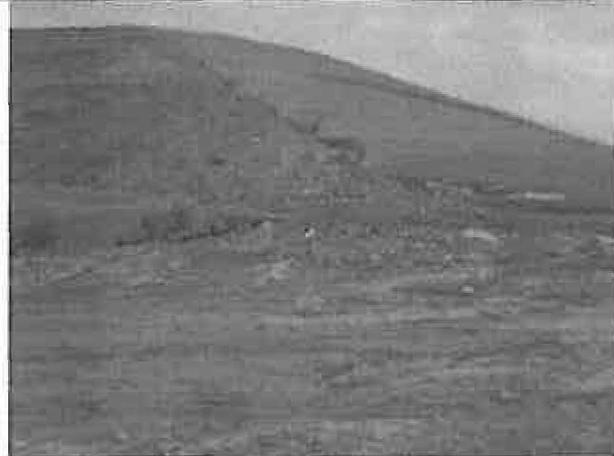
Figure 7 - Extensive erosion gullies are present throughout the un-stabilized portions of the site.

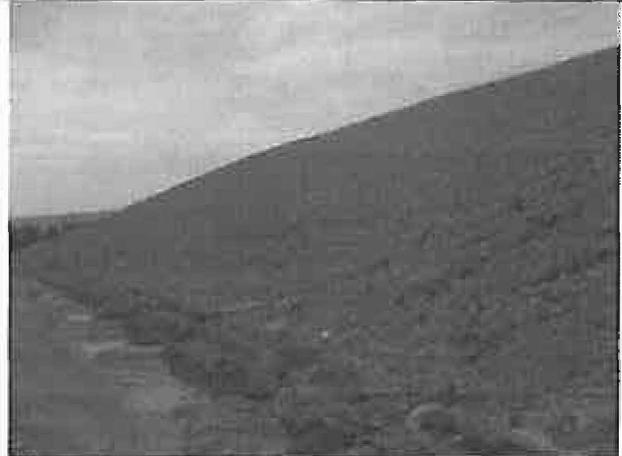
Figure 8 - Extensive erosion gullies are present throughout the un-stabilized portions of the site.

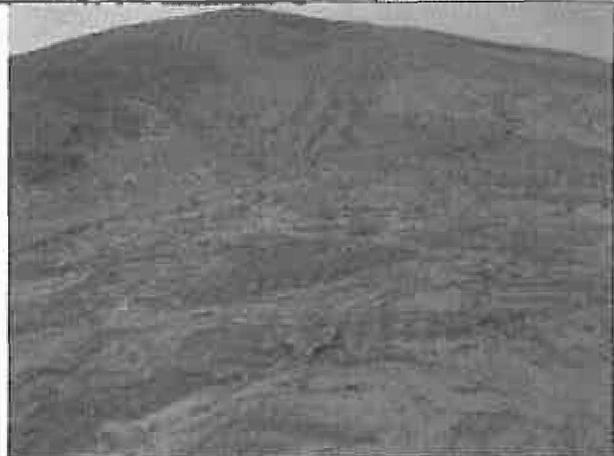
Figure 9 - Extensive erosion gullies are present throughout the un-stabilized portions of the site.
