**Environmental  
Protection Agency**

August 21, 2012

RE: ASHTABULA COUNTY  
ALERIS SPECIALTY PRODUCTS  
NPDES PERMIT NO. OHR000005  
OHIO EPA PERMIT NO. 3GR00599\*EG  
INDUSTRIAL STORM WATER INSPECTION

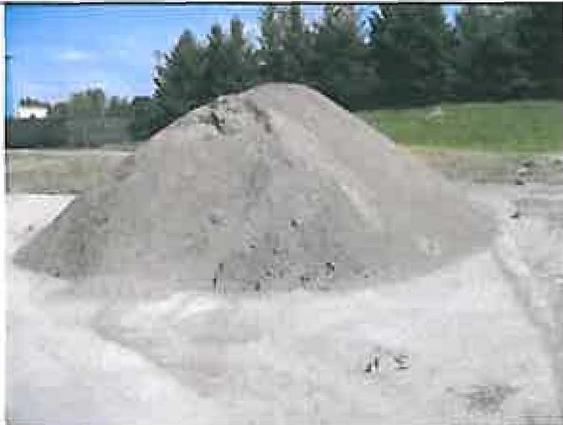
- Haydite is stockpiled uncovered outdoors in an area exposed to precipitation events (Figure 1). Section 4.4 of the facility's storm water pollution prevention plan (SWP3) details that material storage shall be covered when not in use. The facility must begin covering outdoor material storage areas.

**Figure 1** - Haydite is stockpiled uncovered outdoors in an area exposed to precipitation events.

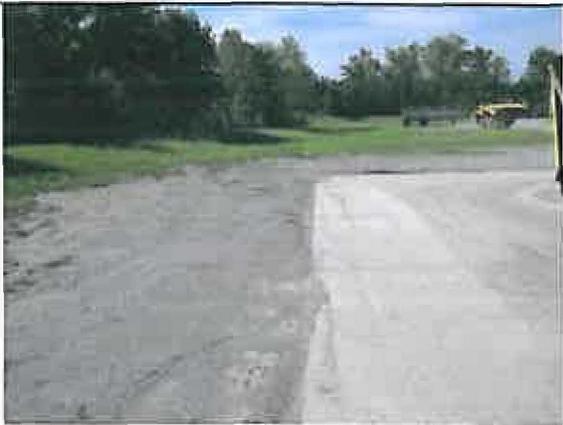
- General housekeeping measures must be significantly improved as fine materials are present on the paved areas throughout the facility resulting from being tracked, spilled, and/or transported from the loading, unloading, outdoor storage, and baghouse areas (Figures 2 to 5).

**Figure 2** - General housekeeping measures must be significantly improved as fine materials are present on the paved areas throughout the facility.

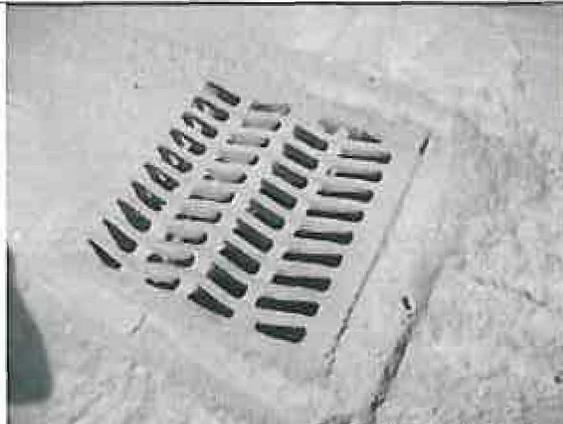
**Figure 3** - General housekeeping measures must be significantly improved as fine materials are present on the paved areas throughout the facility.

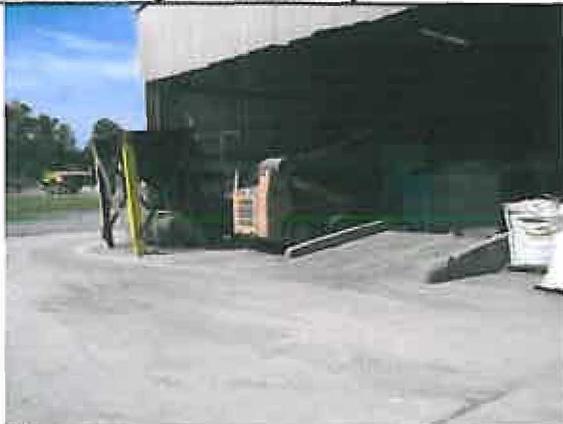
**Figure 4** - General housekeeping measures must be significantly improved as fine materials are present on the paved areas throughout the facility.

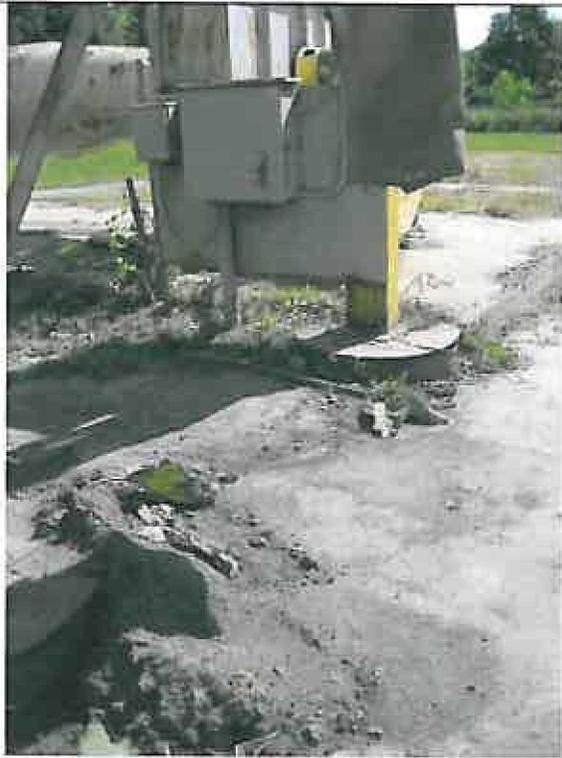
**Figure 5** - General housekeeping measures must be significantly improved as fine materials are present on the paved areas throughout the facility
