Re: **Notice of Violation**  
Defiance Municipal WTP  
NPDES Permit 2IW00060/OH0078417  
Compliance Evaluation Inspection  
Defiance County

October 10, 2012

NPDES Compliance Inspection Report

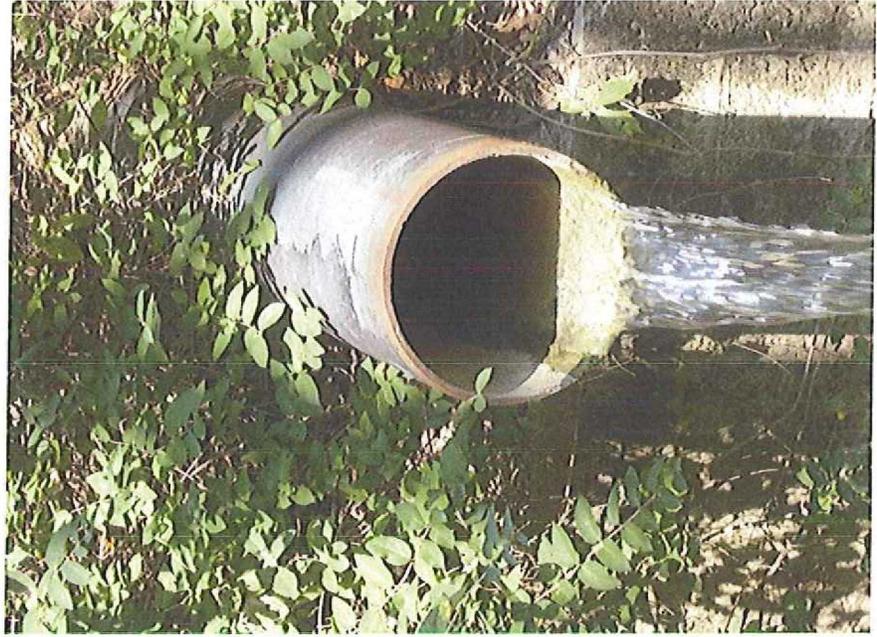
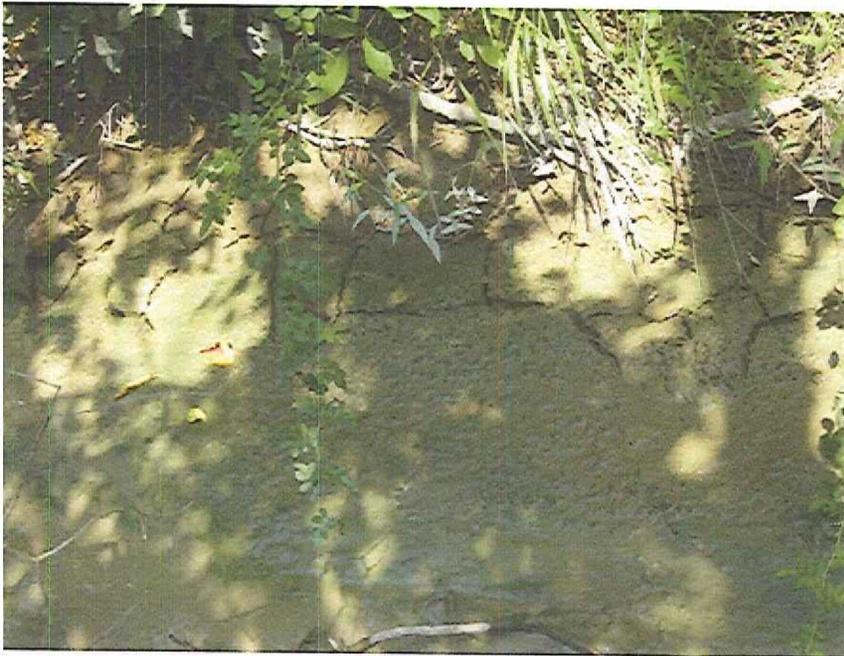
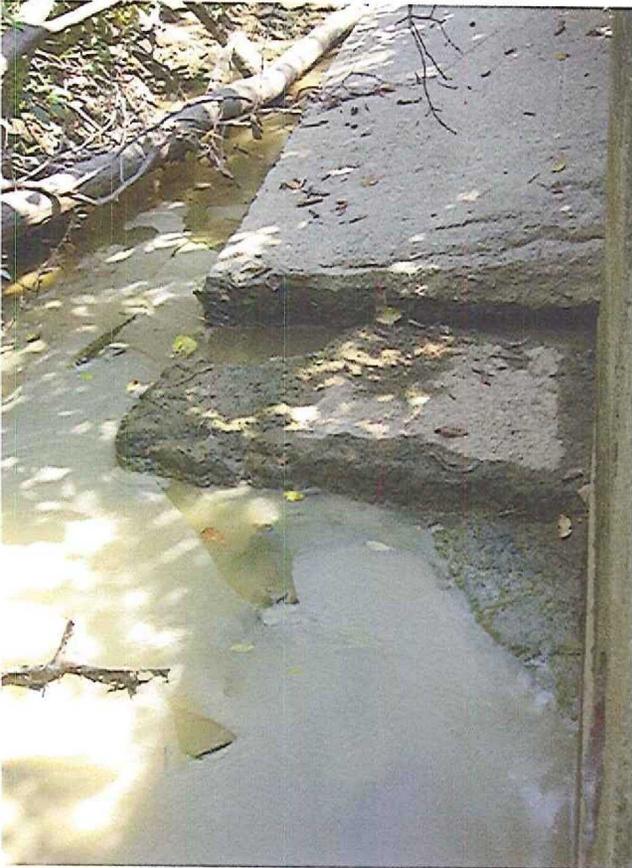
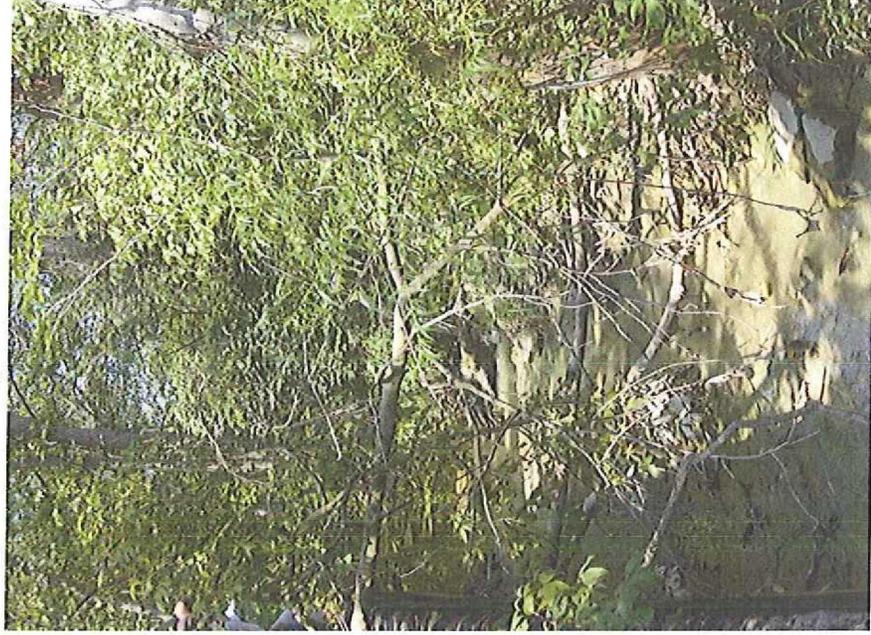
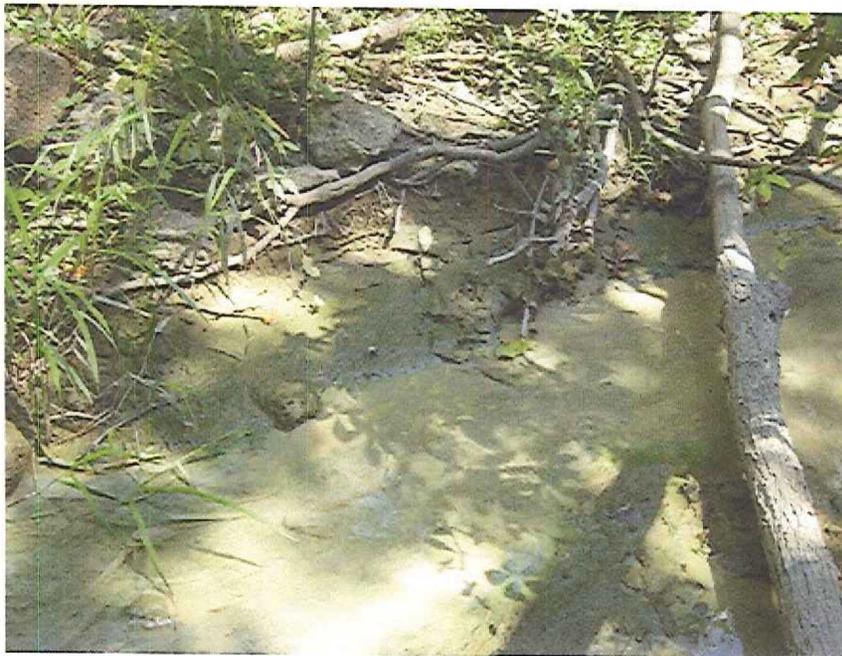
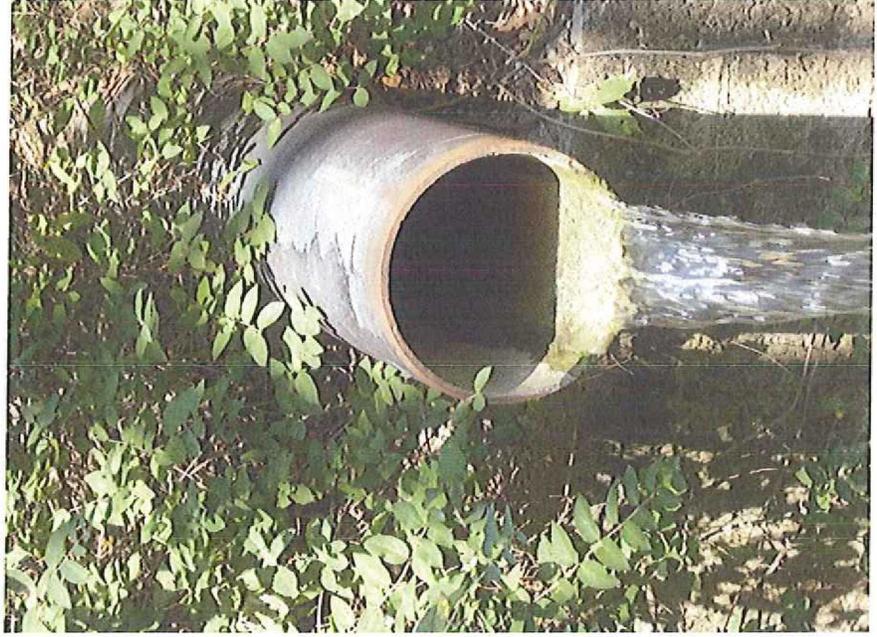
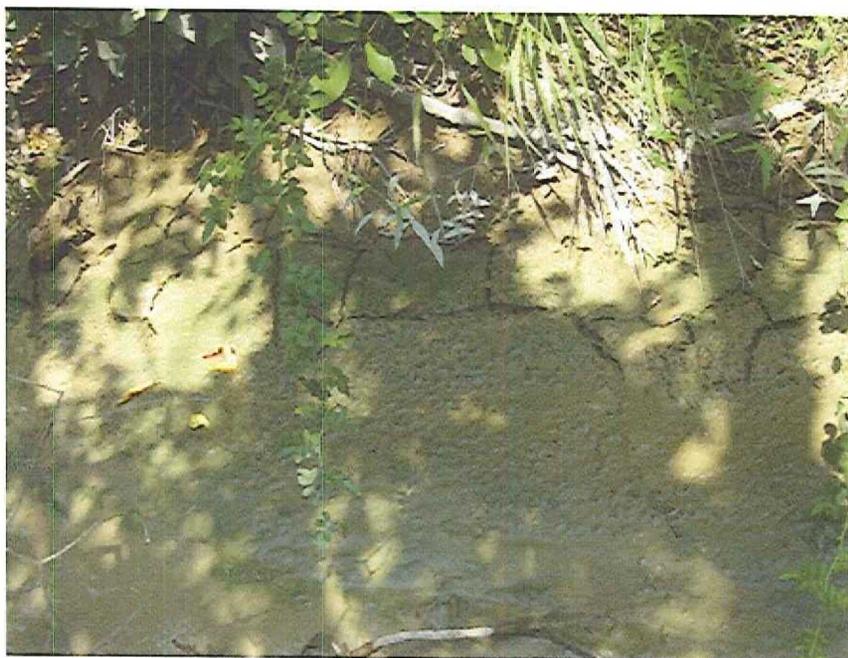
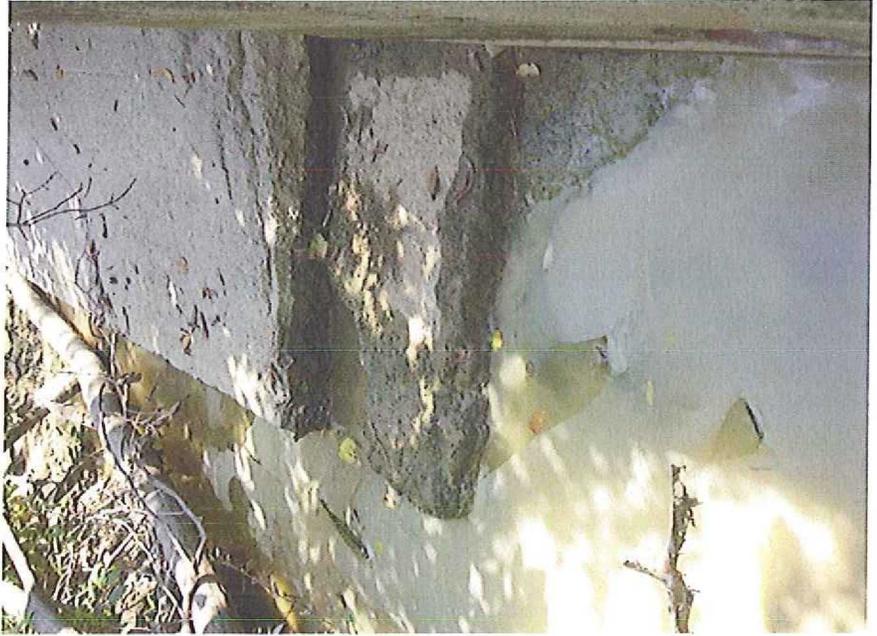
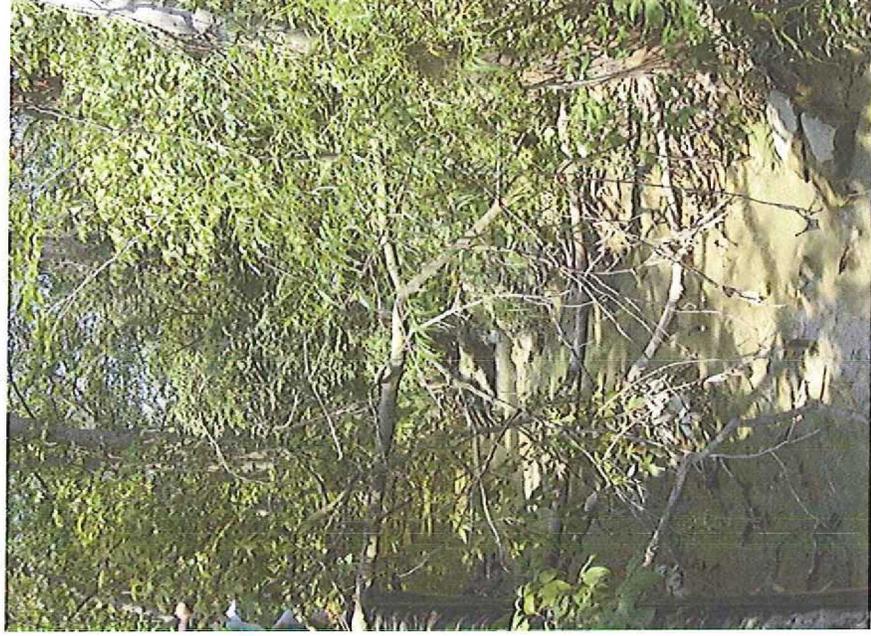
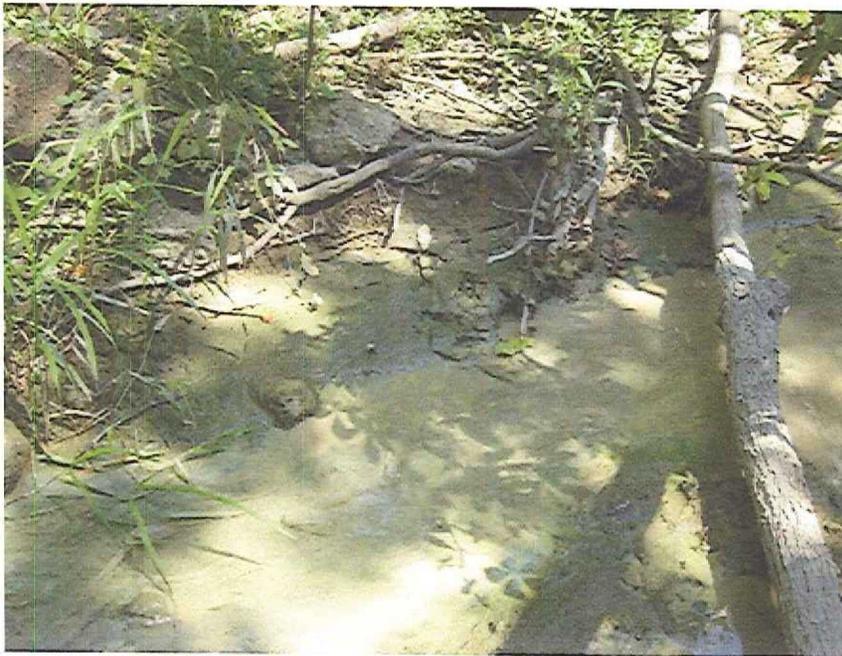
During my inspection, white sludge solids were observed in Colwell Ditch within a 50 foot long stretch of stream, which acts like a basin due to large concrete blocks located downstream of the discharge. The white color was attributed to algae growth and dry weather. I requested that the solids be removed from the stream as quickly as possible.

Solids accumulated in Colwell Ditch are present for approximately 50 feet length of the ditch in a section that acts as a bowl, which is due to concrete slabs placed downstream of the effluent. The solids were white in color and Mr. McDowell stated this was due to algae and dry weather. During the reconnaissance inspection, the solids in the stream were orange in color due to recent rain events that had removed the top layer of white sludge/algae and may have been deposited further downstream. Cleanup efforts and modifications to the lagoons (installation of valves and reduction of wastewater – filter backwash water- discharging to the lagoons) is being scheduled immediately.

Defiance Water Treatment Plant Inspections  
Colwell Ditch at Discharge from Waste Water Treatment Lagoons  
Pictures taken by Dana Martin-Hayden , Ohio EPA NWDO

Allowing the sludge to discharge and accumulate in the stream is a violation of Ohio Administrative Code (OAC) Section 3745-1-04. Therefore, the deposited sludge must be removed from the stream immediately.

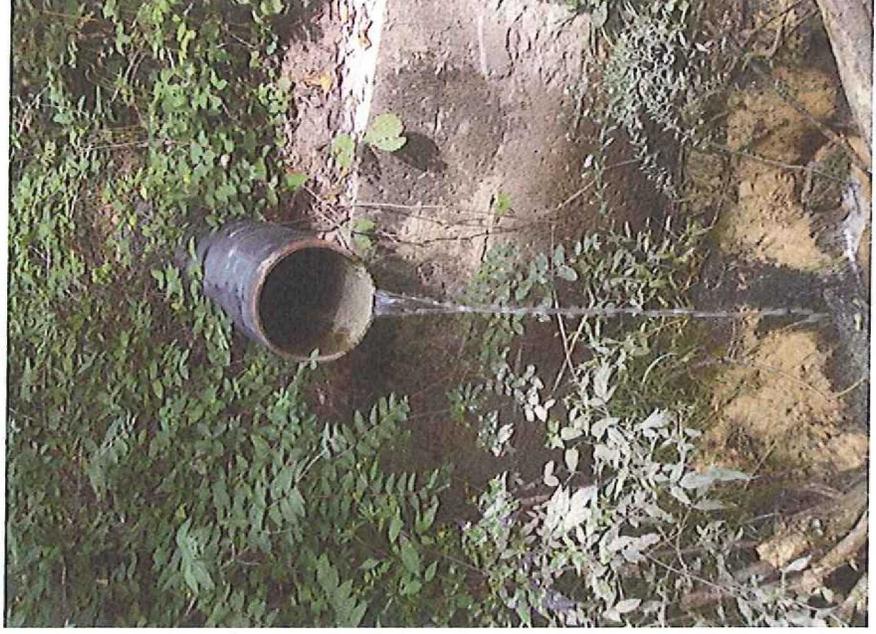
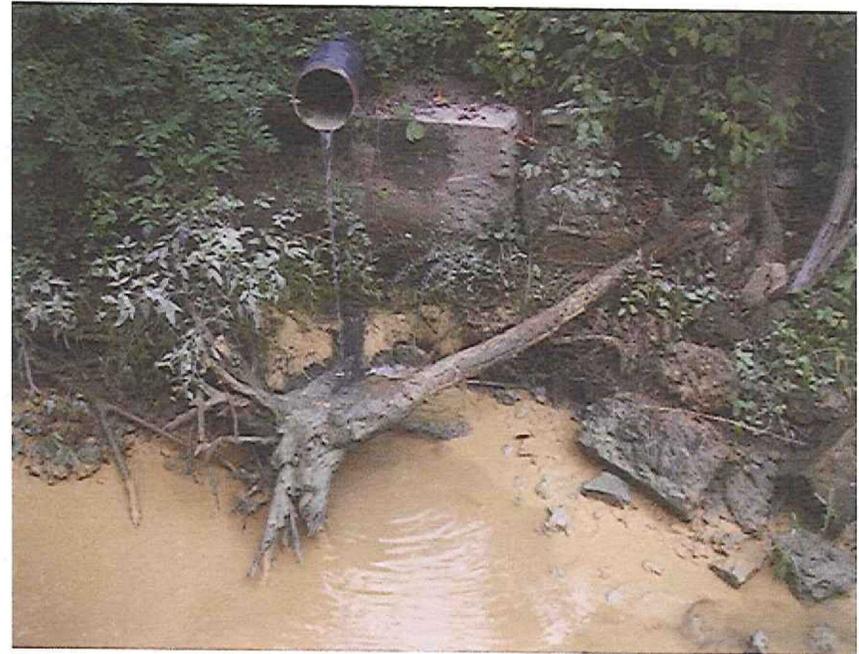
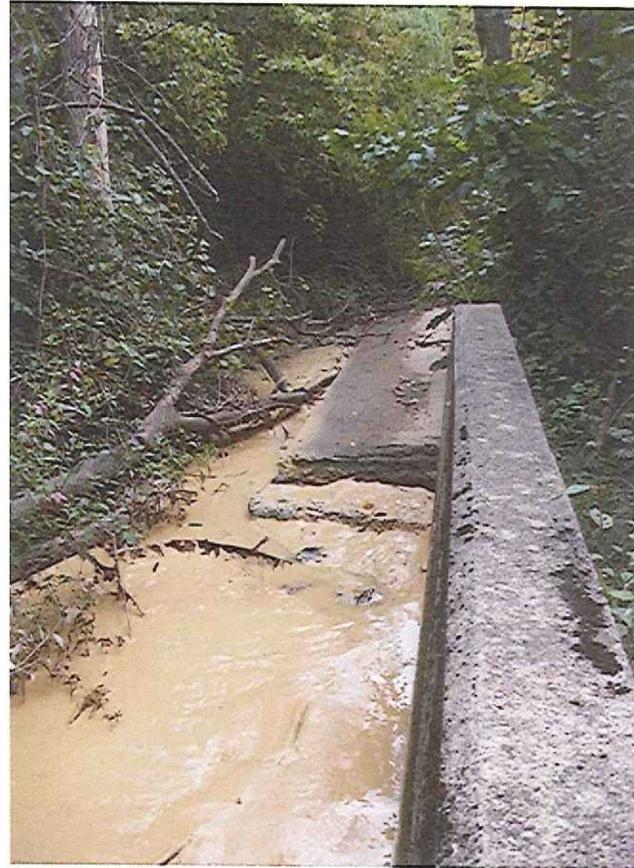
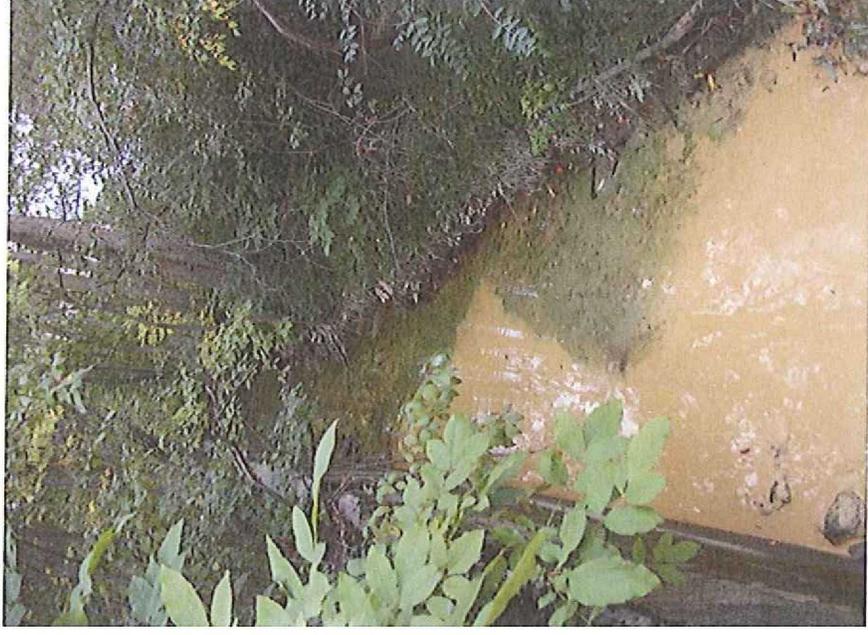
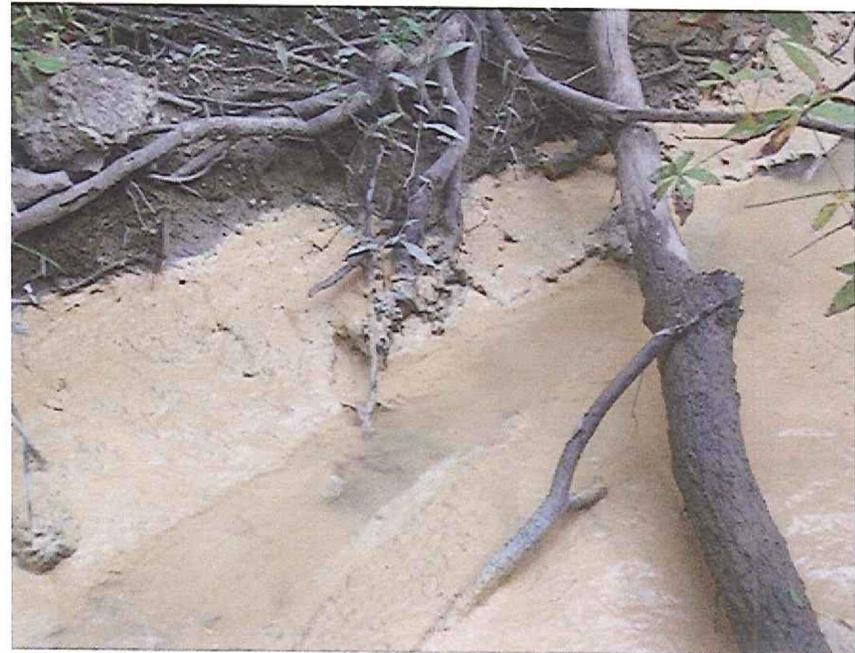
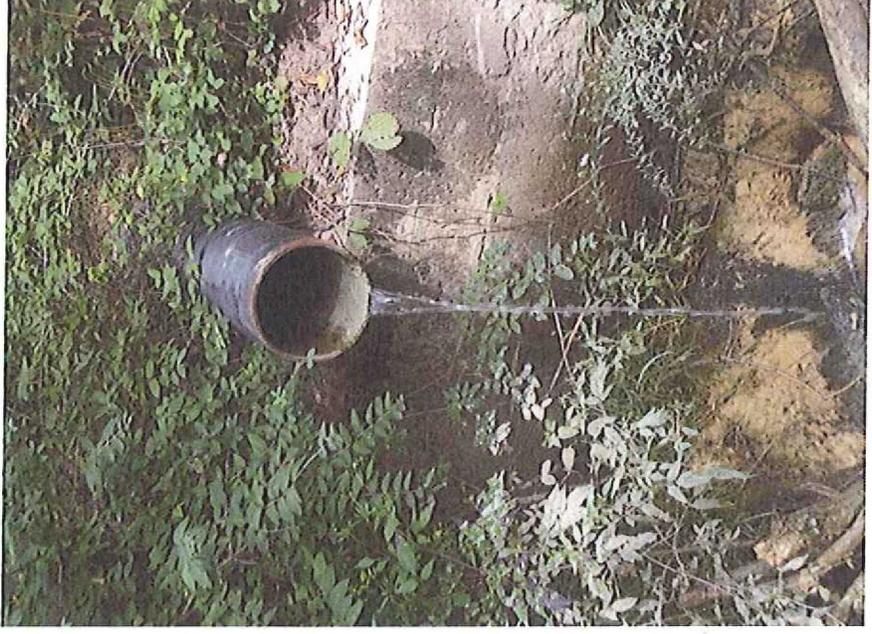
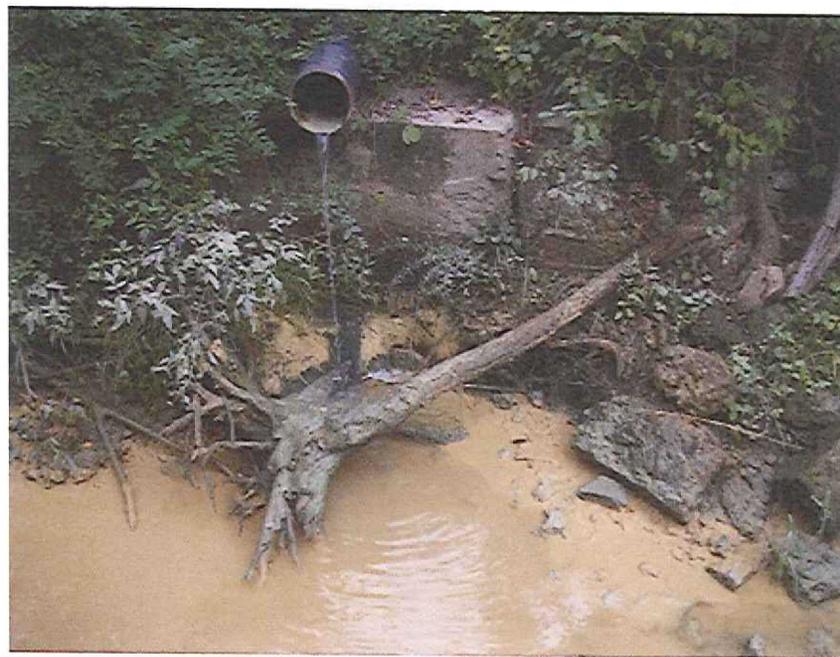
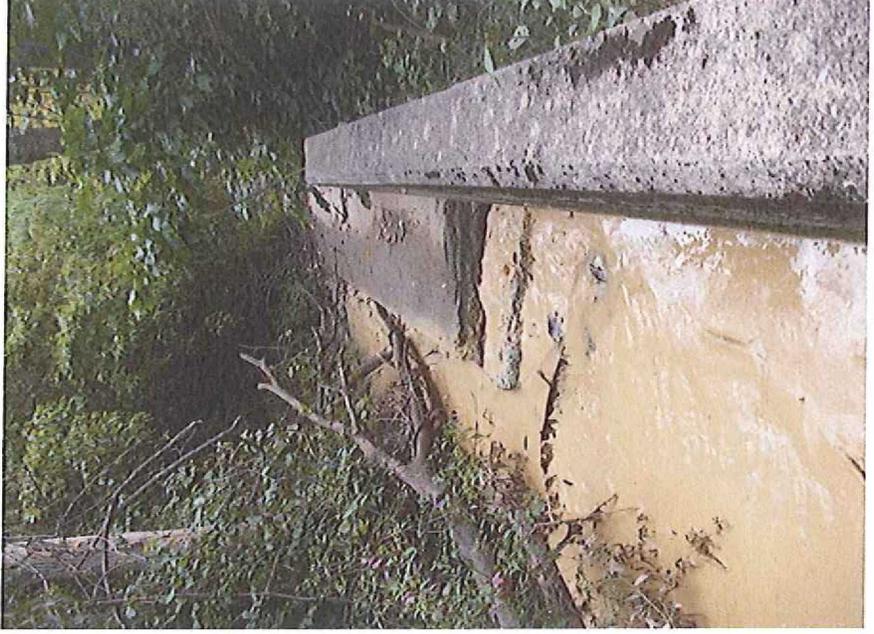
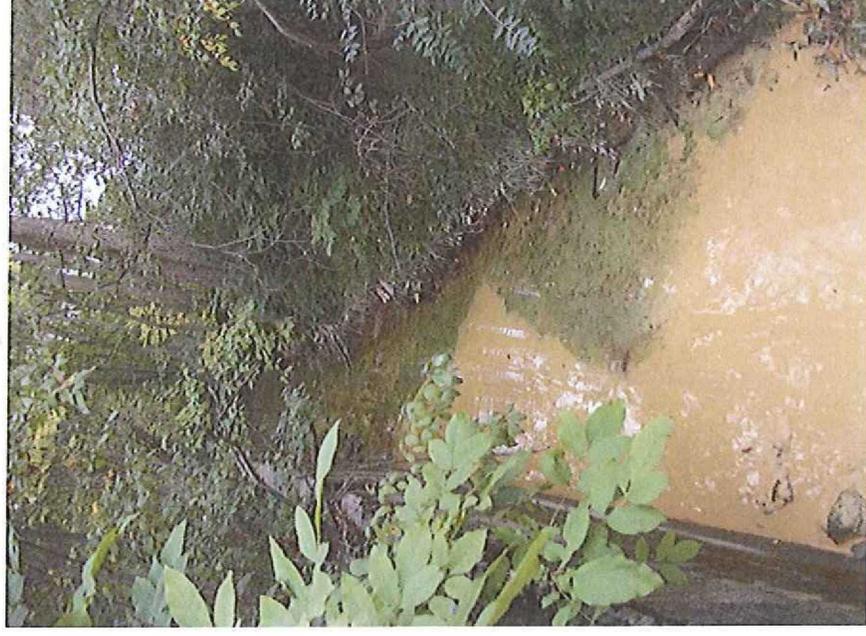
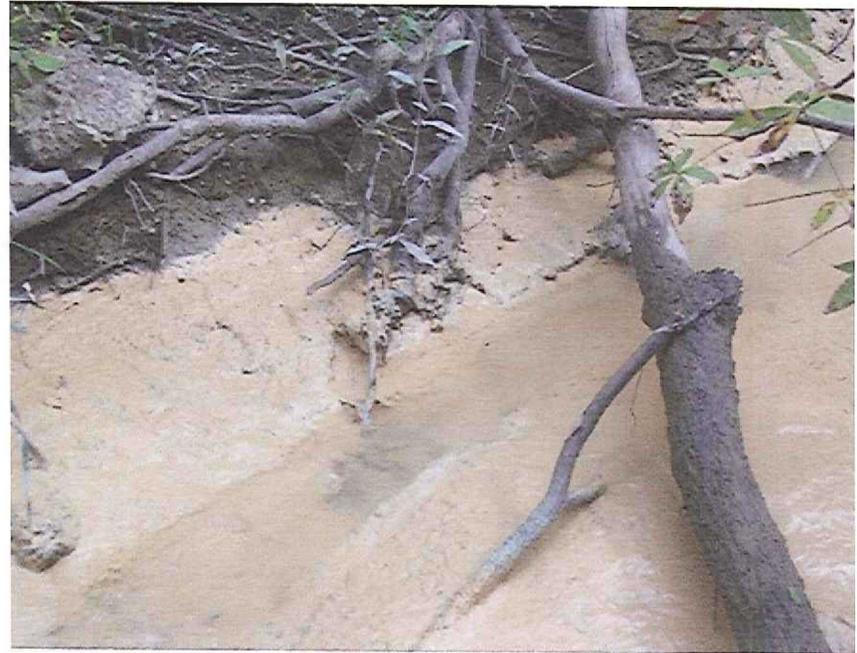
A reconnaissance inspection was conducted on September 20, 2012, to verify that the sludge solids had been removed from the stream. The sludge solids had not been removed from Colwell Ditch and due to recent rains, the white algae was no longer present. Instead, the sludge was the orange (iron) color that we have observed in this stream on two other occasions. Please see enclosed photos.

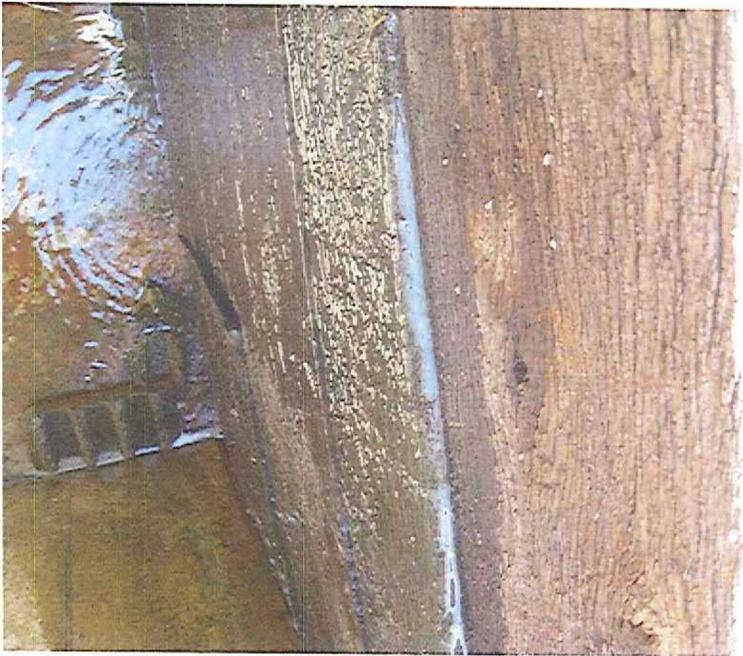
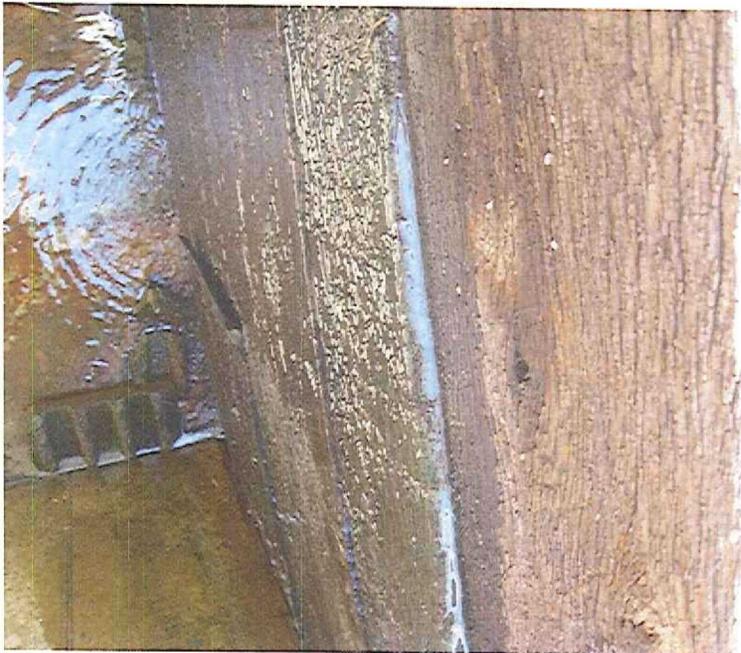
Defiance Water Treatment Plant Inspections  
Discharge Structure at the Waste Water Treatment Lagoons  
Pictures taken by Dana Martin-Hayden , Ohio EPA NWDO

A logbook is recorded for the plant and any significant issues are logged into the logbook. Preventive Maintenance was performed in that boards were changed out and water levels adjusted, however, issues with using boards as a decanting barrier has not been a sustainable or reliable method to prevent leakage. Therefore, efforts to maintain them has not produced a successful result.

On October 4, 2012, you notified me by phone that the first physical modification to the lagoons had been completed. Butterfly valves have been installed at every lagoon discharge pipe.

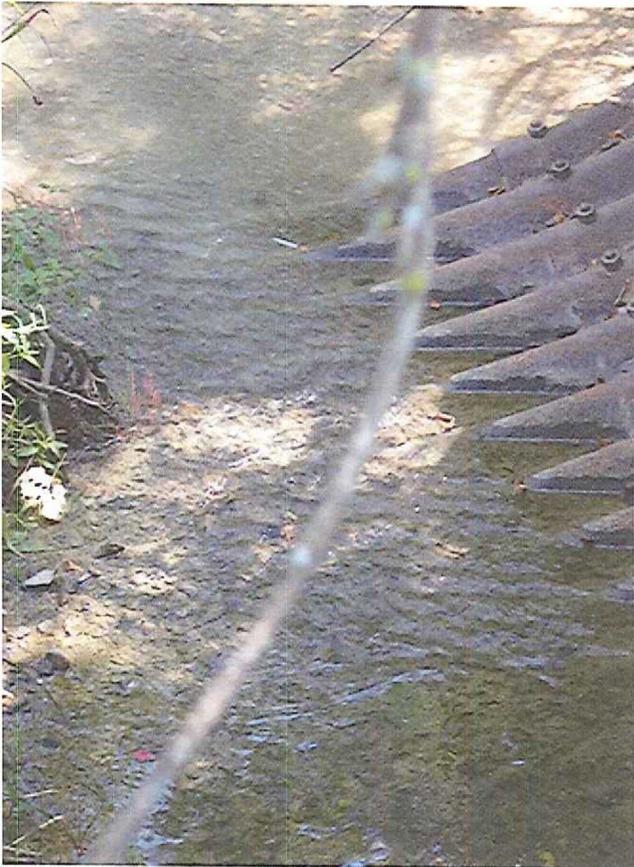
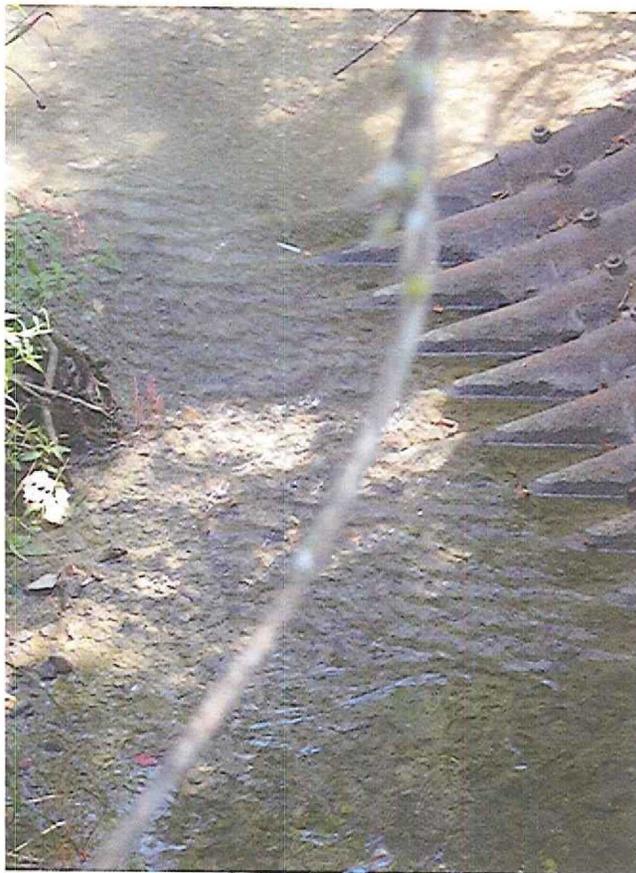
**August 30, 2012**

Defiance Water Treatment Plant Inspections  
Colwell Ditch approximately 100 feet downstream of the  
Discharge from Waste Water Treatment Lagoons  
Pictures taken by Dana Martin-Hayden, Ohio EPA NWDO
