**Environmental
Protection Agency**

RE: LAKE COUNTY
CONCORD TOWNSHIP
CONSTRUCTION STORM WATER
LAK-90.13.10 PID 75479

Photos Taken: October 10, 2012
By: Dan Bogoevski, DSW, NEDO

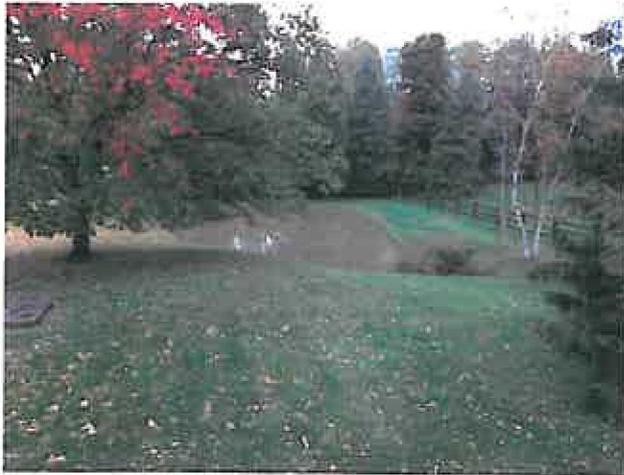
A review of the complainant's pond revealed that it does appear brown from sediment (Fig 1); however, it was noted that the pond is built within an unnamed tributary of Kellogg Creek and there is some downcutting of the stream channel upstream of the pond. It is likely that sediment due to natural bank erosion is settling within the pond. Although it had rained earlier in the day and intermittent showers occurred during the time of inspection, there was only a moderate amount of sediment in the water being discharged across Kellogg Road from I-90 (Fig 2 & 3).

Fig 1 (ABOVE). The complainant's pond is brown from sediment.

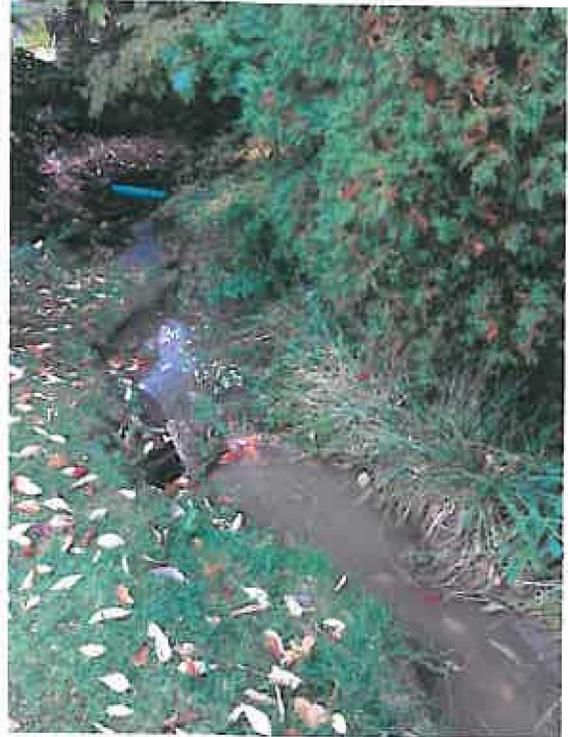
Fig 2 (RIGHT). Tributary that feeds into pond, upstream of the pond. Downcutting in the stream channel is evident. A lawn is maintained to the stream edge.

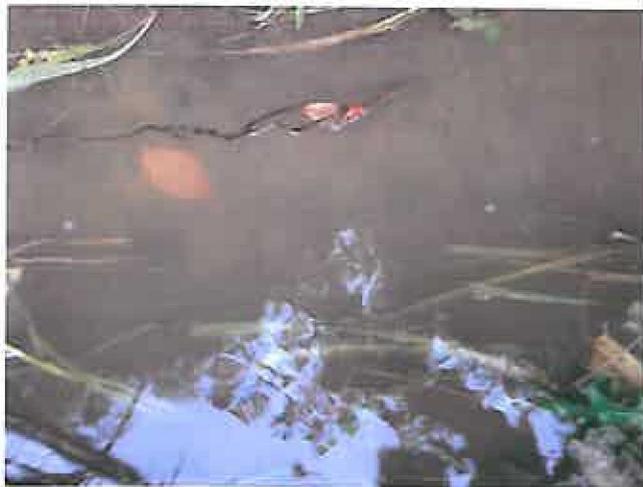
Fig 3 (ABOVE). Close-up of stream channel upstream of pond and downstream of construction shows that there is a slight amount of sediment in the water.

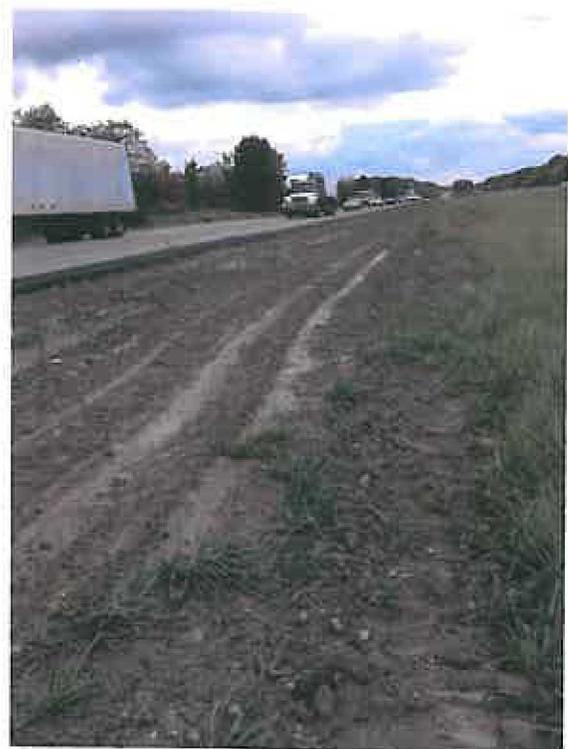
Fig 4 (RIGHT). Disturbed area along the median of I-90 has not been stabilized.

A review of construction activities on I-90 tributary to the pond indicates that there is limited to no construction occurring at this time. Although a crossover was constructed at approximately mile marker 199.2, construction appears to be complete. Storm sewer inlets were protected with standard storm drain inlet protection. Although some maintenance is required, the majority of the inlet protection devices were in good working order. However, areas disturbed by construction along the I-90 median and shoulders had not yet been stabilized. The NPDES permit requires temporary stabilization to be initiated within seven days of last disturbance on any area disturbed by construction but where construction activities are expected to cease for 21 days or longer. Permanent stabilization must be initiated within seven days of reaching final grade. It appears that the construction activities tributary to the complainant's pond meet one of these criteria. As such, please seed and mulch disturbed areas immediately.

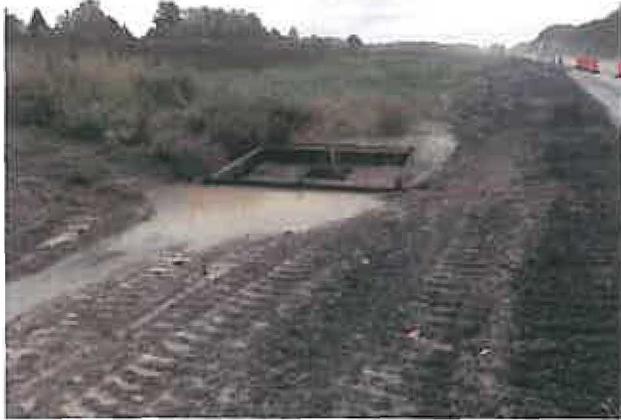
Fig 5 (LEFT). Storm drain inlet protection is in place around catch basins. This inlet is located along the eastbound lanes of I-90 at the crossover.

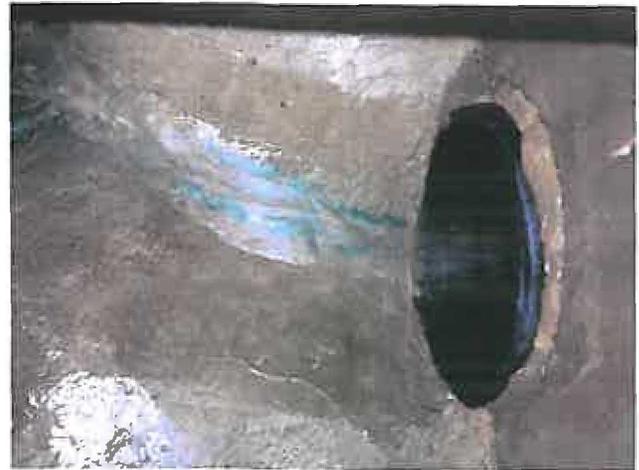
Fig 6 (RIGHT). Runoff inside catch basin pictured in Fig 5 shows that inlet protection is effectively minimizing sediment discharges to the storm sewer system.

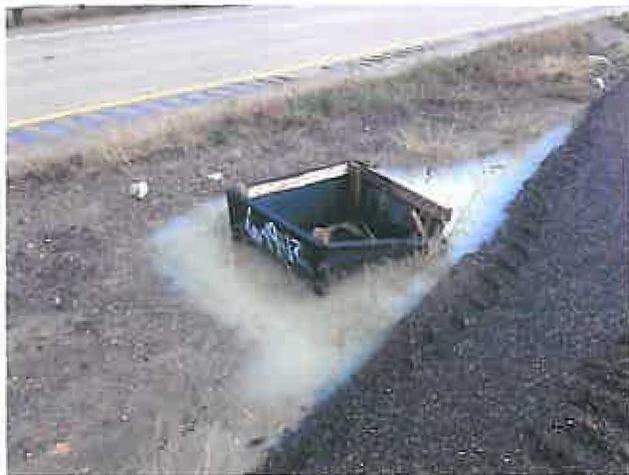
Fig 7 (ABOVE). This storm drain inlet protection requires maintenance. It is located along the westbound lanes of I-90 at the crossover.

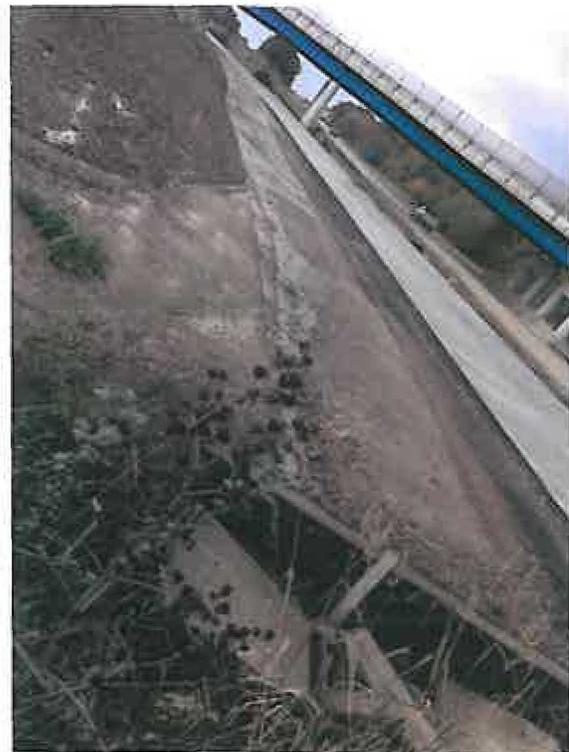
Fig 8 (RIGHT). Additional disturbed areas at the crossover need to be stabilized.
