**Environmental
Protection Agency**

October 22, 2012

RE: PORTAGE COUNTY
BRIMFIELD TWP.
CONSTRUCTION STORM WATER
DISTRIBUTION WAREHOUSE FACILITY

NOTICE OF VIOLATION

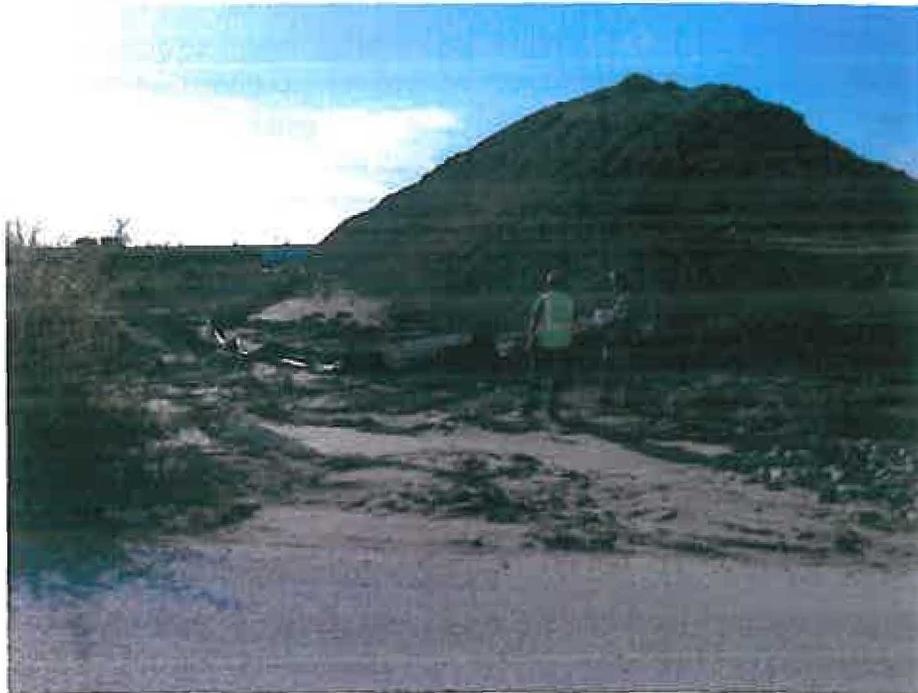
- **Entrance Drive off Crystal Parkway** – The amended storm water pollution prevention plan (SWP3) submitted to Ohio EPA on September 4, 2012, indicates that a sediment pond is to be provided within the entrance drive. This basin was not present on the date of inspection and no equivalent control was provided as an alternative to the planned basin. As a result, the ditch along Crystal Parkway remains filled with sediment and sediment-laden runoff will discharge to a storm sewer catch basin along Crystal Parkway as well as into Wetland C (see photos).

Fig 1. Sediment has filled the roadside ditch along Crystal Parkway. Sediment originates from the soil stockpile at the Crystal Parkway entrance.

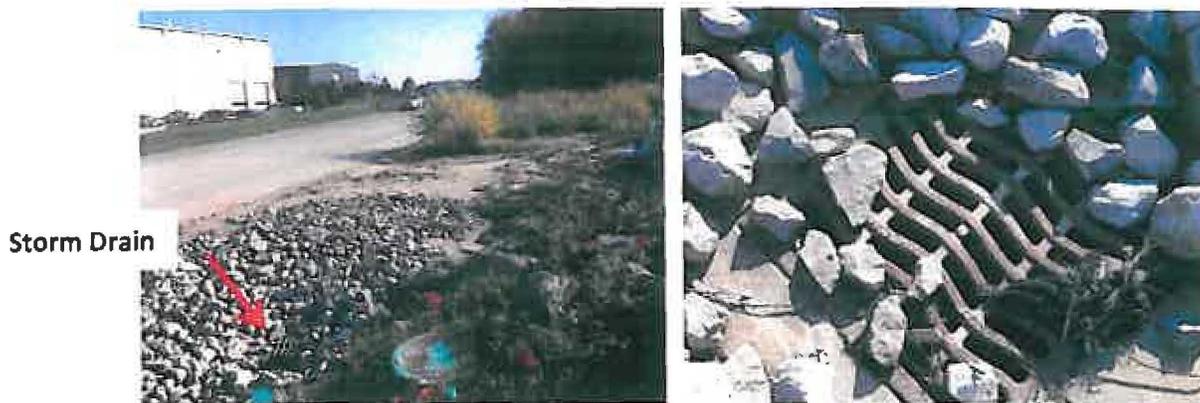
Storm Drain

Fig 2 & 3. Sediment from the stockpile also enters the storm drainage system on Crystal Parkway. Attempts to protect the catch basin with geotextile have failed.

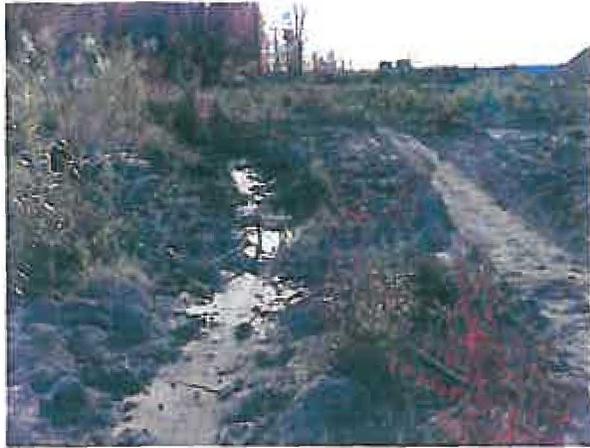
Fig 4 (LEFT). A swale directs sediment-laden runoff originating from the soil stockpile at Crystal Parkway to Wetland C.

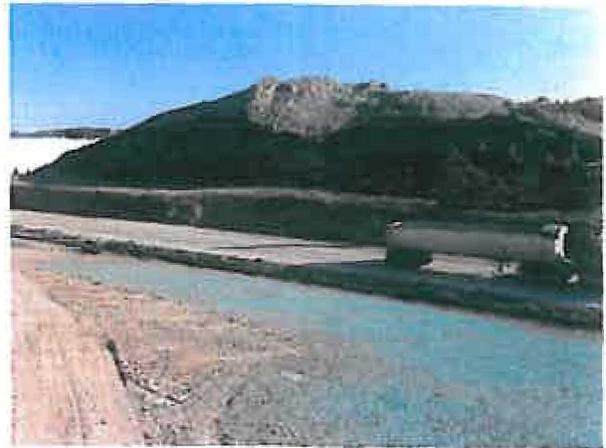
- **Failure to initiate temporary stabilization of disturbed areas within seven days of last disturbance if the area is to remain idle for 21 days or longer.** This is a violation of Part III.G.2.b.i of the NPDES permit and ORC 6111.04 and 6111.07. This violation has occurred throughout the development. Although many areas of the site have now been hydroseeded or seeded and matted, this is only occurring now because the project is nearing completion. Temporary stabilization is intended to be a continual process throughout the life of a construction project. Most perimeter slopes and the large soil stockpile at the Crystal Parkway entrance required seeding long ago. The large soil stockpile was never seeded or mulched and is now in the process of being removed from the site. Some areas have been hydroseeded, but the seeding does not extend to the edge of disturbance. Please be sure that all areas disturbed by construction activity are seeded and mulched no later than October 31, 2012.

Fig 5 (RIGHT). The soil stockpile at the Crystal Parkway entrance has remained in place for longer than 21 days, yet it has never been temporarily stabilized.

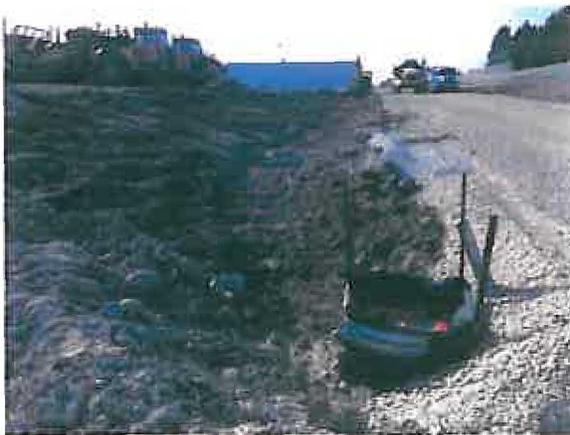
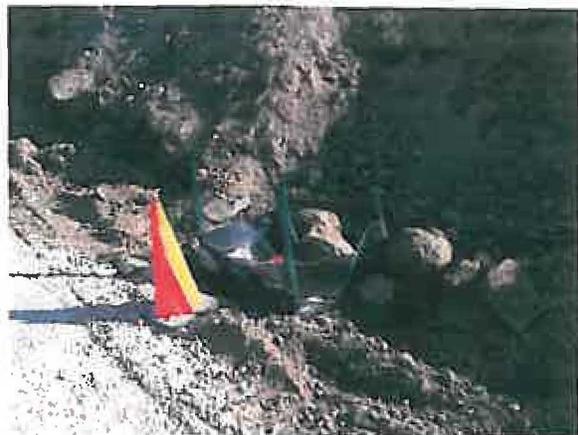
- **Failure to install storm drain inlet protection to minimize the discharge of sediment to active storm drain systems which do not drain into a sediment settling pond.** This is a violation of Part III.G.2.d.iv of the NPDES permit and Ohio Revised Code (ORC) 6111.04 and 6111.07. This violation pertains to storm drains located along the extension of Progress Boulevard and the storm drain located along Crystal Parkway. Catch basins in these locations did not drain into a sediment settling pond on the date of inspection. As such, storm drain inlet protection is required. Storm drain inlet protection was either not installed or installed in a non-functional manner (see photos). Install the appropriate form of storm drain inlet protection on these inlets (see enclosure from *Rainwater and Land Development, Ohio's Standards for Stormwater Management, Land Development and Urban Stream Protection*, ODNR, 2006). Also, please review storm drain inlet protection along the entrance drive off Crystal Parkway. At least one inlet requires repair.

Fig 6 & 7. Storm drain inlet protection has been installed on the inlets along the entrance drive off Crystal Parkway, but some needs repair (photo at right).

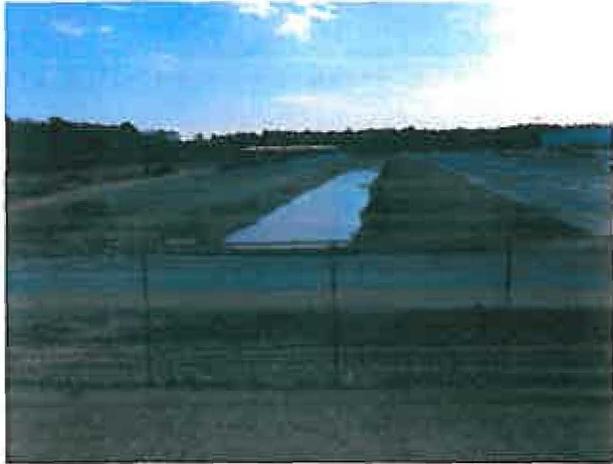
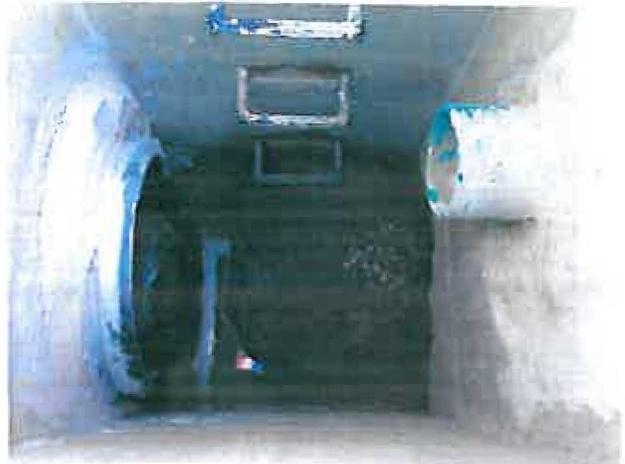
Fig 8 & 9. The East Basin is ponding runoff and the embankments have been hydroseeded. However, please note that sediment was observed inside the basin outlet structure.

- Review the construction of the East Basin outlet. A significant amount of sediment was observed inside the outlet structure. Please ensure that the outlet is watertight such that runoff can only discharge through the skimmer device.

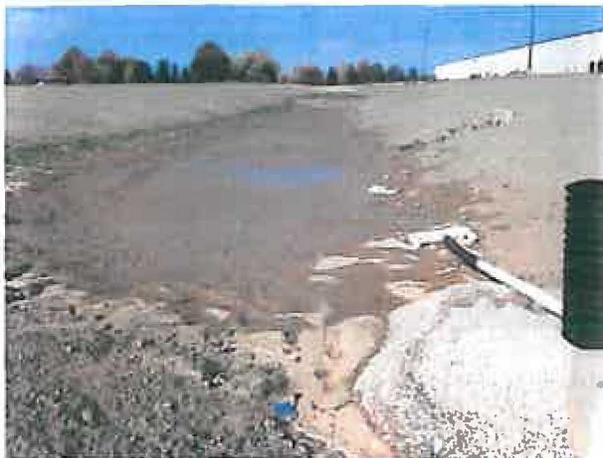
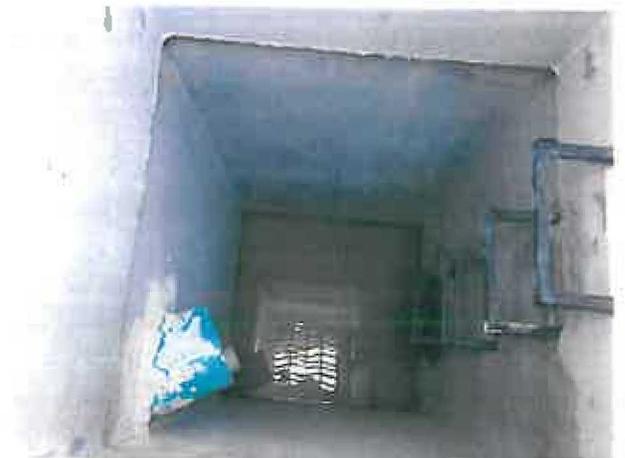
- Whereas there was runoff ponded within the East and Southwest Basins, no water was ponding within the West Basin. This may be an indication of a leak in the outlet structure or open drain pipe. Observation of the interior of the West Basin outlet structure shows that there is a pipe beneath the pipe to which the skimmer is attached. This lower pipe may be allowing runoff to discharge from the pond. Please review this matter and make adjustments as appropriate to ensure the basin functions as intended. At this time, runoff should only discharge from the West Basin via the skimmer device.

Fig 10 & 11. The West Basin is not ponding runoff, but the embankments have been hydroseeded. A look inside the outlet structure indicates that the water quality orifice (white pipe) may not be plugged and is allowing runoff to discharge through it rather than the skimmer as intended.

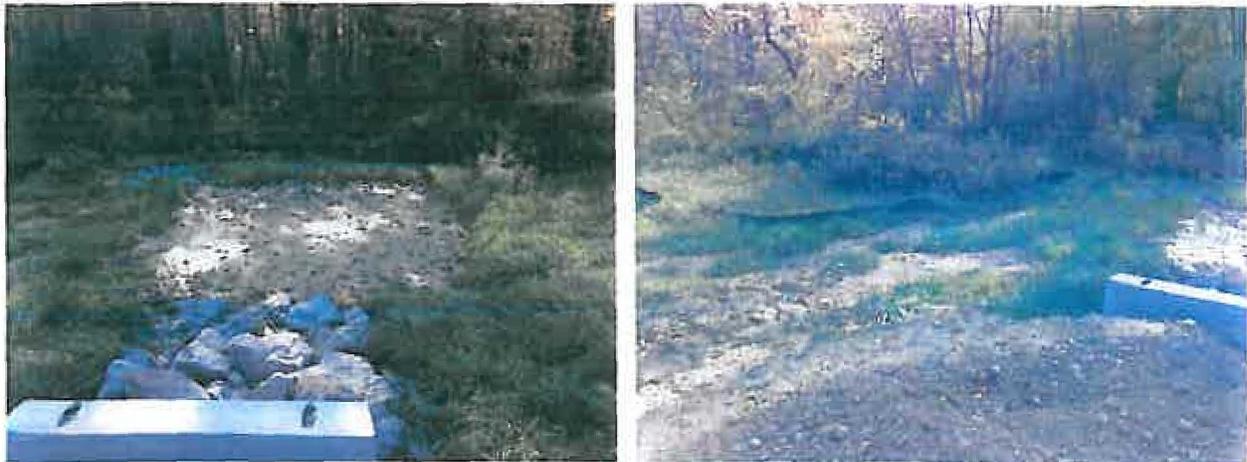
Fig 12 & 13. Sediment deposition at the outlet of the West Basin. The sediment appears to originate from the disturbed area between the basin and the outlet headwall. This same condition existed during my site visit on August 30, 2012. To address this source of sediment, Mr. Hampton was instructed to relocate the silt fence so that came up to the headwall. This did not occur.

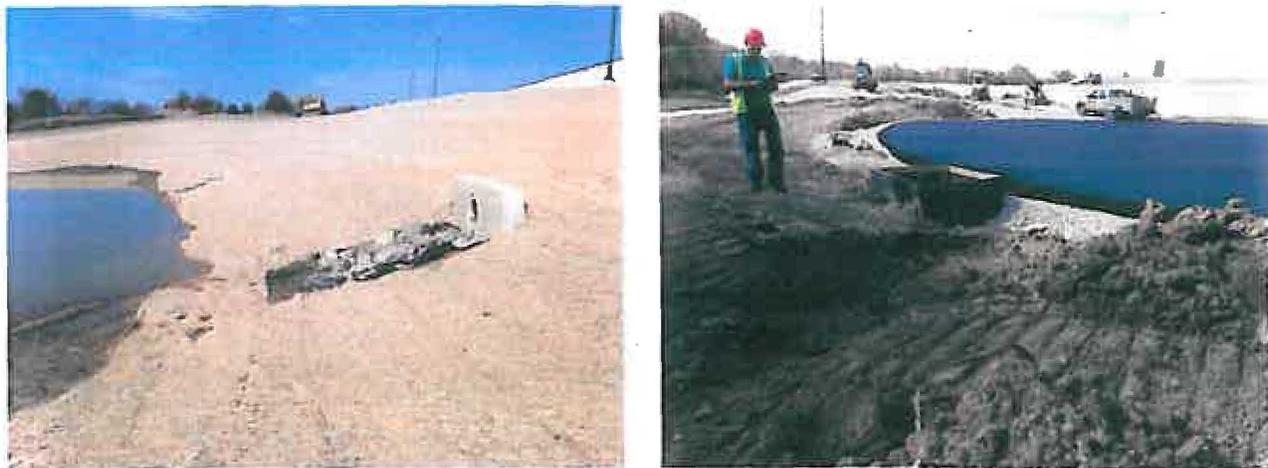
- **Progress Boulevard Extension** – The amended SWP3 submitted to Ohio EPA on September 4, 2012, indicates that a sediment pond is to be provided to the south of the new cul-de-sac associated with the extension of Progress Boulevard. This basin was not present on the date of inspection and no equivalent control was provided as an alternative to the planned basin. As a result, sediment is discharging into wetlands that lie south of this area.

Fig 14 (LEFT). Rip-rap placement within the Southwest Basin. Insufficient stone has been used and stone is not extended to the normal waterline elevation. This will allow erosion to occur at each inlet if not corrected.

Fig 15 (RIGHT). The sediment basin for the Progress Blvd extension has not been installed, yet the road has now been paved. Note also that a swale has been created at the storm drain inlet protection to convey runoff away from the sediment control rather than allowing runoff to pond around it.

Sediment basins are to be installed prior to grading and within seven days of first grubbing the area they are intended to control. As construction progresses and topography is altered, appropriate controls must be constructed or existing controls altered to address the changing drainage patterns. Appropriate sediment controls must be implemented immediately and the storm water pollution prevention plan (SWP3) revised accordingly if you no longer intend to install the sediment controls depicted in the SWP3 amendment received on September 4, 2012.

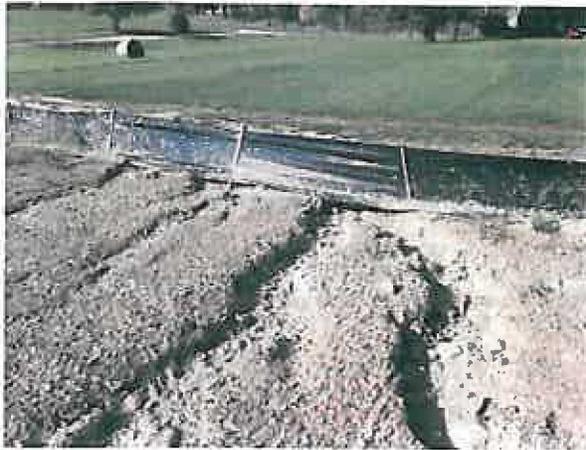
- **Failure to maintain and repair silt fence as needed to ensure continued performance of its intended function.** This is a violation of Part III.G.2.h of the NPDES permit and ORC 6111.04 and 6111.07. There are a number of locations where runoff has eroded under silt fence, silt fence needed to be relocated to serve its intended function, or where silt fence was damaged and in need of repair (see photos). Many of these same locations were noted as deficient during the site visit on August 30, 2012, yet not repaired as of the current inspection. Although Ohio EPA did not provide a written notice of our inspection findings for our site visit on August 30, 2012, Mr. Hampton did accompany me on the inspection and was aware of the areas that needed maintenance. Repair and adjust all sections of silt fence as needed to ensure it is functional.

Fig 16 (LEFT). There are a number of locations where perimeter silt fence requires maintenance and/or replacement. Note that soil is eroding underneath this stretch of silt fence along the north site perimeter. Runoff is directed toward Howe Road.

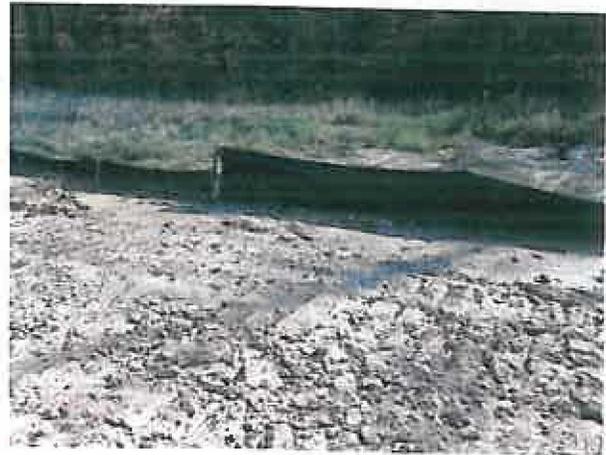
Fig 17 (RIGHT). There is a gap between these two sections of silt fence along the south site perimeter. Runoff must pond along silt fence in order to be an effective sediment control.

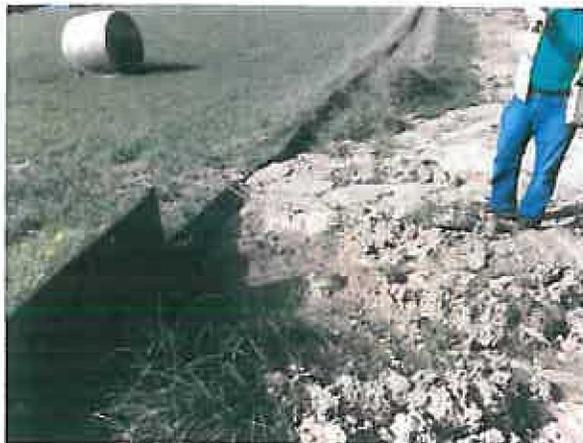
Fig 18 (LEFT). Sediment has built up and knocked down this stretch of silt fence along the west site perimeter.

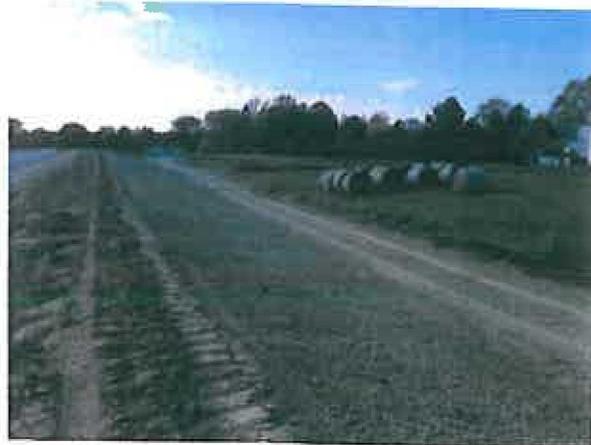
Fig 19 (RIGHT). This stretch of silt fence along the north perimeter is down and must be restored. Although the slope above the silt fence has now been hydroseeded, silt fence must remain in place and be functional until the vegetation in the contributing drainage area reaches a growth density of 70% or greater. Given the late seeding date, this may not occur until Spring 2013.

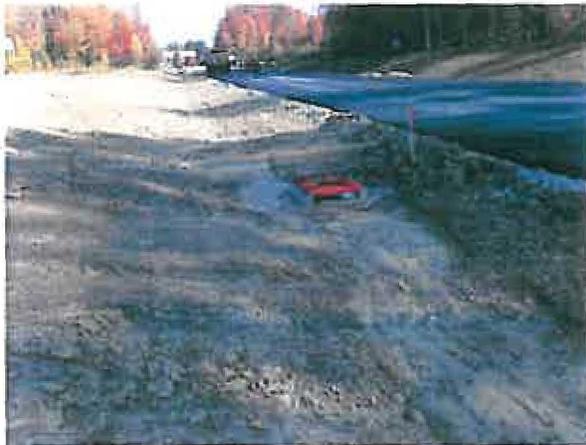
Fig 20 (LEFT). Although a Dandy Bag has been placed on top of storm drain inlets along the Progress Blvd extension, note that there is nothing in place to keep sediment from entering the side windows of these outlets.

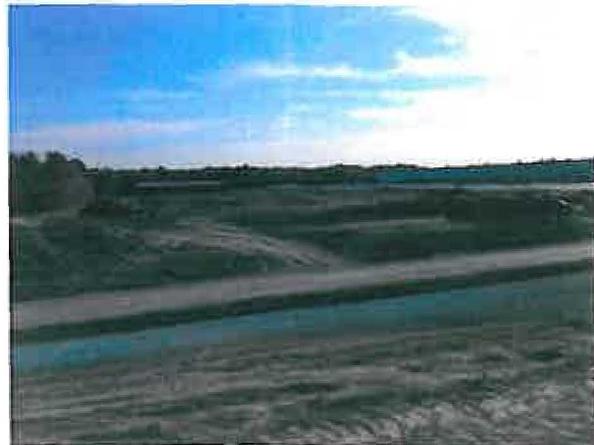
Fig 21 (RIGHT). The disturbed area east of the warehouse has not yet been stabilized. Please ensure this area is either temporarily or permanently stabilized as required by the NPDES permit.

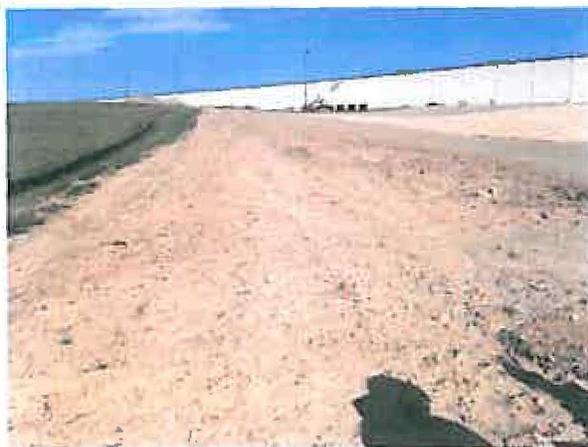
Fig 22 (LEFT). Hydroseeding does not extend to the edge of disturbance around the west side of the Southwest Basin. All areas disturbed by construction that are either at final grade or a grade that will remain for 21 days or longer must be stabilized.

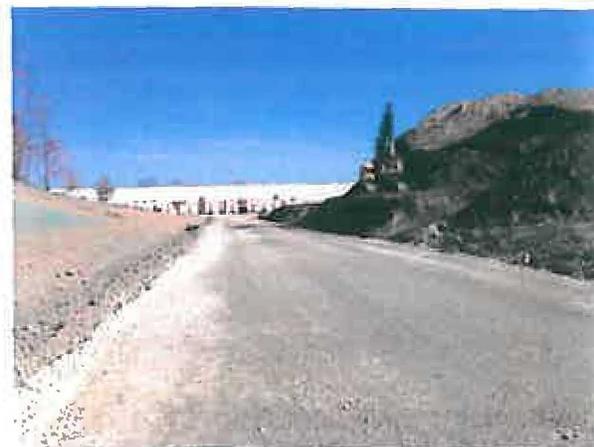
Several options were discussed with Mr. Mosyjowski. Due to topographical issues, it does not appear that you will be able to provide a single post-construction BMP for both the roadway and the future development on the lot south of the roadway off Crystal Parkway. Although Ohio EPA can defer the post-construction BMP for the lot until the lot is developed, we cannot defer the installation of the post-construction BMP for the entrance road as it is being constructed now. Options within Table 2 that may work for you include sand filters, enhanced dry swales and bioretention cells. Design standards for sand filters and bioretention cells can be found in the *Rainwater and Land Development* manual online at:

Fig 23 (RIGHT). Due to topographical differences, it may not be possible to provide a single post-construction BMP that can address both the entrance drive off Crystal Parkway and the lot on which the soil stockpile sits.

I provided design standards for dry enhanced swales to Mr. Mosyjowski via e-mail on October 19, 2012. Please review these options for feasibility with site conditions and amend the SWP3 to include one of these practices. If you can demonstrate that none of these practices are feasible due to physical site constraints, Ohio EPA may consider the use of alternative post-construction BMPs or off-site mitigation. However, Ohio EPA believes that one of the standard post-construction BMPs will be feasible for this project.
