RE: Clean Water Ltd., 1GRN00493*DG, Inspection

NPDES Compliance Inspection Report

Industrial Storm Water No Exposure Inspection

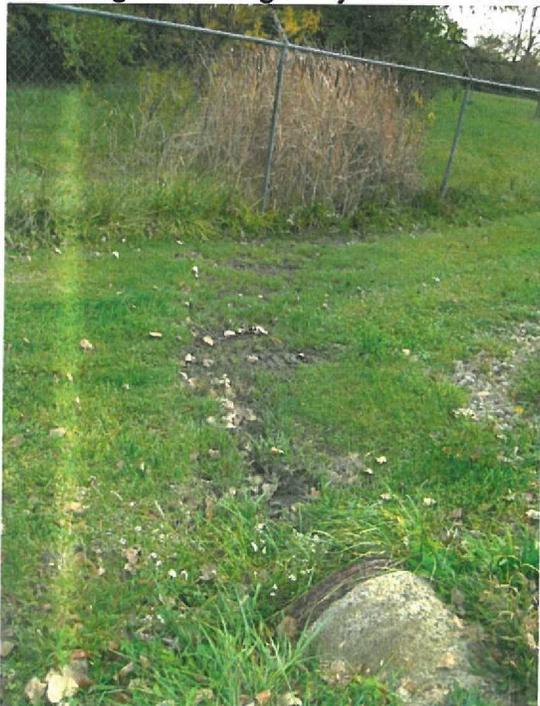
The inspection started with a brief meeting with Josh Rembusch and Ms. Cruset. After the meeting, Ms. Cruset and I walked the facility. There are two catch basins on the north side of the facility which discharge into the one storm water outfall for the site. This outfall then discharges into a grassy swale. The following is a picture of the storm water outfall:

The swale had mud in it from the previous night's rain. There was no evidence of any oils or oily waste discharging from this outfall. There are two catch basins tributary to this outfall.

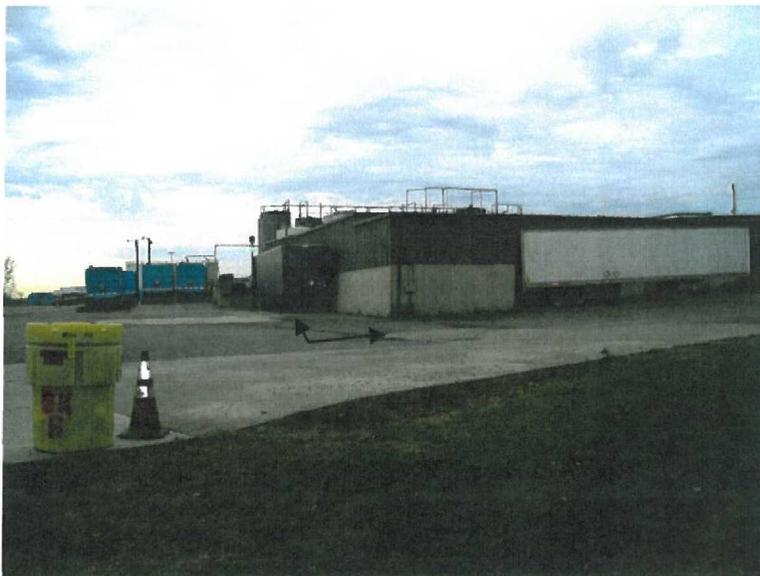
The arrows note the location of the two catch basins looking from the outfall

There are frac tanks and 55 gallon drums stored in this area. There were no leaks noted during the inspection. There was no evidence of any spills or leaks in the catch basins. The frac tanks with material in them were in temporary secondary containment. This consisted of a liner with metal braces to hold the sides in place. These containment units need to be inspected at least daily to ensure the braces are still in place, and the liner isn't sagging. At least two of the secondary containment units were sagging. They did not appear to be leaking any liquid.

Clean Water Ltd. must add the secondary containment around the frac tanks to its daily inspections to ensure it is working as required. This must begin immediately.

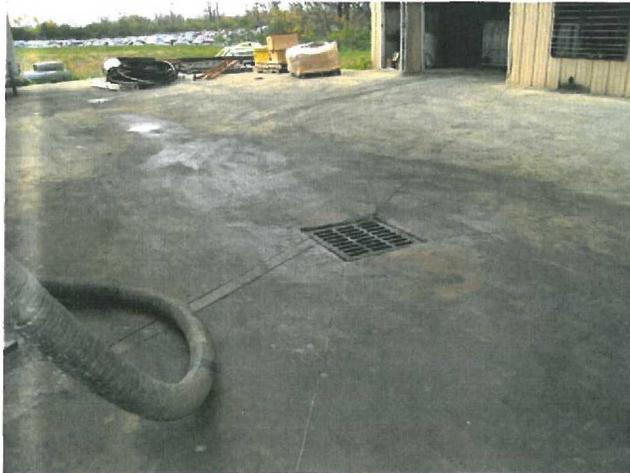
There is a catch basin in the unloading area near the wastewater treatment system. The following is a picture of this basin:

This basin is pumped into the pretreatment system. The hose shown in the picture is used for unloading tanker trucks directly into the wastewater treatment system. This is not discharged to waters of the State. This is discharged to the Montgomery County (the County) Sanitary Sewer under a permit issued by the County. The treatment chemicals are seen in the back of the picture. There was also an open bucket used under the valve to catch drips when the truck is unloading, and totes with sludge from the wastewater treatment system waiting to go to the filter press. The following are pictures of these two items:

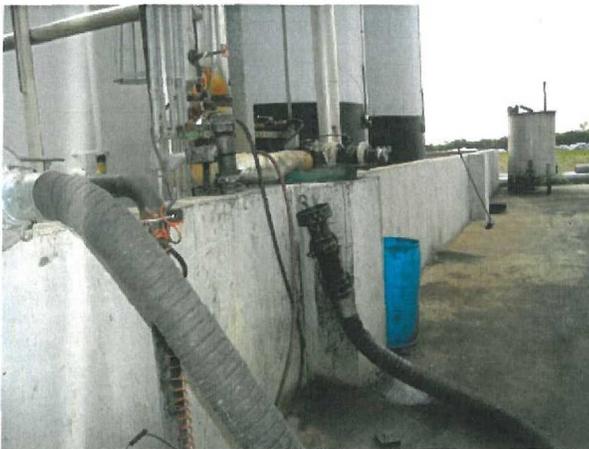
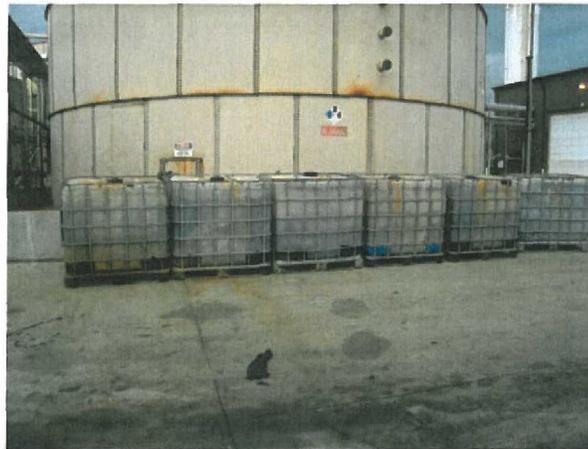
The totes could be a potential source of odors. This material can turn anoxic or anaerobic sitting in the totes. The quicker the solids are taken to the filter press and processed, the less of a chance there is for odors to occur.

Clean Water Ltd. must prevent the exposure of storm water with the sludge from the filter press. At the inspection, a roofed building extension was discussed. Please provide the means for doing this by November 19, 2012. If this cannot be done, then the facility would no longer be eligible for the No Exposure Certification.
